# SAVANNAH CITY HALL INTERIOR CONDITION ASSESSMENT AND RESTORATION PLAN

Completed June 2018 for the City of Savannah

Lominack Kolman Smith Architects  
301 W Broughton Street  
Suite 301  
Savannah, GA 31401  
912.232.5561

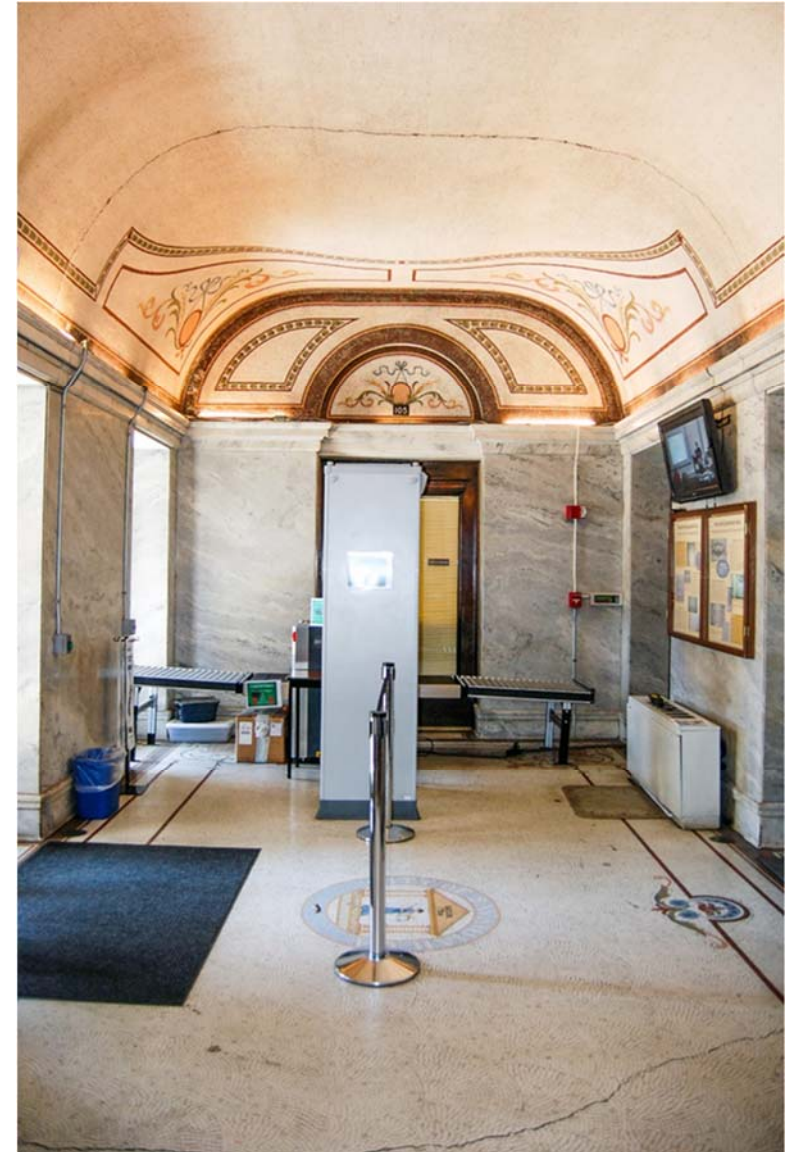
The most noticeable concern in this space are the cracks that run the full length of the space from north to south at both the floor and the ceiling, in addition to other smaller cracks that extend in the same direction (Figure 4). The cracks along the floor are also visible within the tiled portico floor, just outside the building's front door. The cracks are identifiable by prominent dark colored mortar joints which run along the crack line, which are missing grout. The surfaces at each crack location appear to remain flush with the floor, however, as deflection only appears to have occurred laterally.

View of Lobby, looking west.  
Figure 4

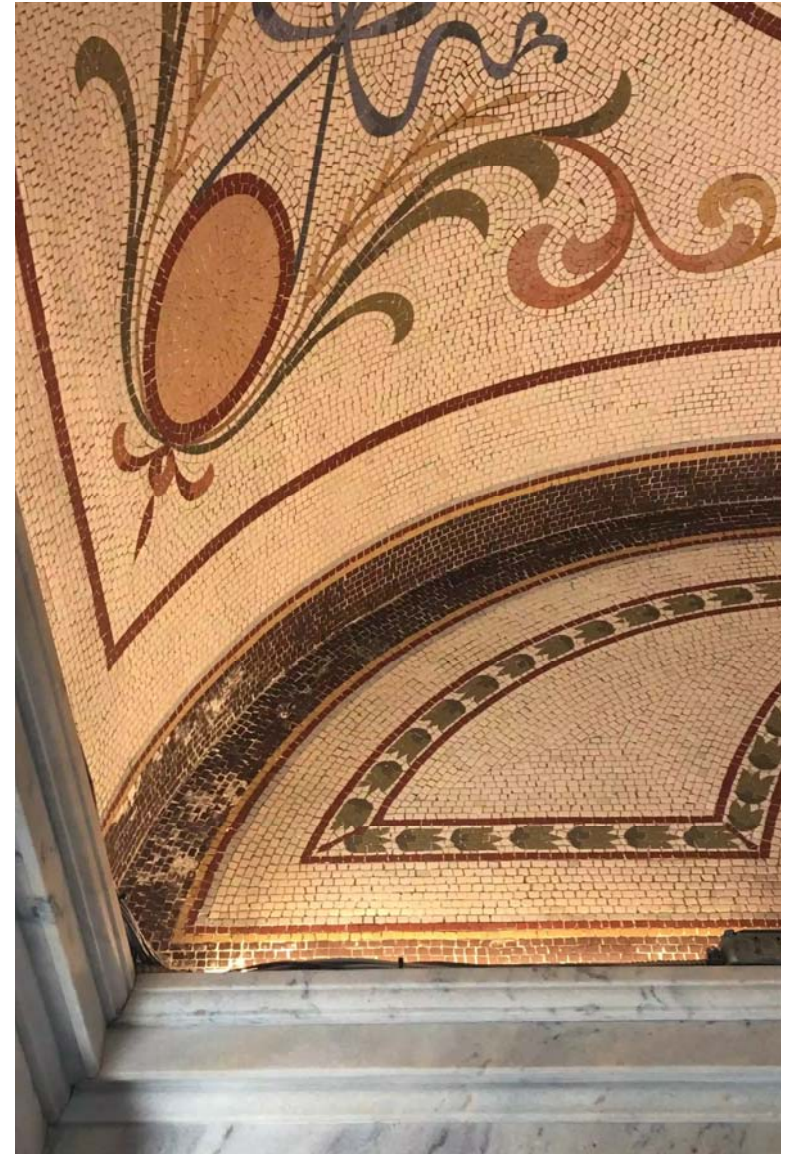
Additional deterioration has occurred at the ceiling level, where the southwest corner of the room's vaulted ceiling appears to be suffering from efflorescence, or surface salt build up, which is present on the ceiling's historic mosaic tile (Figure 5). No warping or bubbling has occurred.

*Efflorescence on mosaic tile in southwest corner of Lobby ceiling.  
Figure 5*

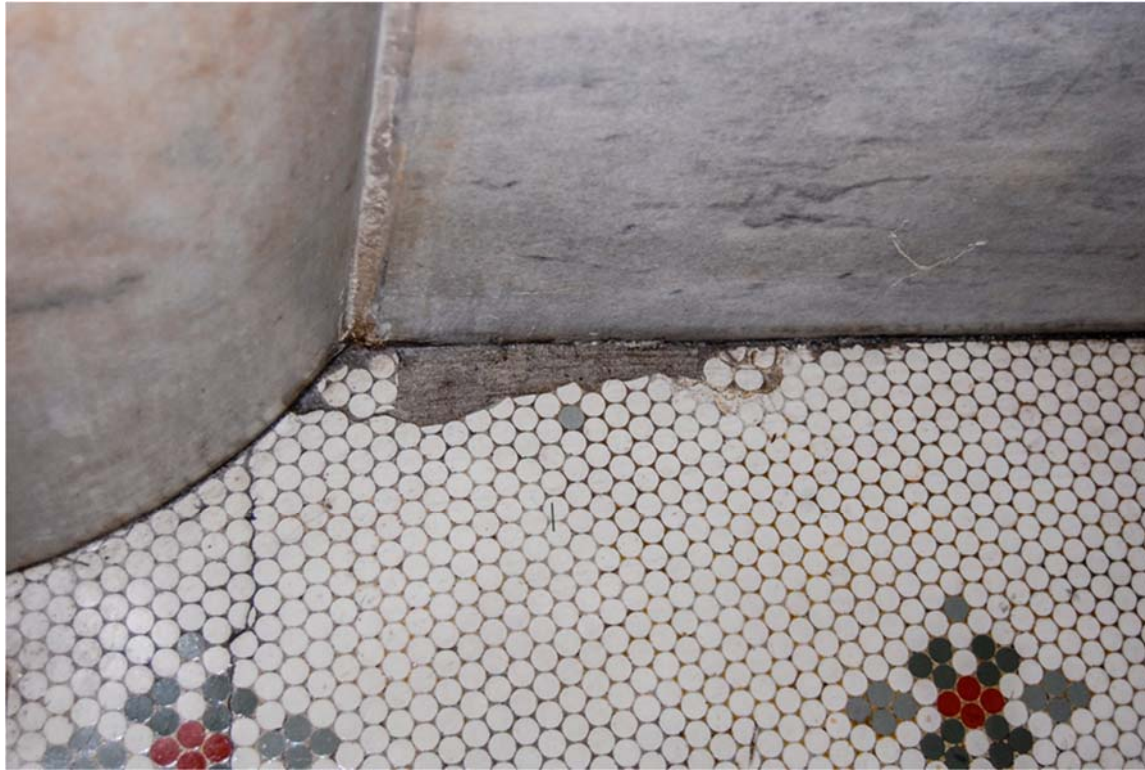
*Tile loss in northeast alcove on east wall of first floor Rotunda  
Figure 7*

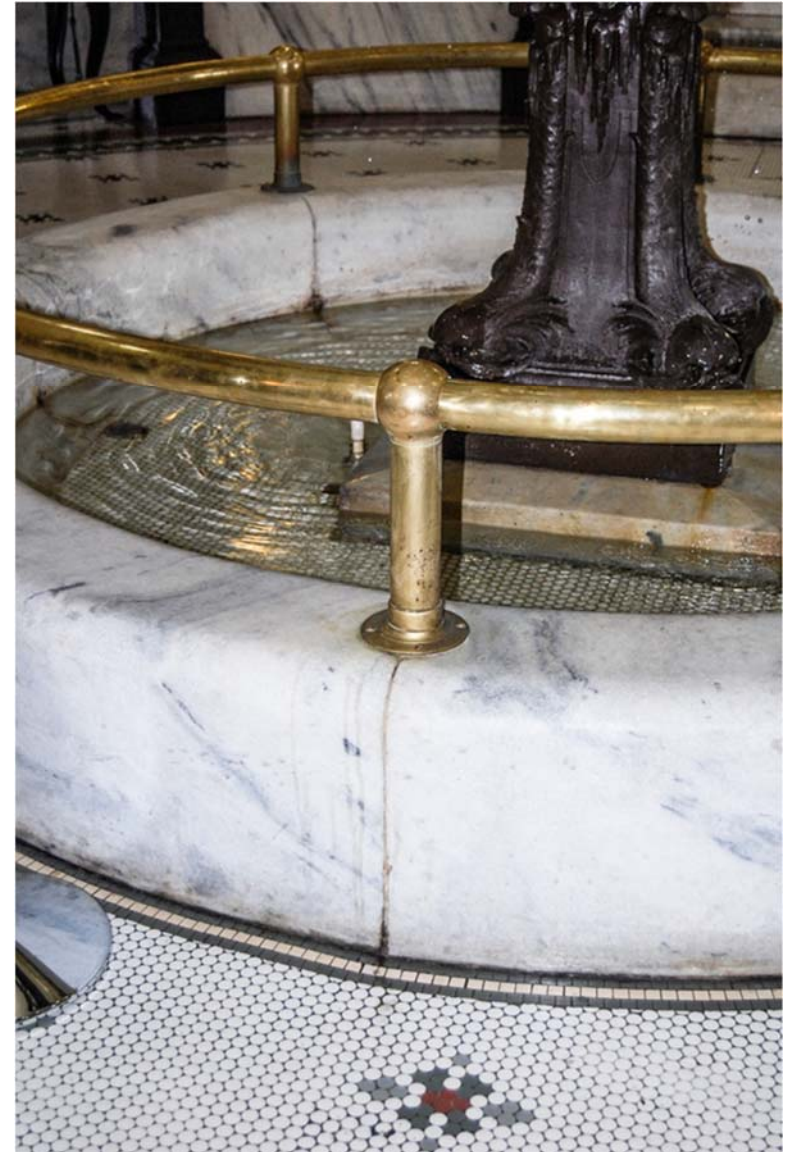
The brass handrail is in good condition but is lightly tarnished (Figure 9). Other brass elements in this space include flush mount ceiling and wall mount sconce light fixtures, which show similar levels of tarnish.

*Detail of fountain edge showing intersection of mosaic floor tile, marble fountain base, and brass handrail Figure 9*

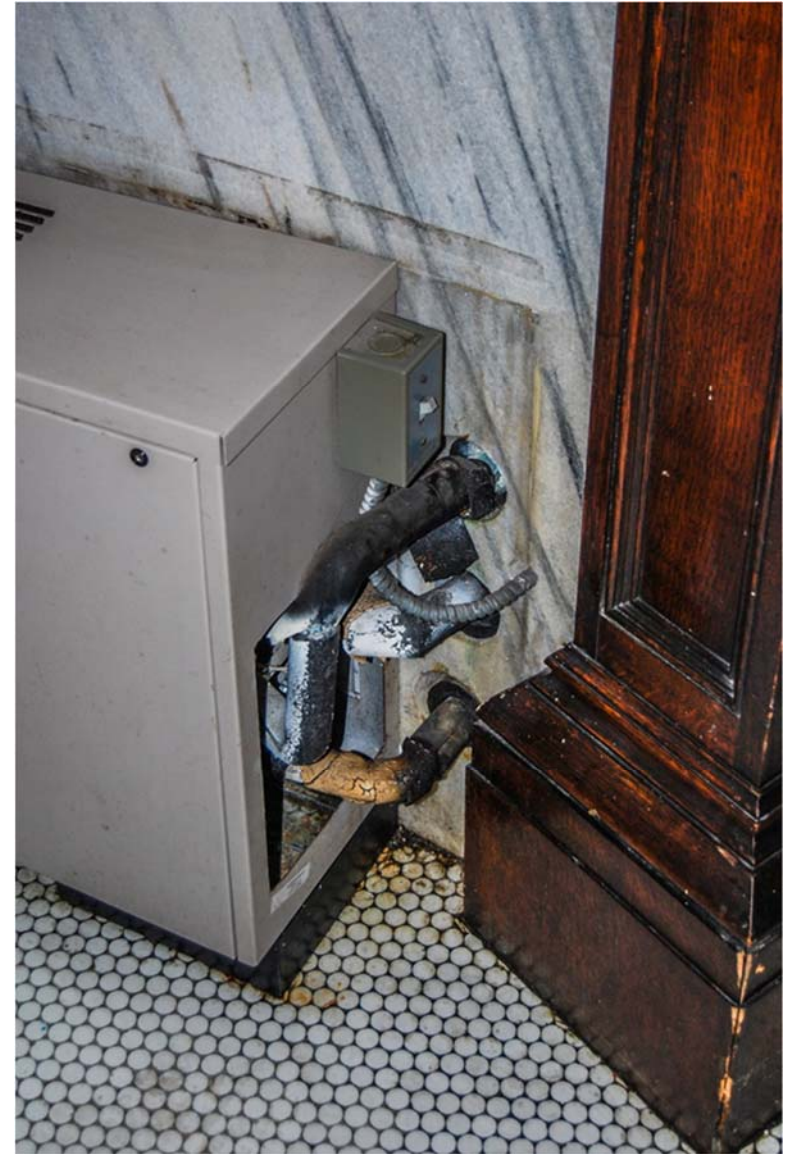
*Detail of HVAC connection on South wall in Second Floor Rotunda.  
Figure 10*

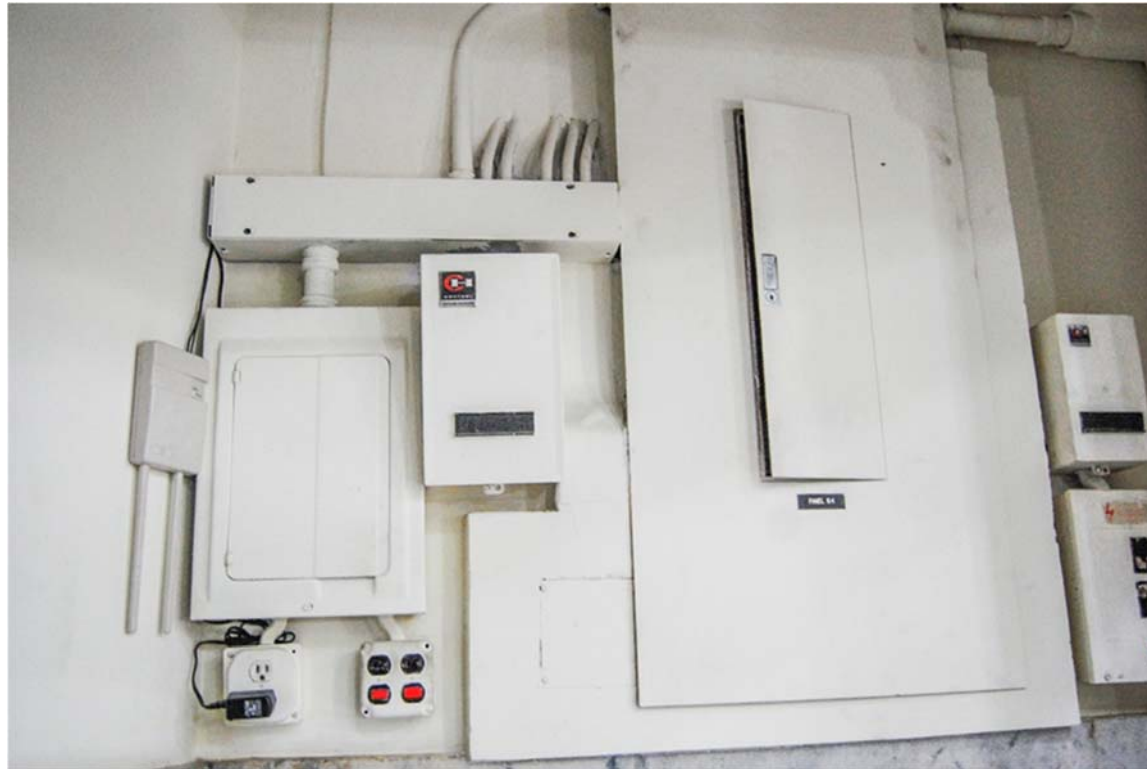
*Electrical panels on west wall of southwest alcove in second floor of the Rotunda.*

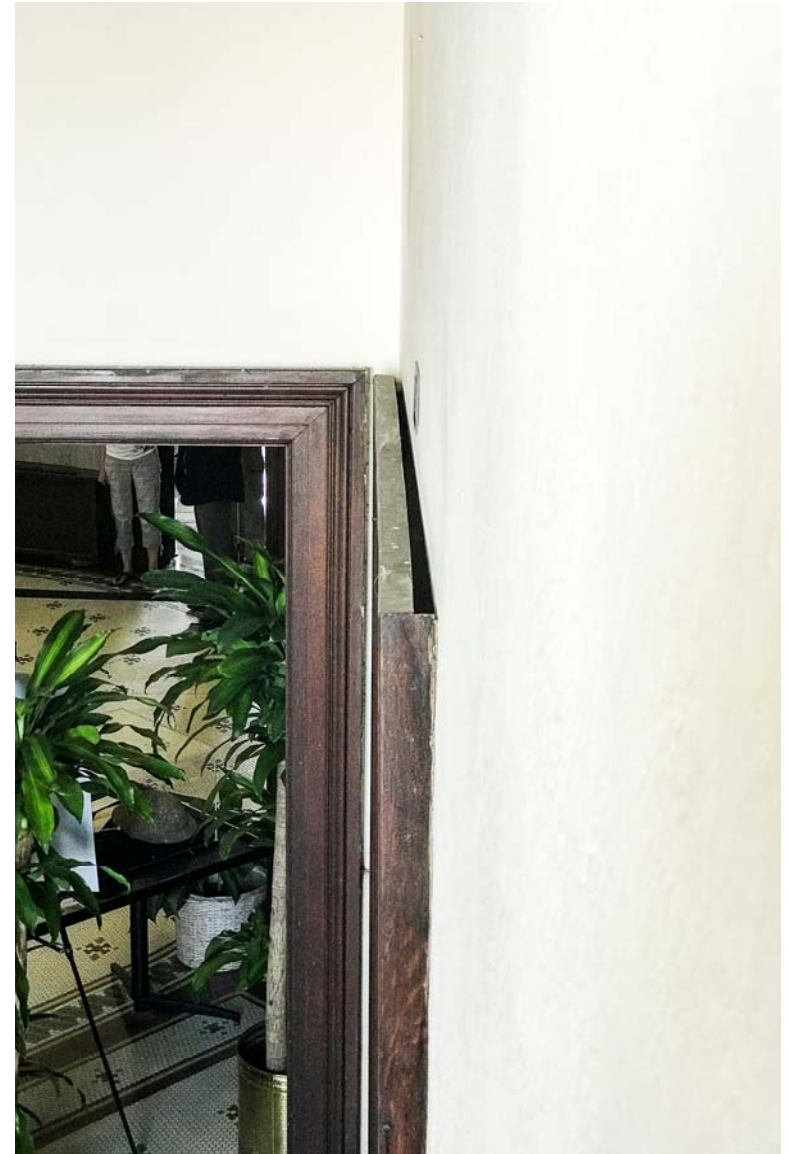
*Detail of unsecured framing of entrance into the Municipal Records and Archives off the first floor Corridor on west wall. Figure 13*

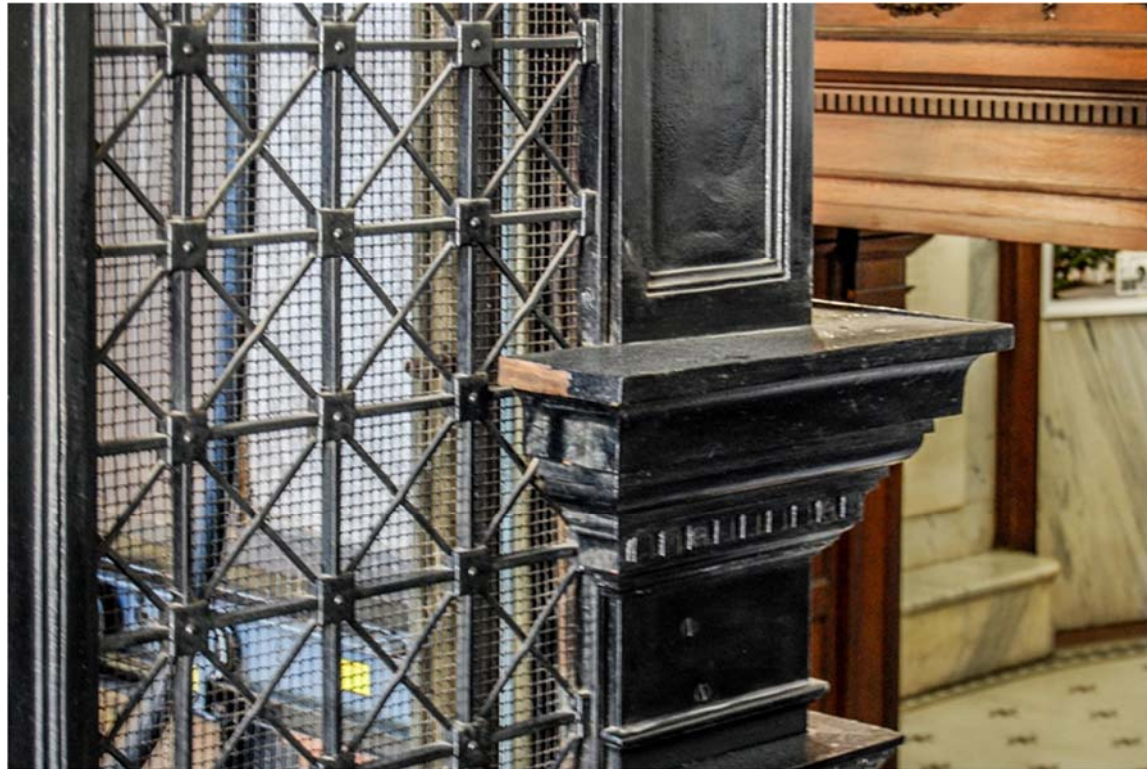
*Location of missing paint on elevator column capital detail.  
Figure 15*

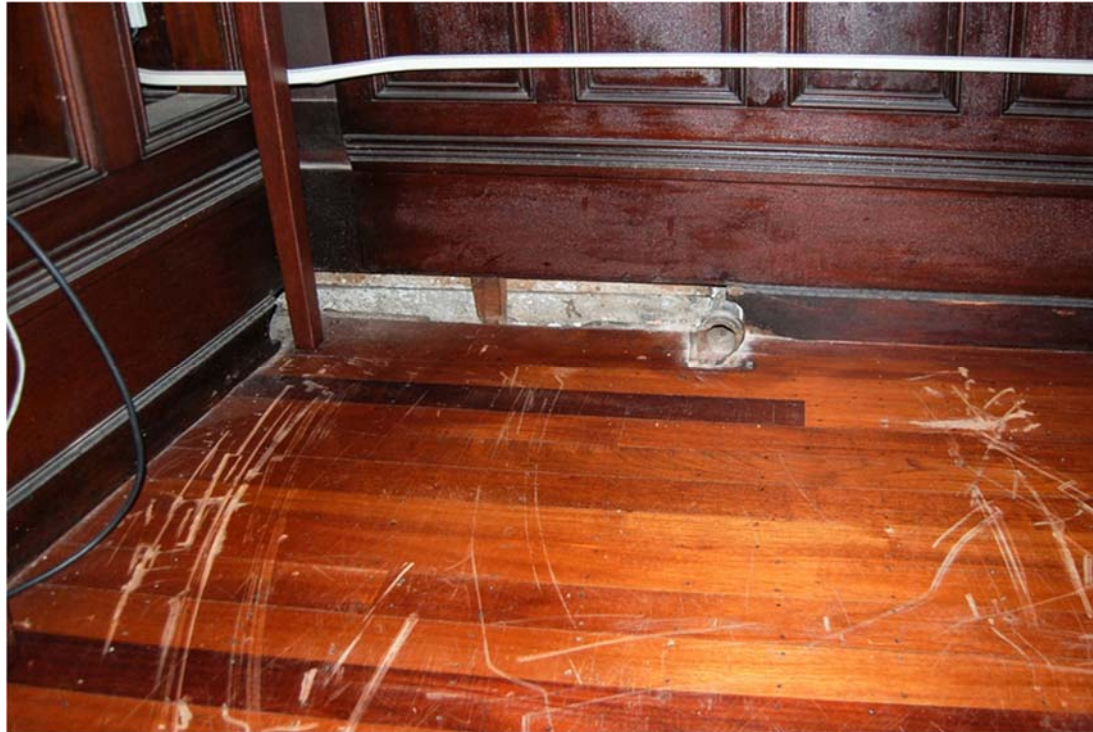
*Detail of wood floor of Council Chambers along west wall, northwest of Council platform.  
Figure 18*

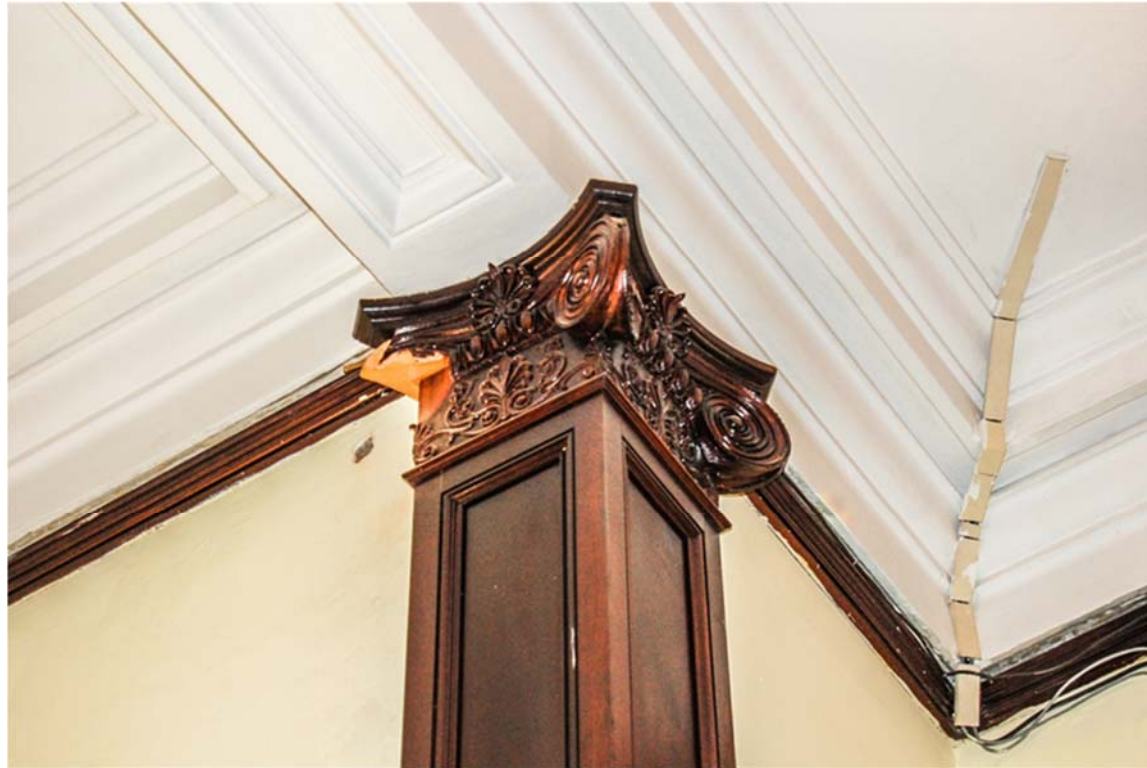
*Missing ionic scroll from engaged column capital in Council Chambers at southwest corner.*

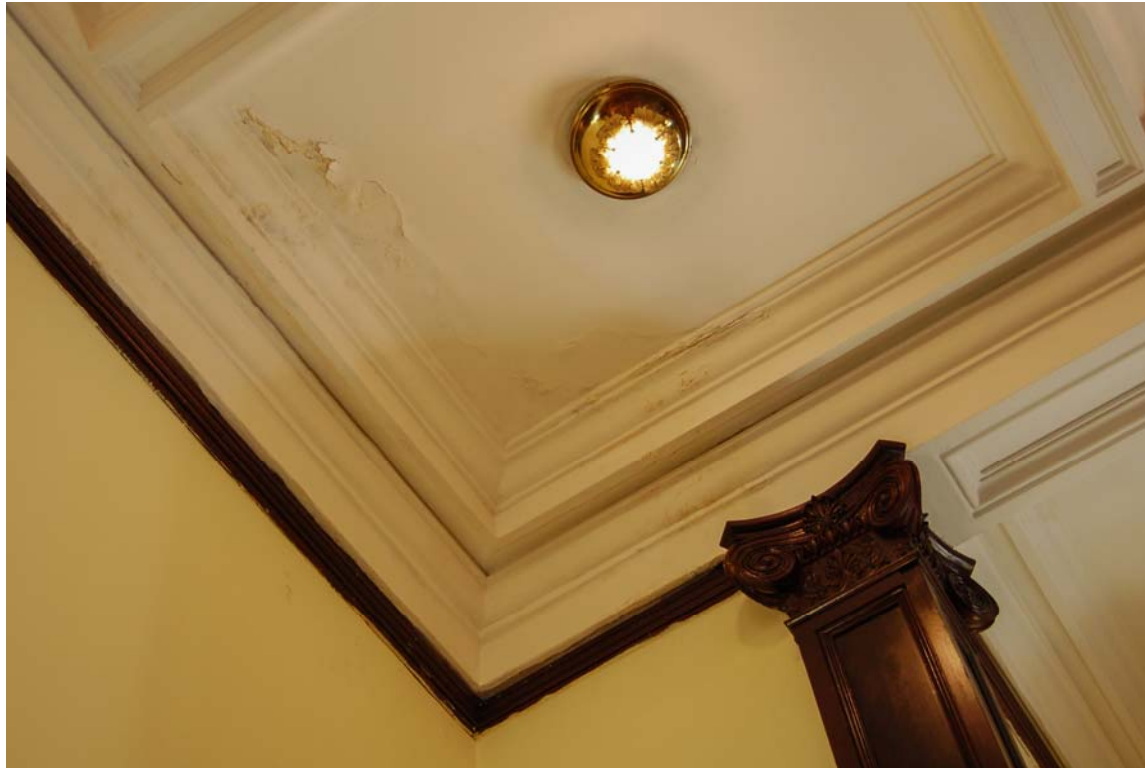
*Detail of ceiling coffer plaster damage at southeast corner of Council Chambers.  
Figure 21*

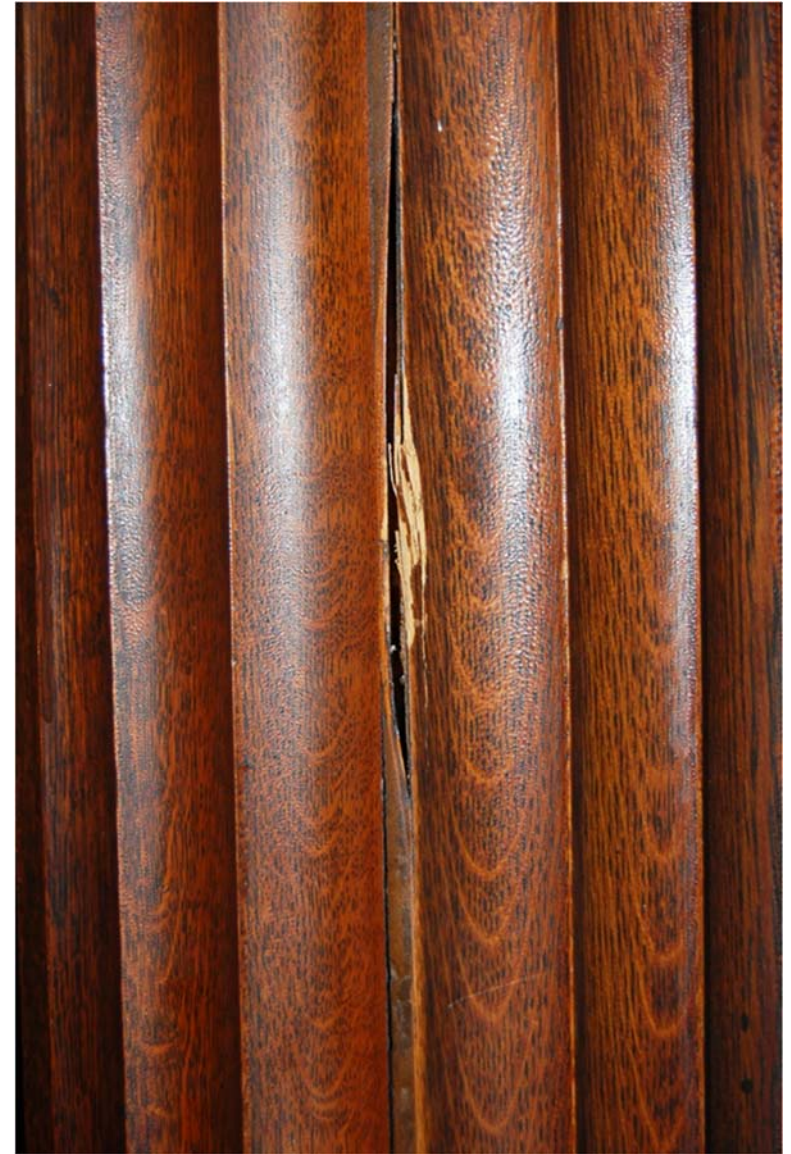
*Detail of split fluting of column framing the eastern entrance to Reception Room. Figure 24*

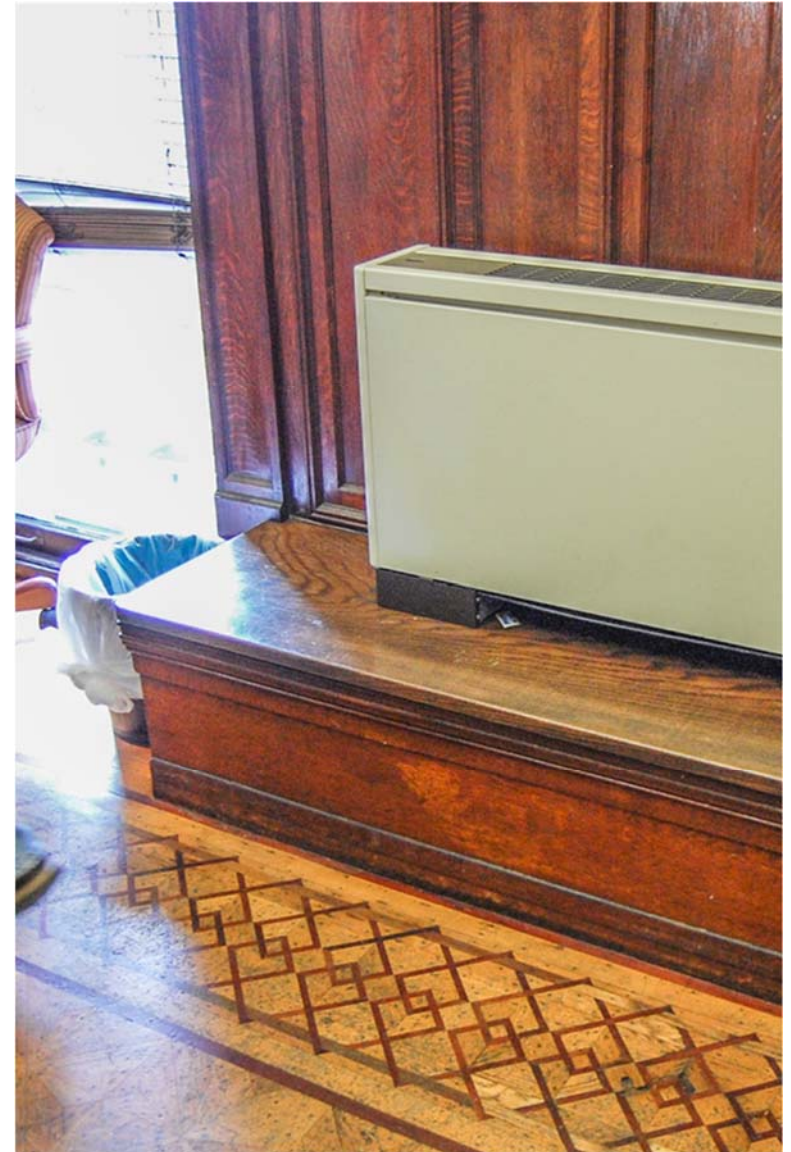
*Modern HVAC units mounted to historic benches on south wall of Reception Room. Figure 25*

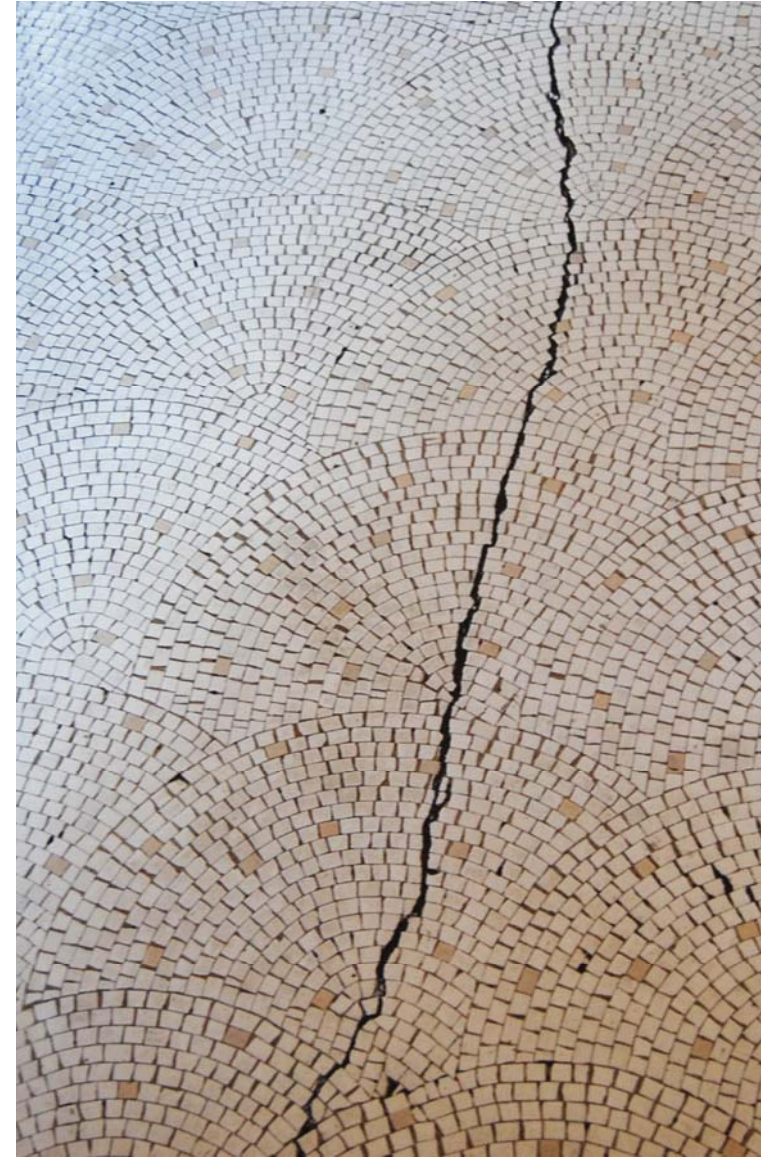
*Crack in mosaic tile floor of Lobby.  
Figure 31*

In order to confirm with greater certainty the existence or absence of settling at City Hall, a structural evaluation of the building in its entirety is recommended. This would involve the development of a topographic map of the floor, showing any variations in elevation, an indication of settlement. Following, structural monitoring should be initiated. While both high-precision and low-precision crack monitoring is available, it is recommended that low-precision monitoring be performed. Rooted in discussions that followed an initial structural assessment with Bennett Preservation Engineering, it is believed that this will provide the information necessary to ensure that the building is not experiencing active settling that would be to the detriment of tile restoration efforts.

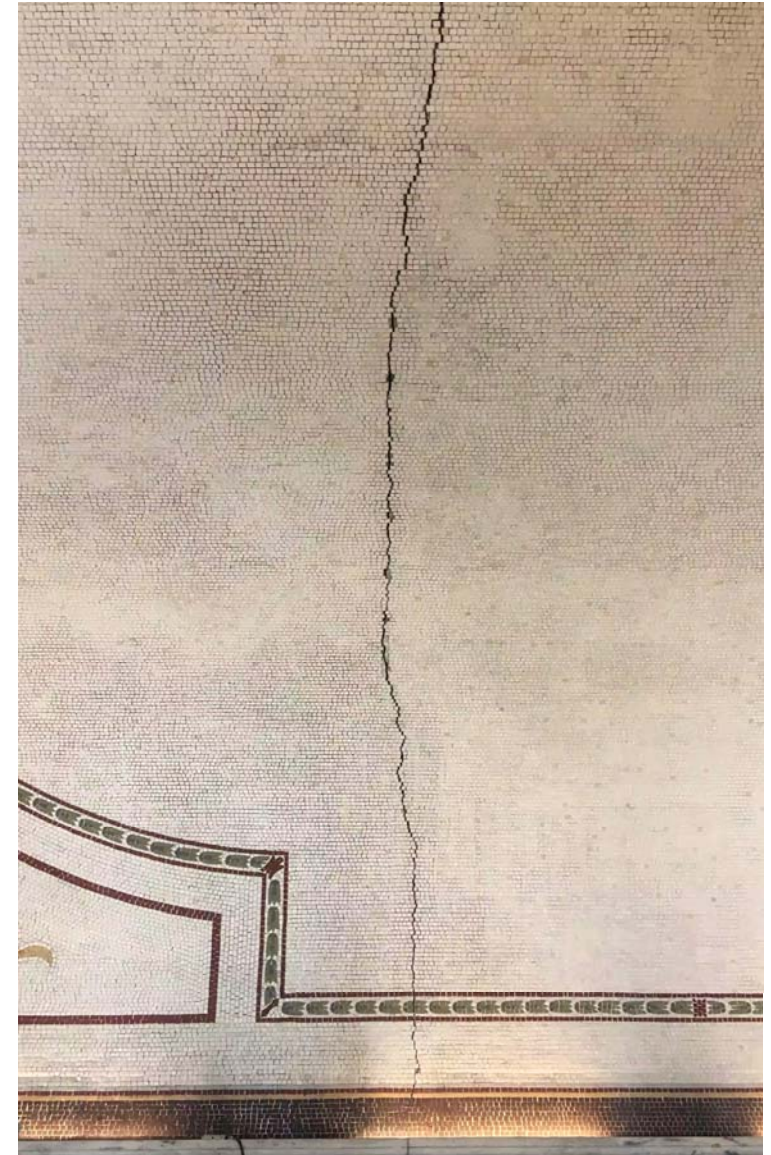
*Crack in mosaic tile ceiling of Lobby.  
Figure 32*

To avoid damage, all grout around each tile should be removed first, best accomplished by an experienced tile installer using a hand tool or grout saw. Potential concerns with this method include differences in new tiles related to thickness, color, and setting bed which may lead to noticeable visual differences or leveling problems (Preservation Brief 40).

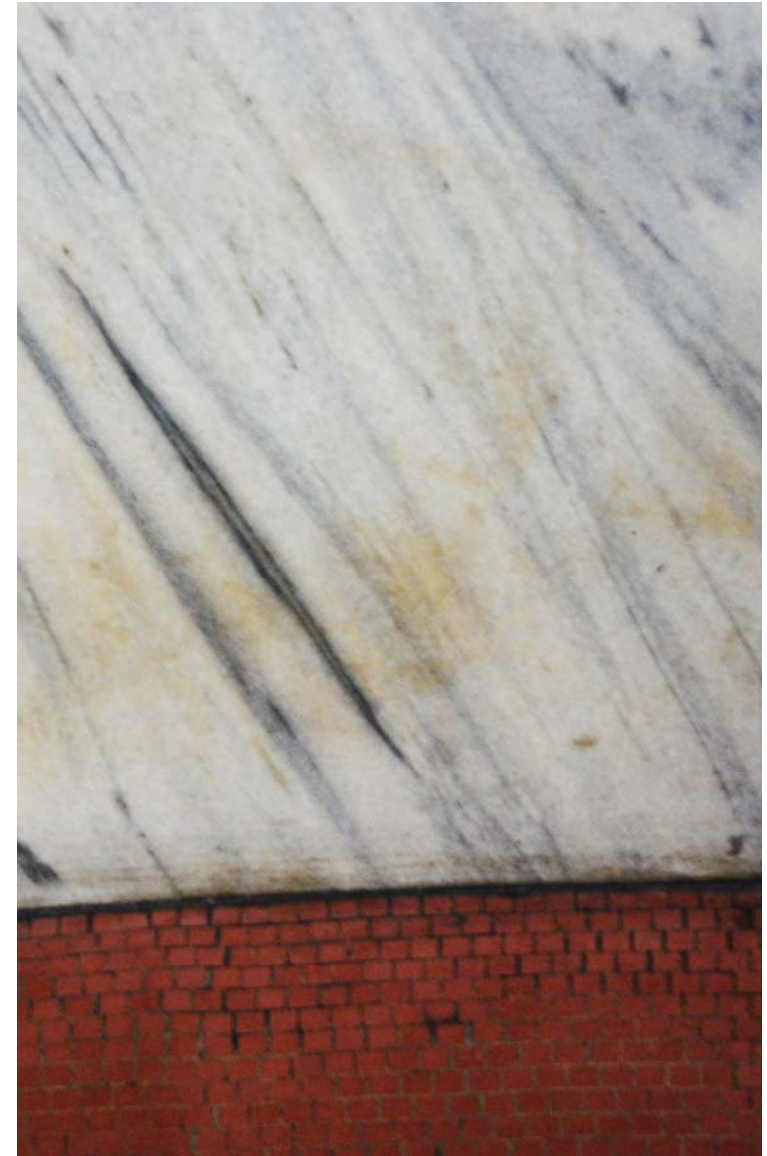
*Stained marble in Lobby wall panels.  
Figure 34*

1. Carefully remove dust and debris from surface using a damp microfiber cloth.
2. Test cleaning products in an inconspicuous location to ensure their effectiveness and that no detriment will occur to the historic material.
3. Mix the liquid additive with a dry poultice, or fuller's earth, to a thick cream consistency to make smooth.
4. Wet the marble and apply a 1/4 inch thick layer of the poultice to stained areas using a stainless steel trowel or other non-ferrous implement.
5. Cover with a plastic membrane and allow to dwell approximately 8 to 24 hours.
6. Scrub all surfaces with non-metallic brushes to remove staining. Use a low pressure water rinse with a sponge or microfiber cloth. Let area dry before inspection. This process should be repeated for a second time or as needed for desired results.

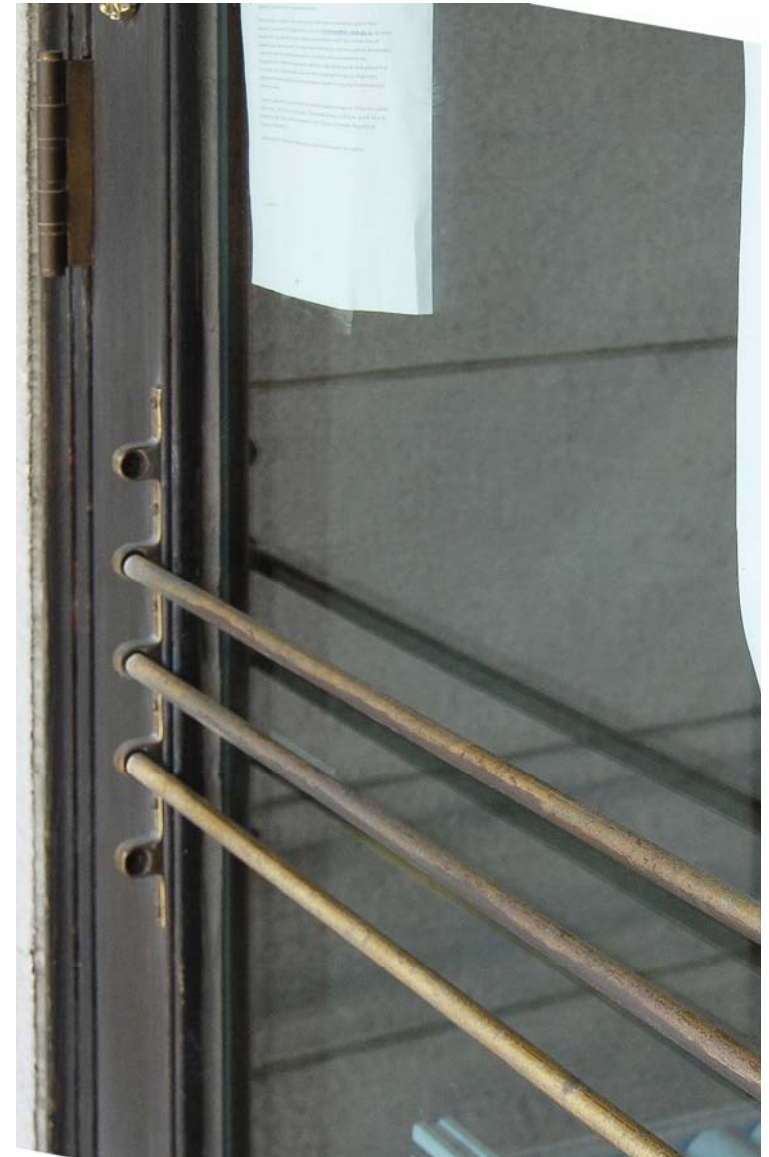
*Front entrance door showing missing brass hardware.*

Due to the fact that the original doors do not remain, it is recommended that the replica doors be retained. The methods recommended for removing the warp from the main entrance door require removal, deconstruction, and reinstallation. As part of this process, the door's stiles and rails will be adjusted, planed, and leveled. This may require the use of heat, pressure, and sanding devices. Care should be taken to retain as much original material as possible. Any new wood stain applied should be made to match the color present on the other doors in the space currently unless part of a larger comprehensive wood stain restoration.

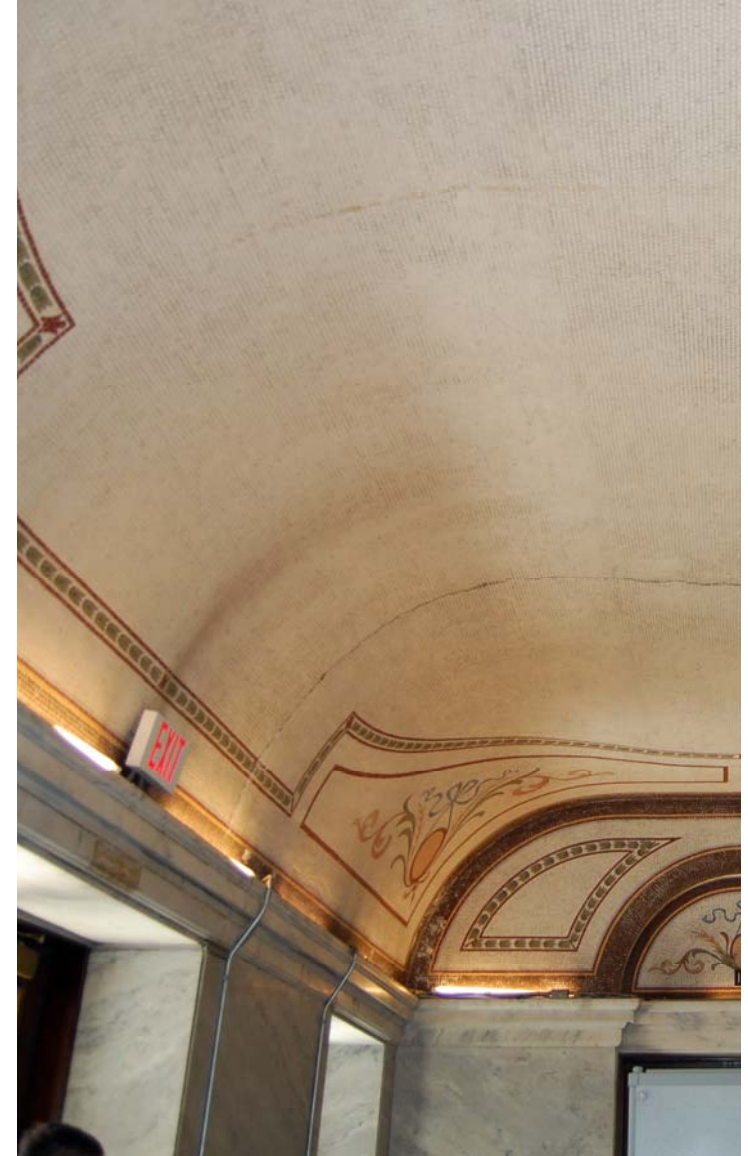
Currently, the Lobby is illuminated by fluorescent cove lights that are unoriginal to the space. These provide light in a hue and temperature inappropriate for this turn of the century space. Further, the fixtures installed are failing to remain hidden from view atop the space's marble cove molding.

*Image showing the cove lights in the lobby.  
Figure 38*

Modern LED cove lights are a good option for replacement of the existing fluorescent tubes as they are thinner, smaller in size, and can be set atop the top plane of the molding to illuminate light upwards. Generally made in a strip light format, LED cove lights provide a consistent glow with a significant life span. They require little to no maintenance and are easy to replace. It is recommended that the correlated color temperature (CCT) selected be between 2700 and 3000 Kelvin, to provide warm white illumination, as opposed to the white glow fluorescent lighting provides, as this would not have been available historically.

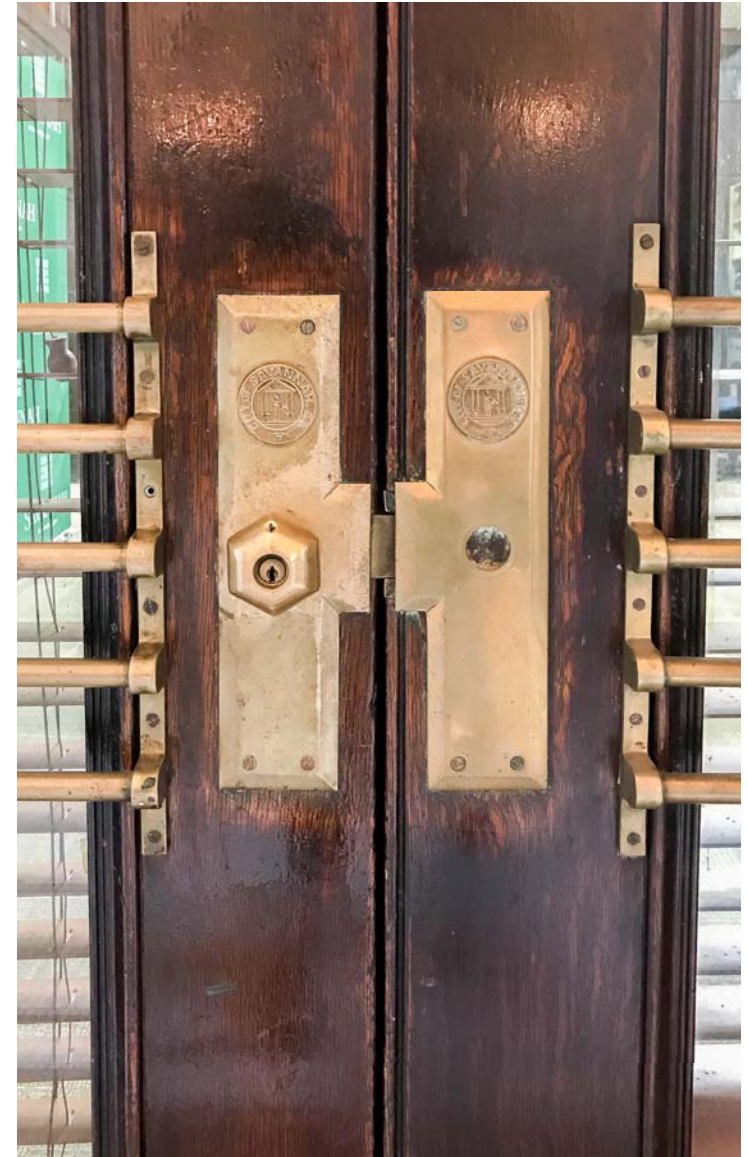
Within the space, the interior doors leading into neighboring spaces to the east and west feature double doors, both sets of which are missing one door knob from the original hardware set.

*Double door hardware with missing knob in Lobby.  
Figure 39*

A secondary solution is to have a replica door knob commissioned from a mold of an existing knob, which would be placed in the location of the missing piece. Care should be taken to consider the existing patina of the brass and the appearance of a new element in conjunction with pieces which have aged. Due to the uniqueness of the hexagonal shape of the knob, it would not be possible to find a replacement without casting a mold from an existing knob. The doors in the lobby should receive original knobs from a less conspicuous, or public, location within the building. In these less public areas, the new replacement knobs should be installed to allow all doors within the building to have working hardware.

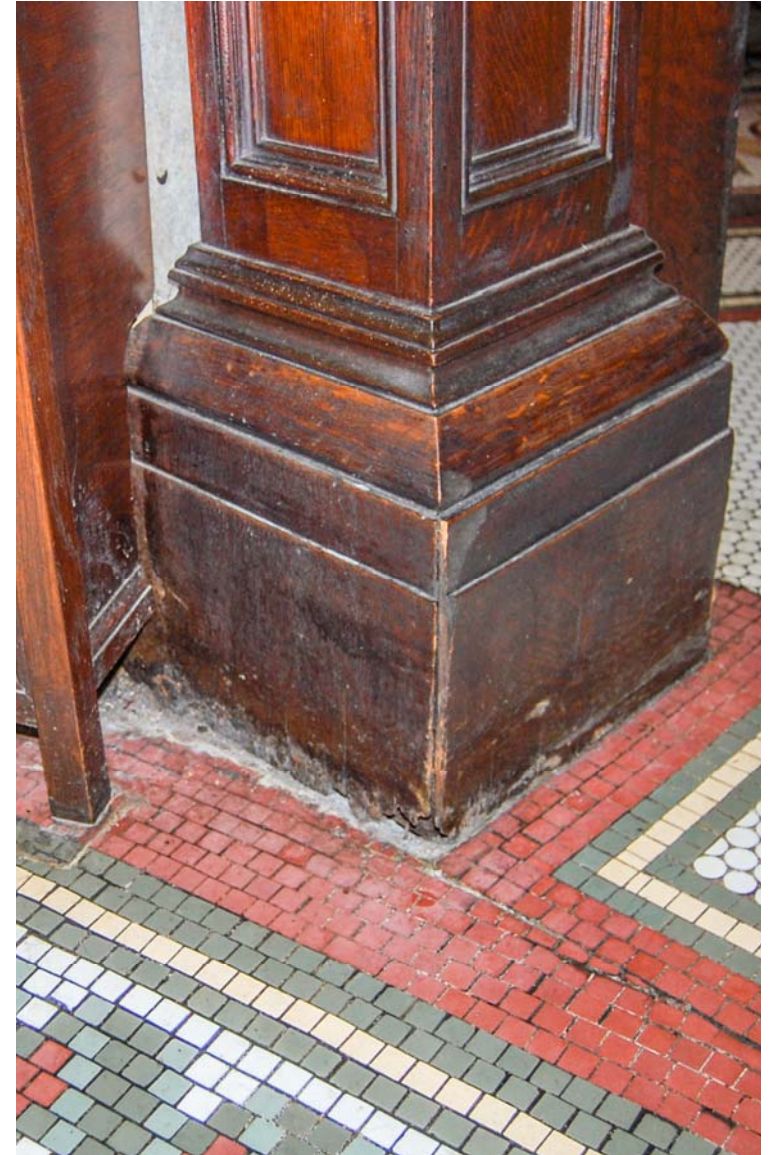
*Detail of base wood door frame in Rotunda.  
Figure 42*

Assess the amount of deteriorated woodwork with the potential to be repaired in place and replace in-kind, only as absolutely necessary. Repairs should utilize original pieces, when available, or the same species of wood, millwork profile specifications, and finish to match the existing. Whole pieces of wood should be replaced when there is damage, such as the missing base pieces of the mezzanine or the bases of the engaged pilasters. Dutchman repair is not recommended. During assessment, the stability of all woodwork should be examined. Following, all repaired or replaced woodwork should receive the same finish treatment as specified on the page 66.

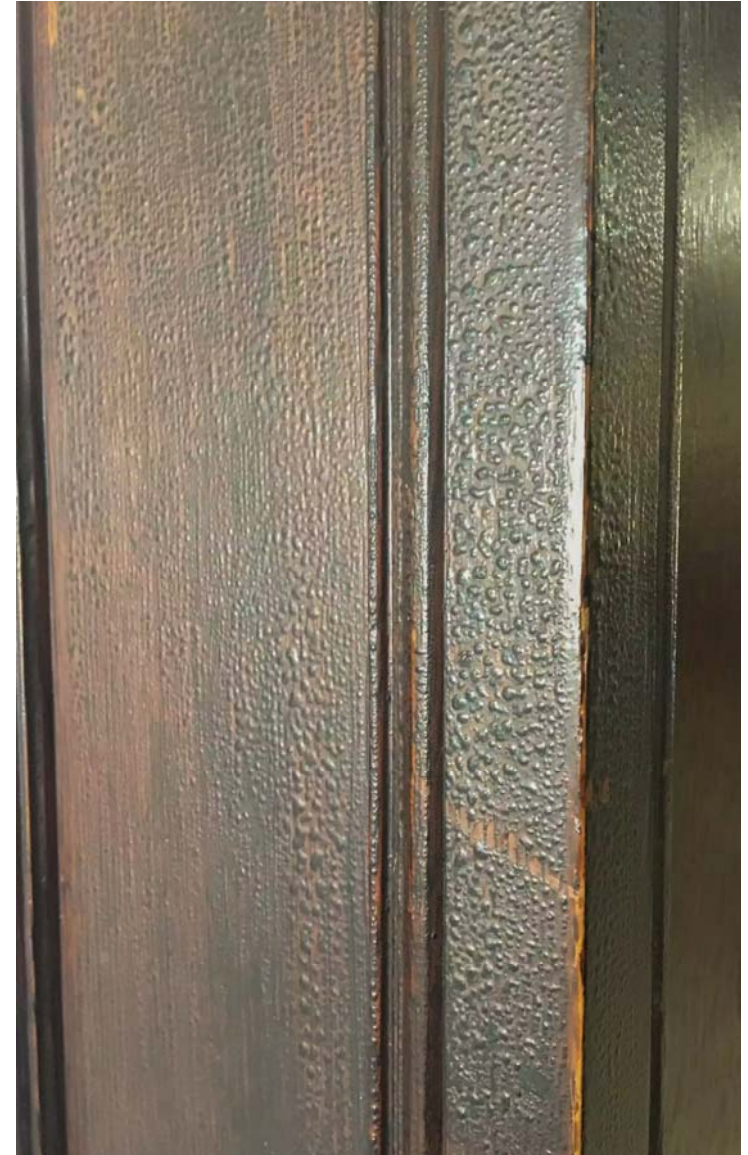
*Detail of stain on wood door frame in Rotunda.  
Figure 43*

A finish analysis should be completed using samples from inconspicuous locations in order to determine the original woodwork finish. Assess the amount of deteriorated woodwork with the potential to be repaired in-place and replace in-kind, only as absolutely necessary. Repairs should utilize the same species of wood, millwork profile specifications, and finish to match as specified in detail on page 64. To refinish, all woodwork should first be cleaned to remove any standing dust or debris, then stripped and lightly sanded. The woodwork should then be refinished using a matching amber shellac and finished using a butcher's wax or paste to seal.

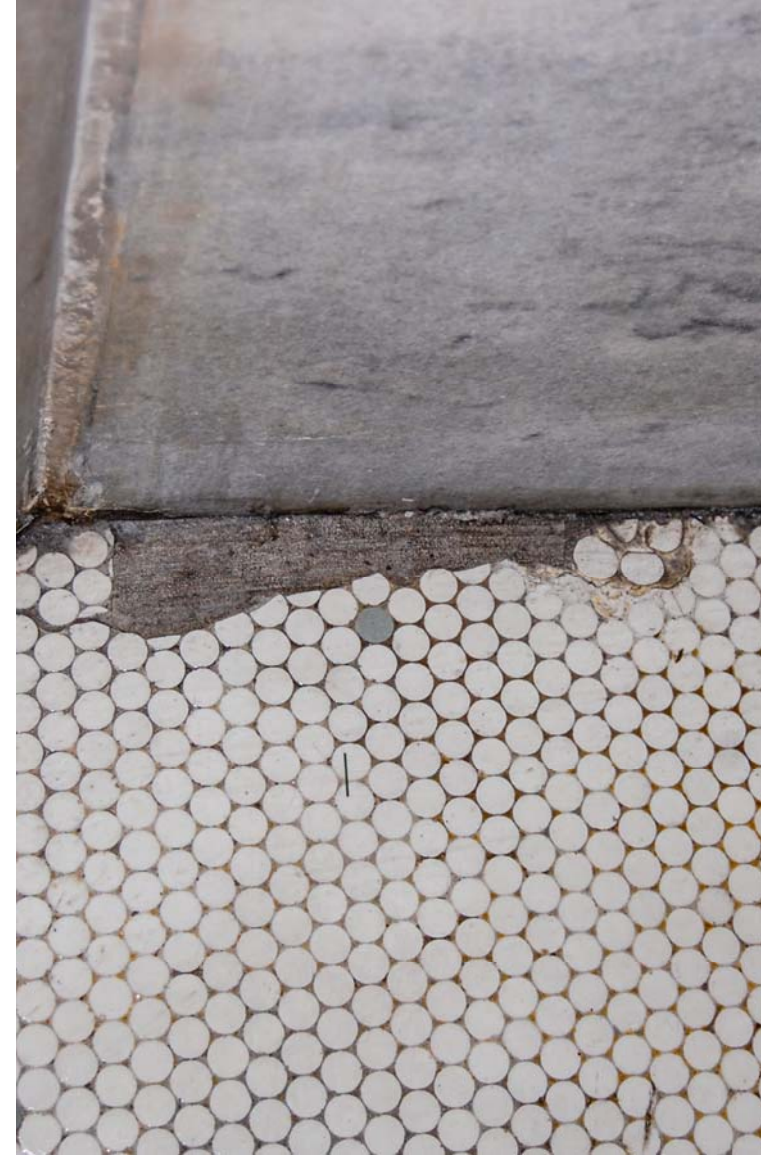
*Missing penny tile in northeast alcove of Rotunda.  
Figure 44*

In this instance, tile replacement is easily achieved as the tiles in this space are still manufactured today. Important considerations include identifying a cream color match as well as the careful removal of severed tiles and flush installation of new penny tiles to fill the void. If the replacement tiles are thicker than the existing tile, it is important that the setting bed be adjusted according to the thickness of the new tiles. The composition and color of the existing grout should likewise be matched.

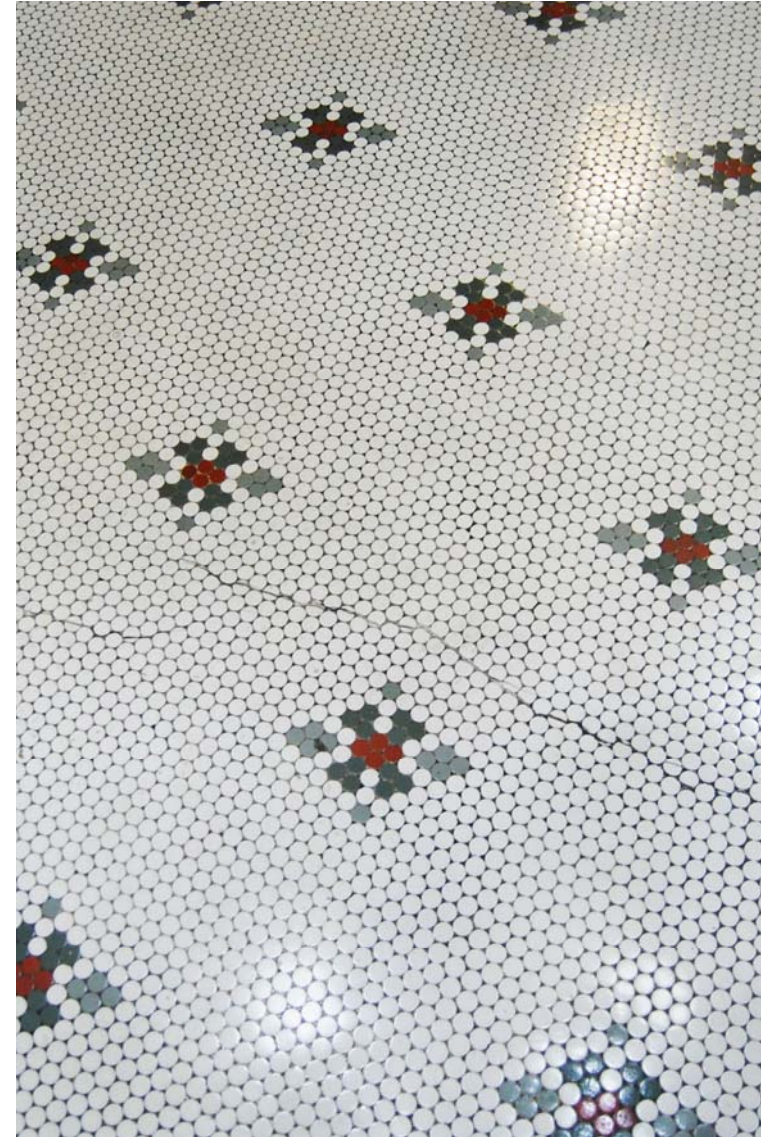
*Floor cracks at the first floor level of the Rotunda.  
Figure 45*
