# SAVANNAH CITY HALL INTERIOR CONDITION ASSESSMENT AND RESTORATION PLAN

Completed June 2018 for the City of Savannah

Lominack Kolman Smith Architects  
301 W Broughton Street  
Suite 301  
Savannah, GA 31401  
912.232.5561

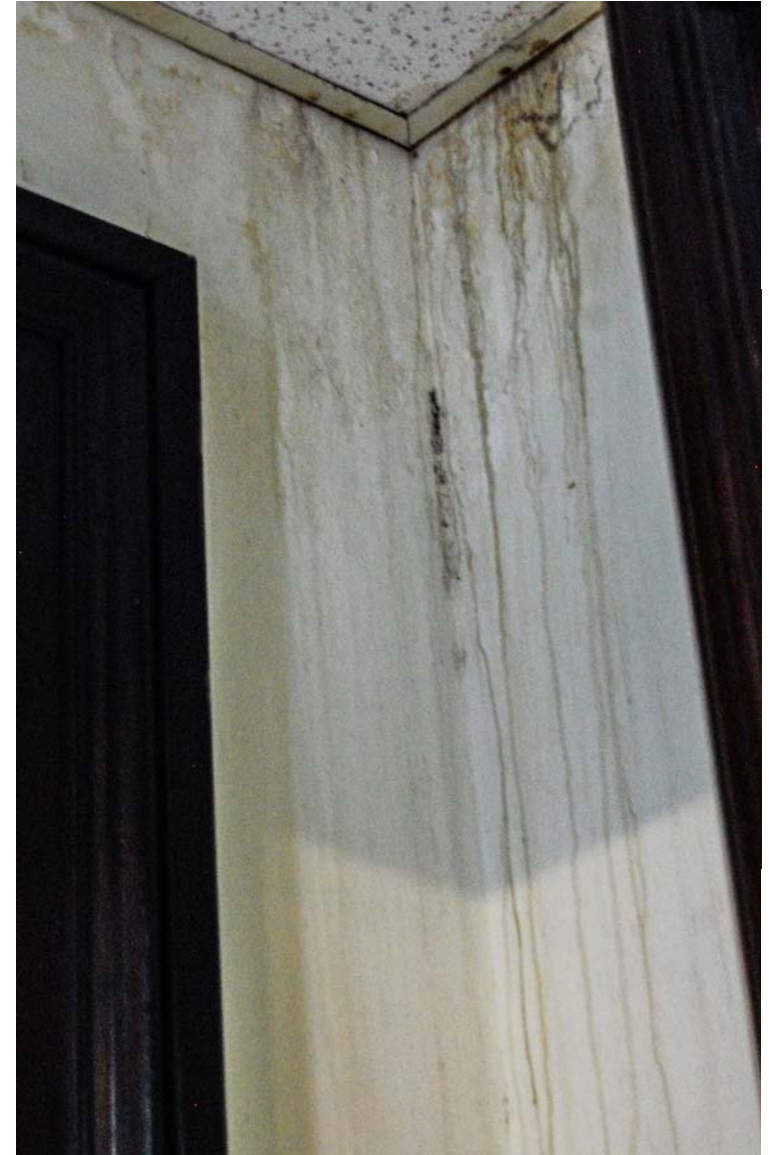
*Detail of water damage in Rotunda alcove corner.  
Figure 48*

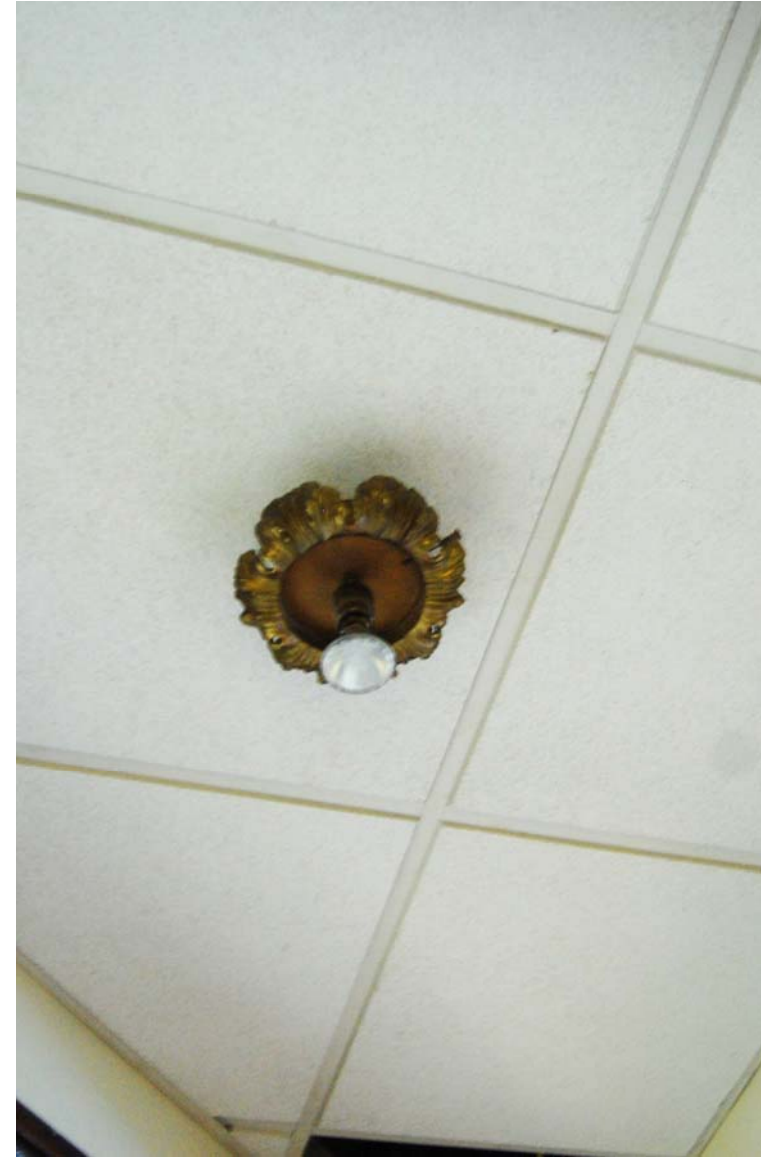
*Original light fixture missing its globe, surrounded by replacement drop ceiling tiles in Rotunda alcove. Figure 50*

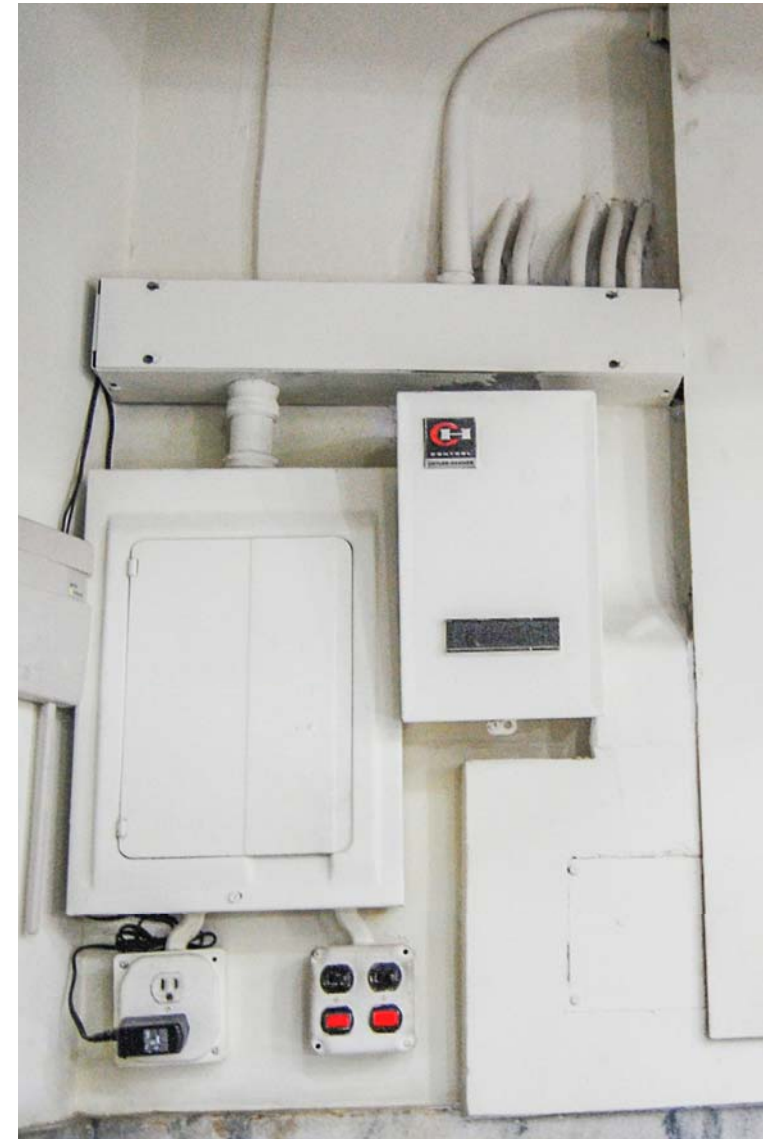
*Some of the many electrical panels in the southwest alcove of the Rotunda. Figure 51*

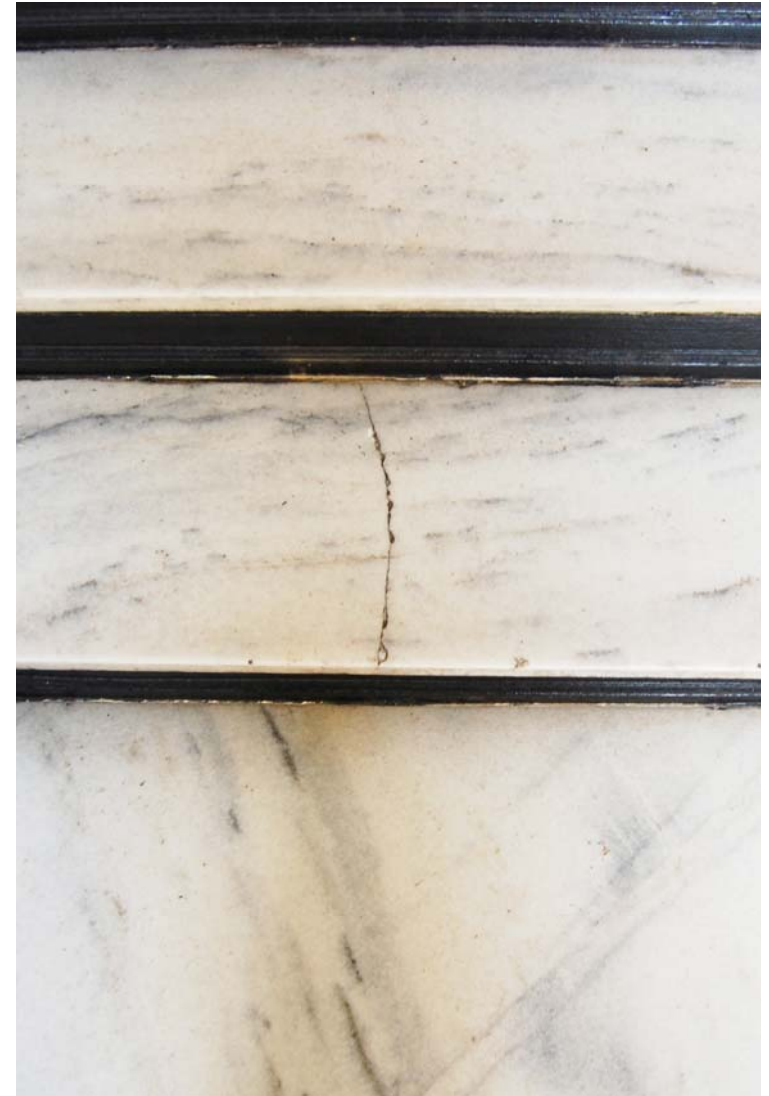
*Detail of cracked marble stair tread.  
Figure 60*

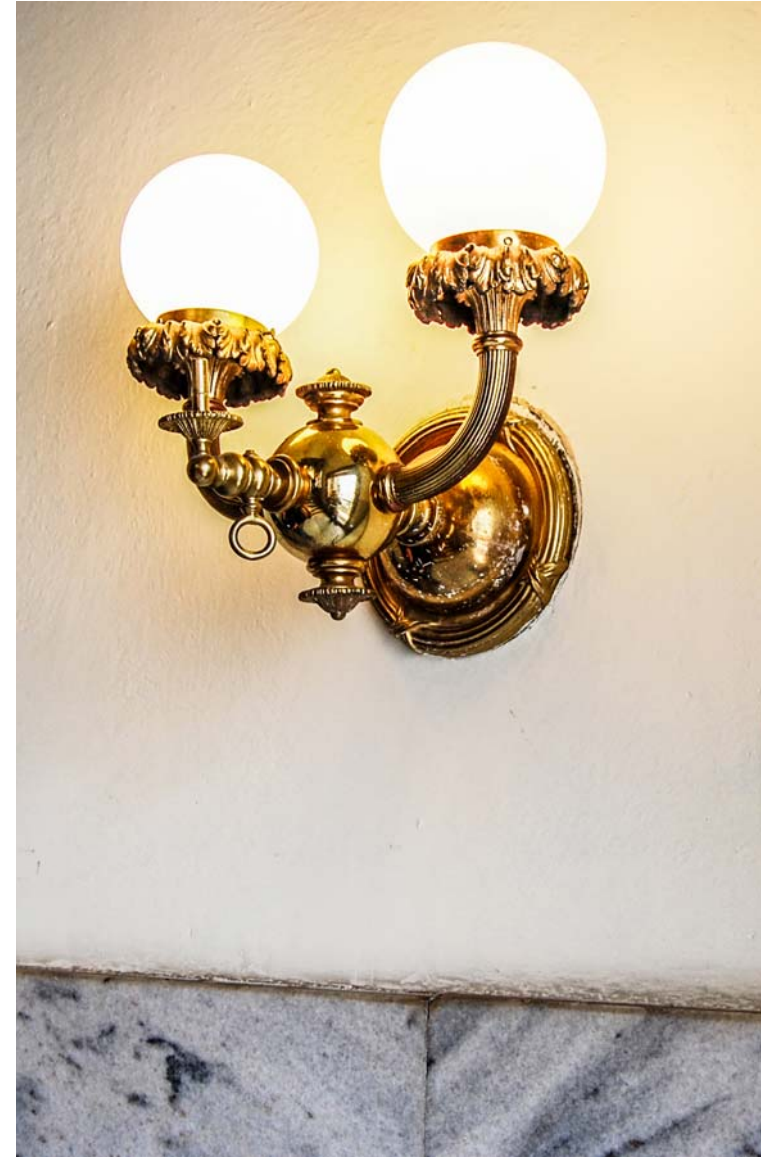
*Original gasolier in City Hall stair with missing glass globe.  
Figure 61*

A check for missing pieces and damage is recommended as part of an annual building inspection (Appendix E).

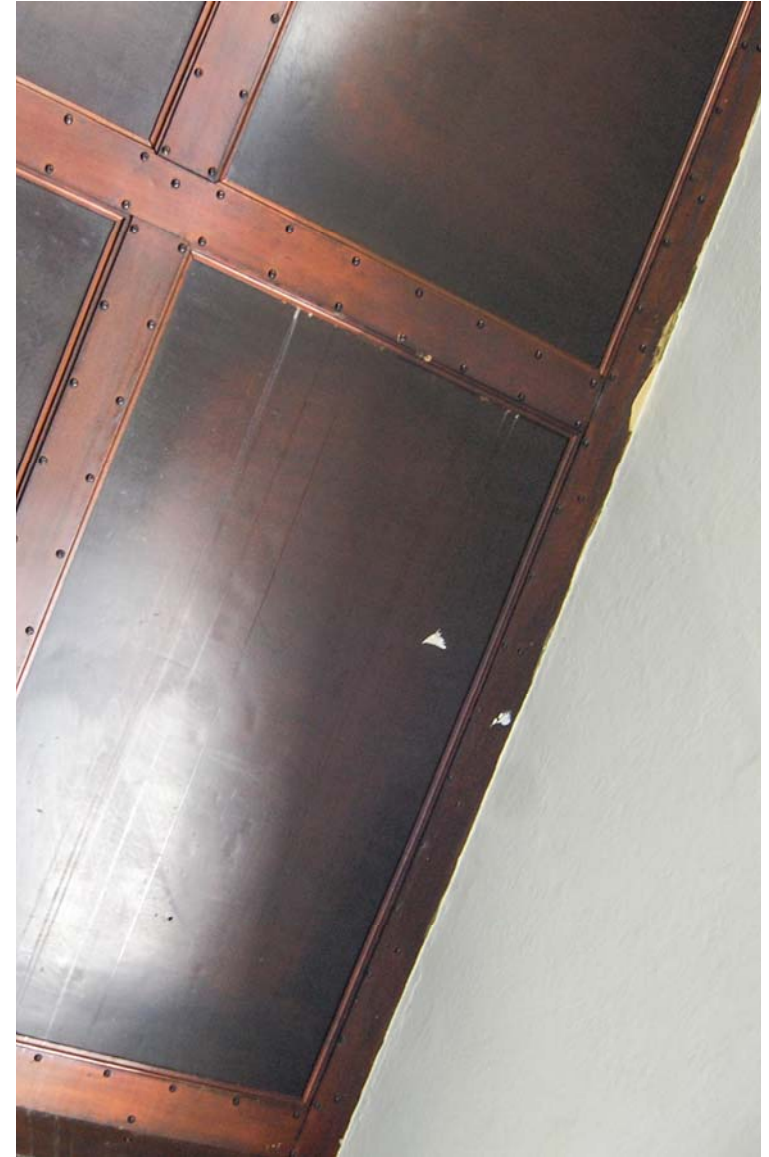
*Paint edging overlap onto stair ceiling between the second and third floor. Figure 62*

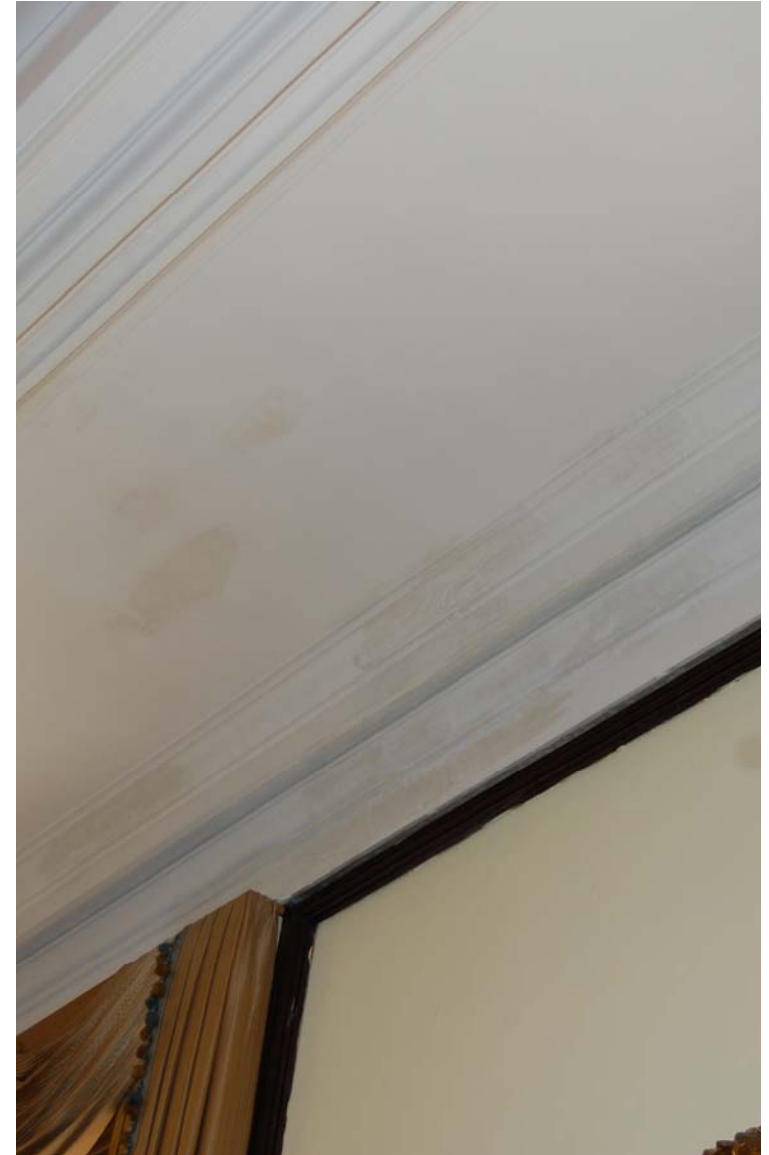
*Water damage located on south ceiling.  
Figure 64*

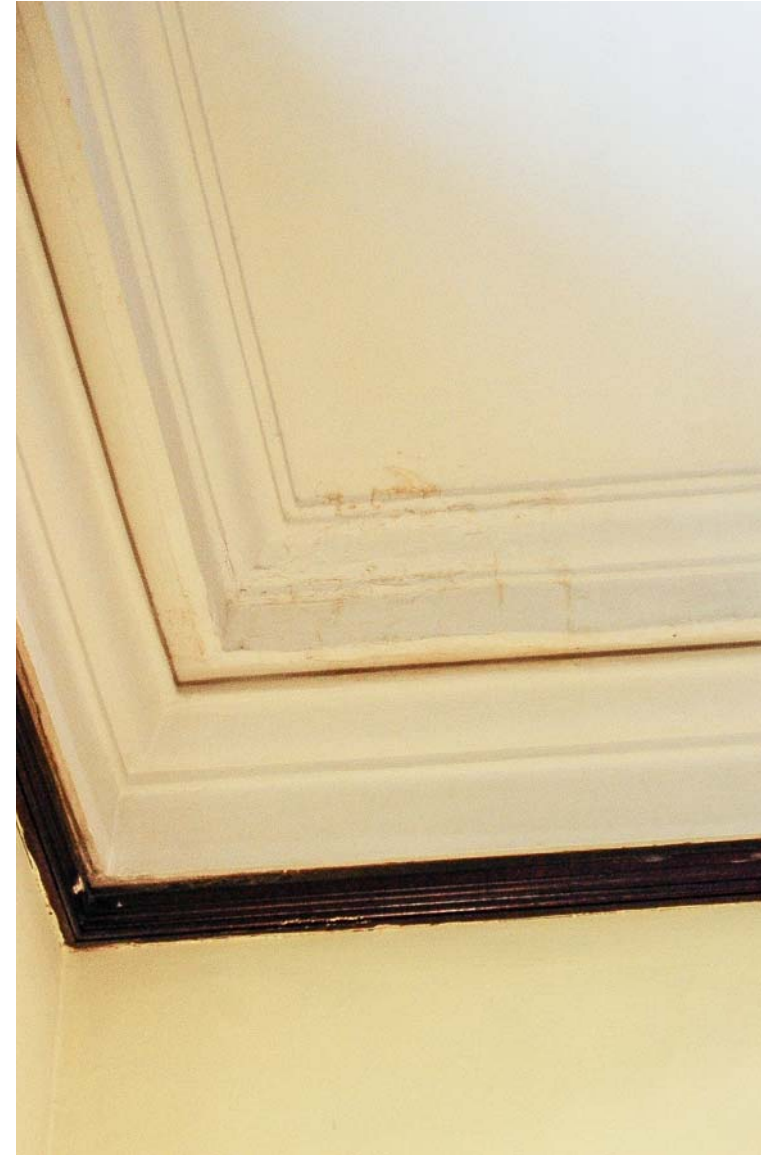
*Water damage located on south ceiling.  
Figure 65*

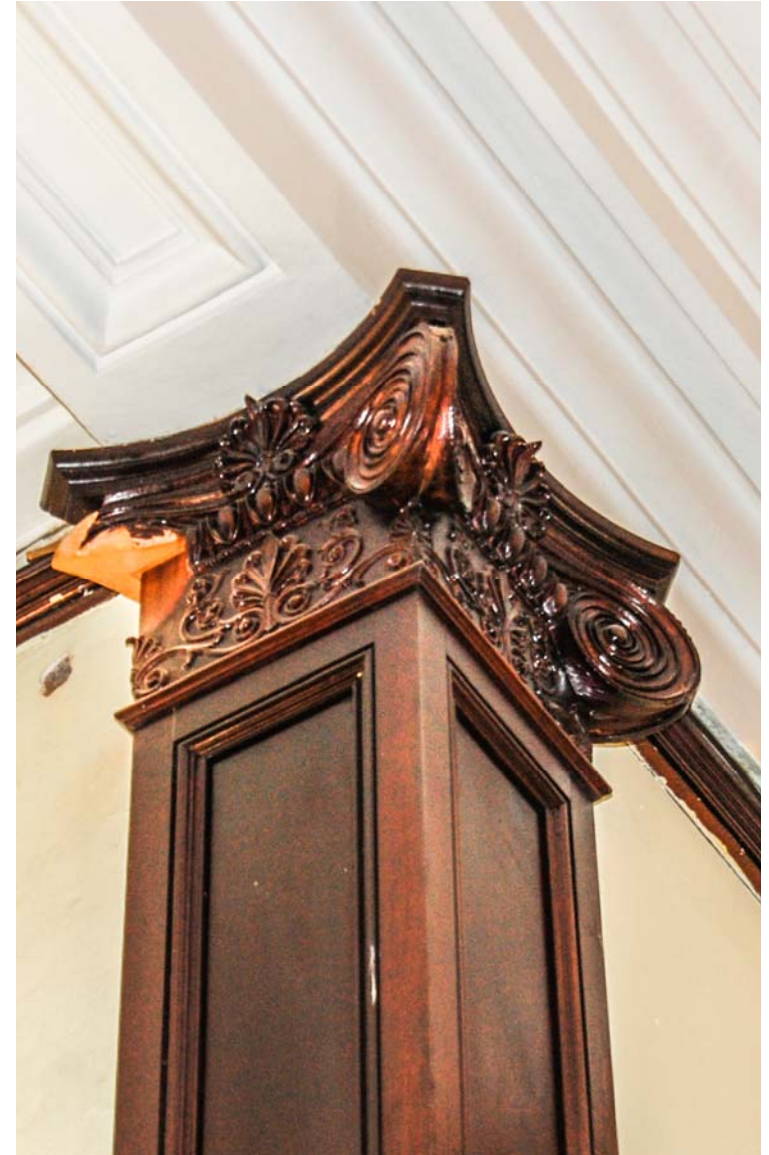
*Missing column capital in Council Chambers.  
Figure 66*

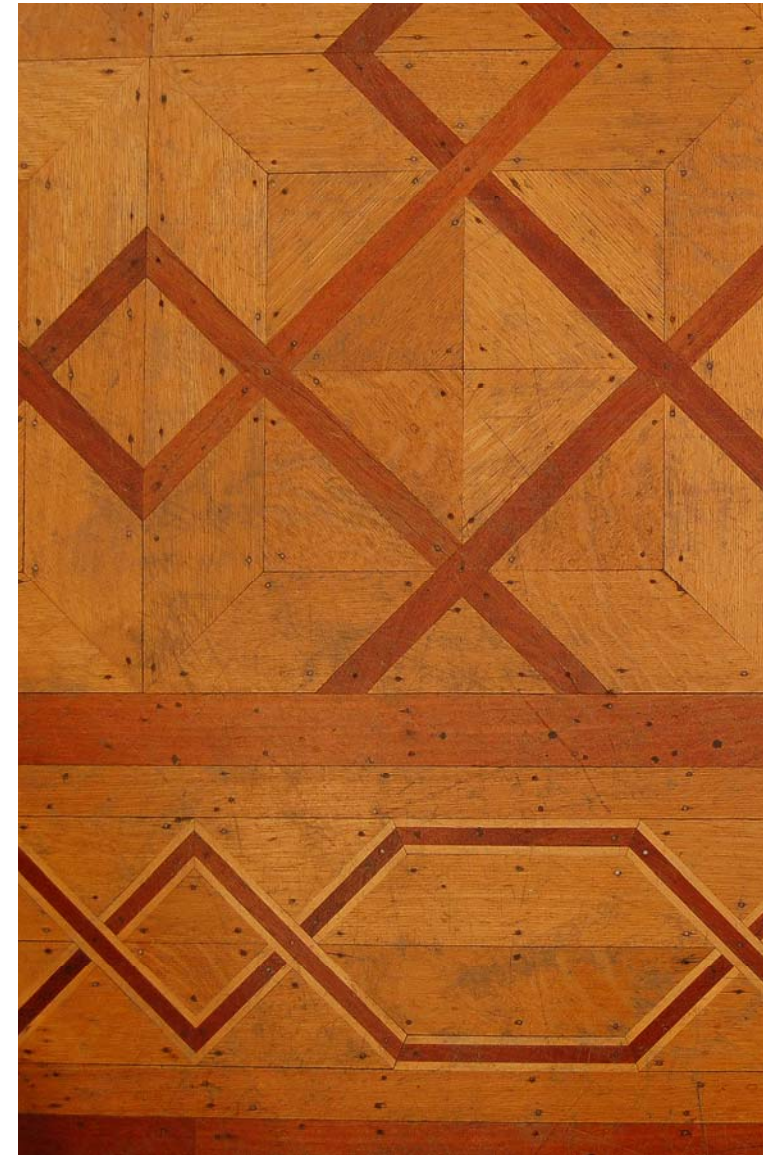
*Parquet flooring in Council Chambers showing scratches and scrapes.*  
Figure 68

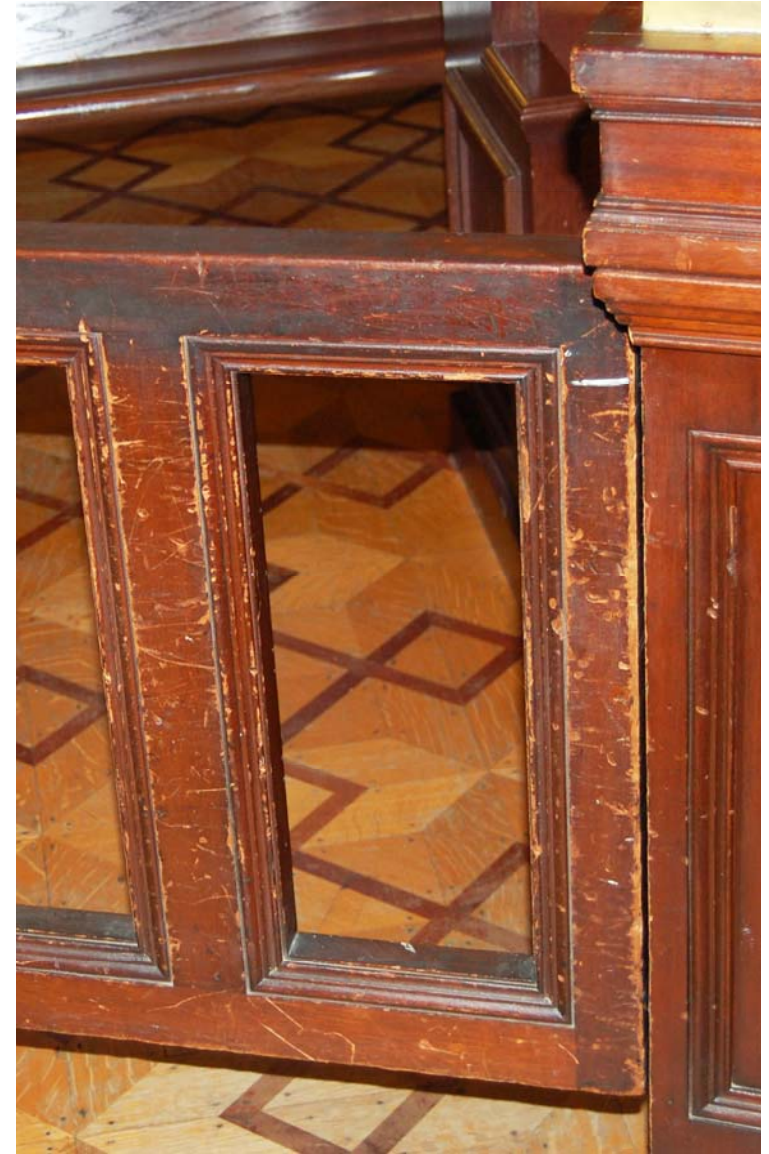
*Detail of Council Chambers swinging door deterioration.  
Figure 73*

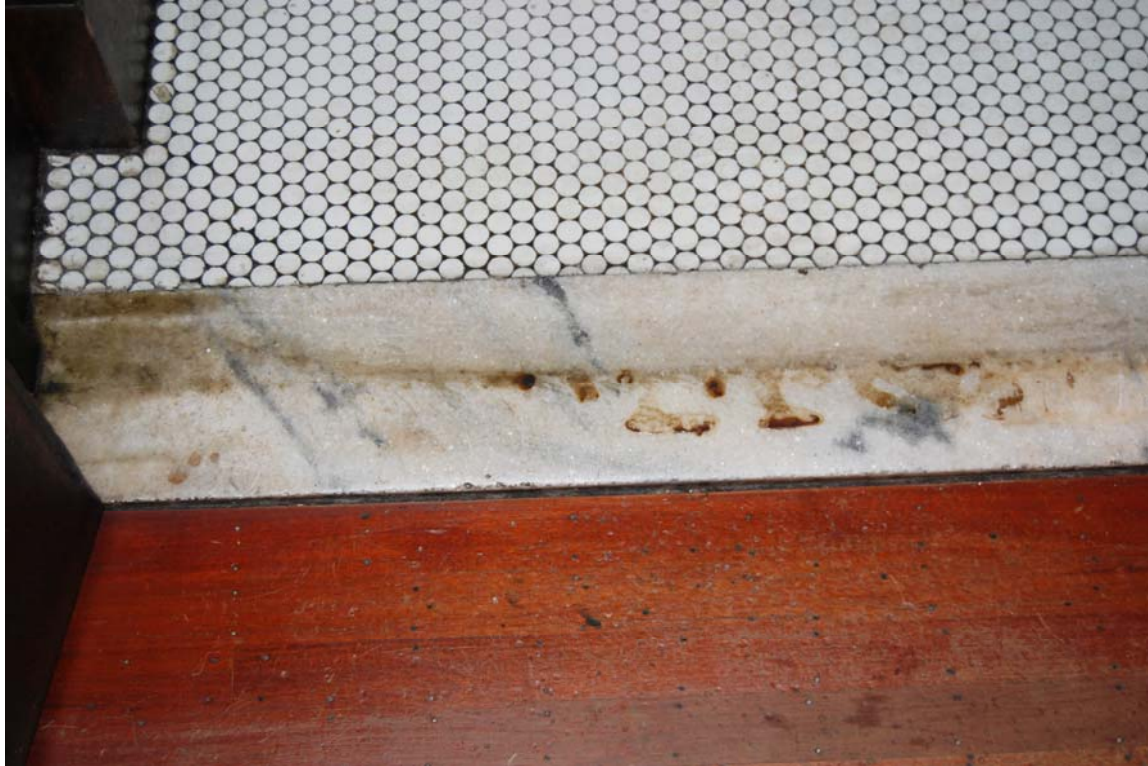
*Stained marble threshold in Council Chambers. Figure 74*

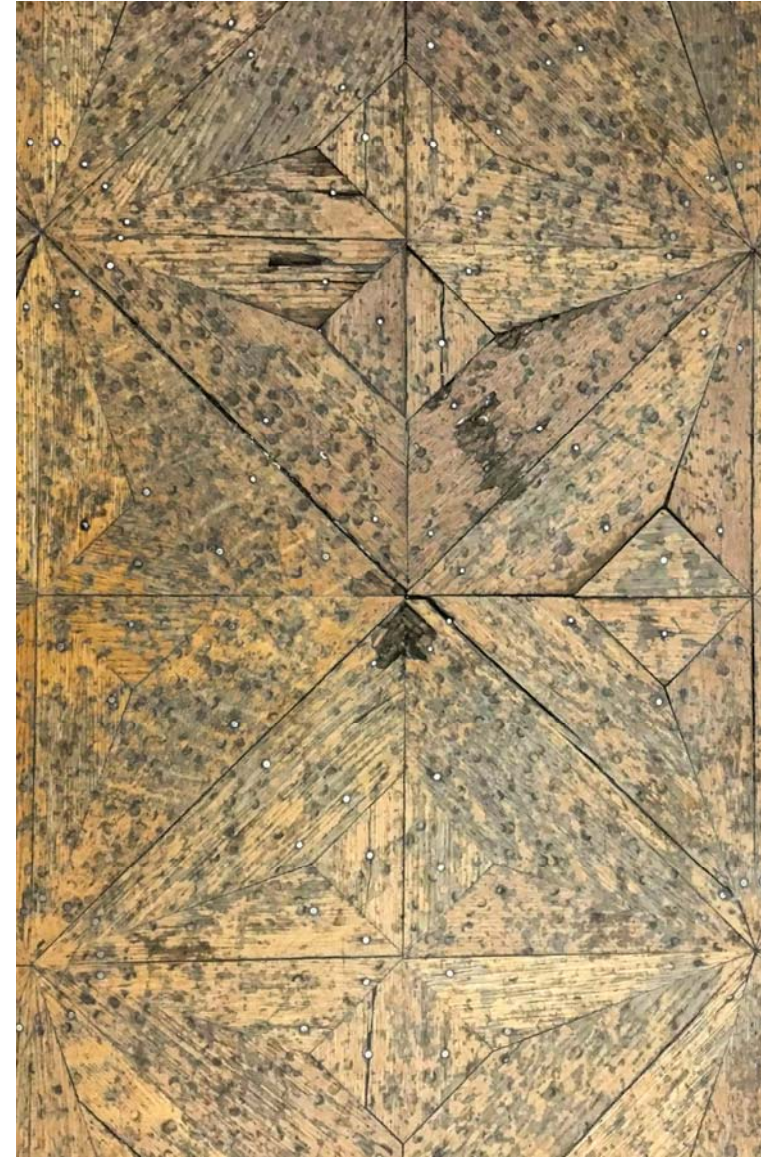
*Detail of deteriorated parquet flooring in Reception Room.  
Figure 80*

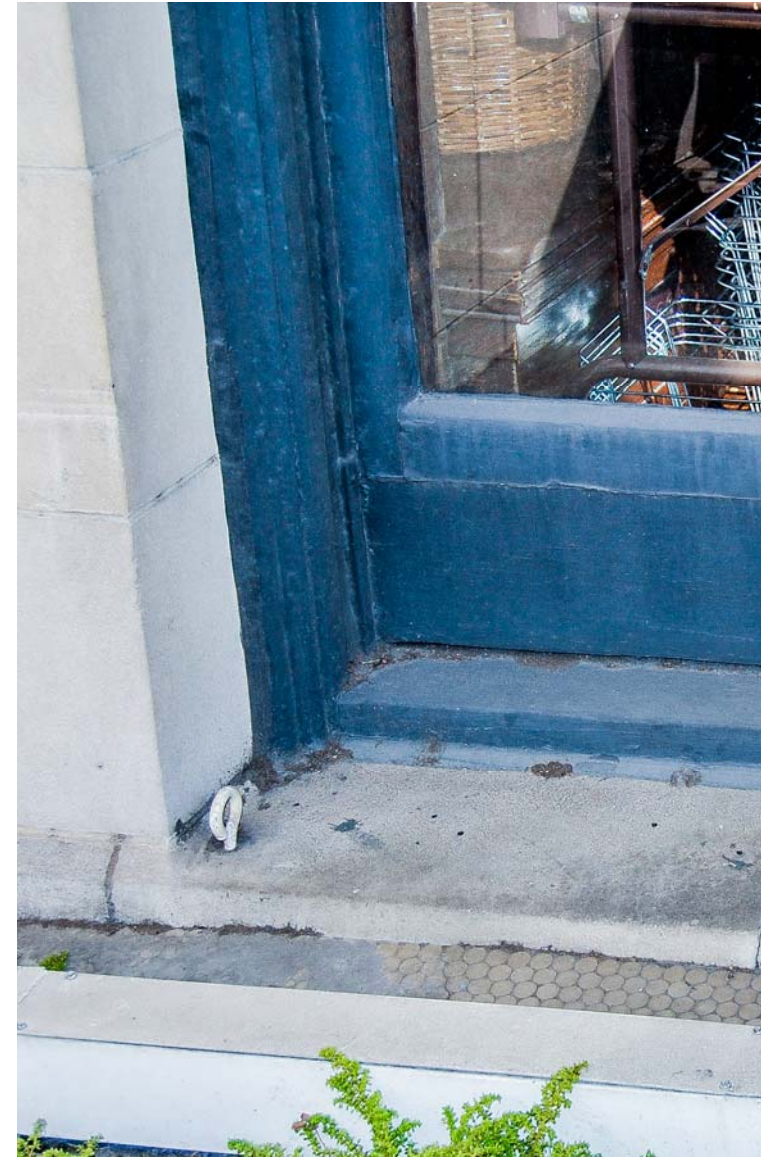
*Detail of exterior of bottom window sash that has been modified on the south wall of the Reception Room. Figure 82*

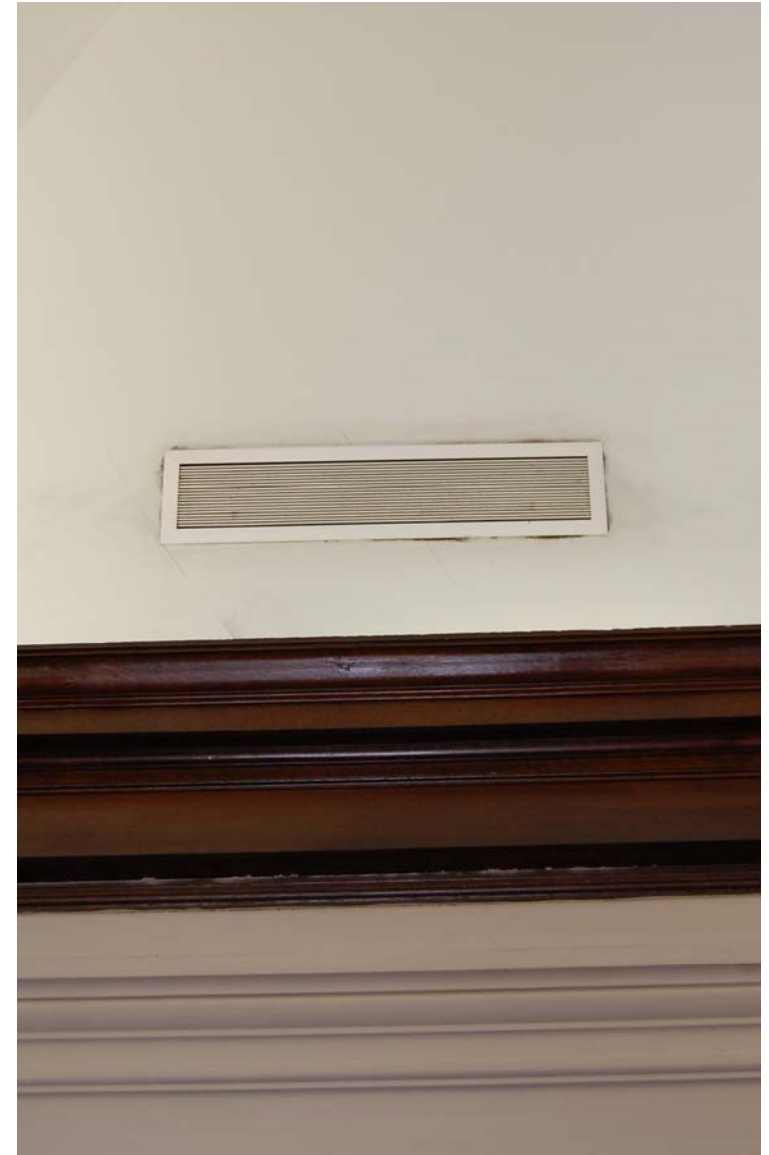
*Abandoned air intake vent in Reception Room ceiling.  
Figure 83*
