HUD MAP Capital Needs Assessment

REPORT DATE: August 21, 2023

Yamacraw Village
555 West Bay Street
Savannah, Chatham County, Georgia 31401

AEI Project No. 480855
Site Assessment Date: July 31 and August 1, 2023

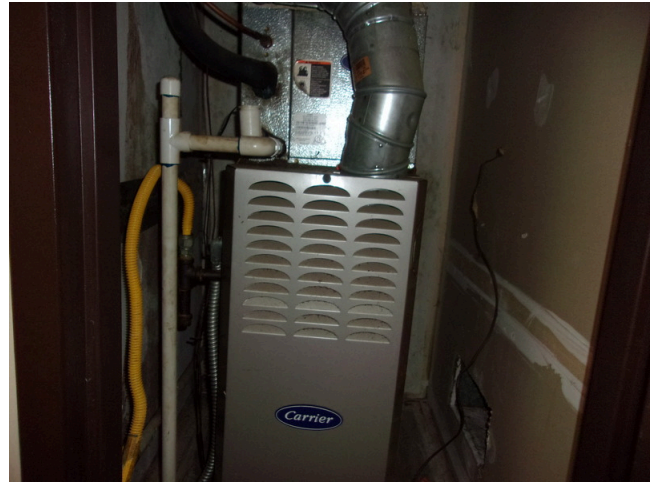
10. 121-128 Yamacraw Village - Unit 126 - 2-bed/
1-bath TH - Replace gas furnace (Non-Critical
Repair)

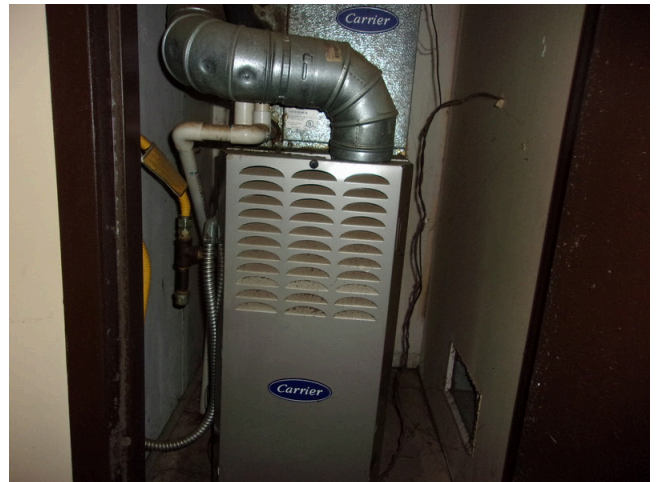
24. 141-148 Yamacraw Village - Unit 142 - 3-bed/
1-bath TH - Replace old gas furnace (Non-Critical
Repair)

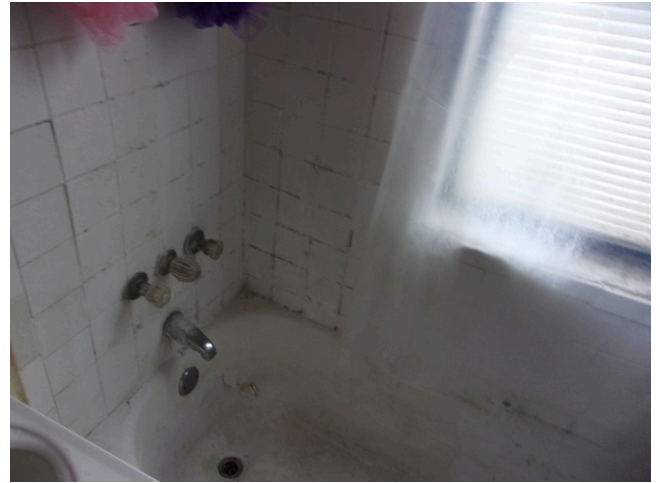
26. 141-148 Yamacraw Village - Unit 142 - 3-bed/
1-bath TH - Replace damaged ceramic tile surround
(Non-Critical Repair)

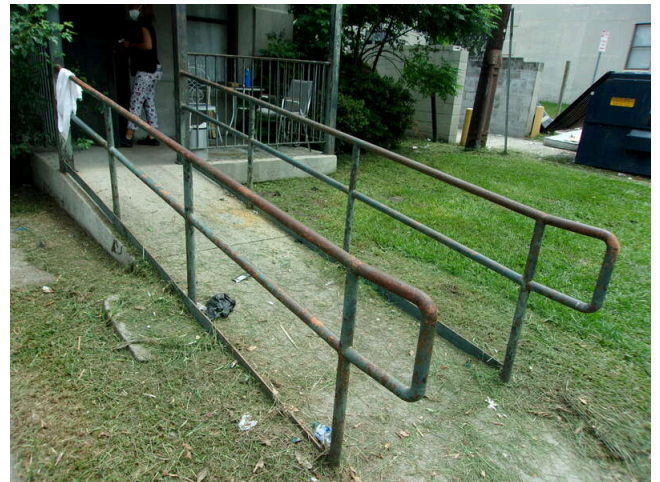
28. 260-268 Yamacraw Village - Unit 261 - 1-bed/
1-bath - HC unit - Replace metal/concrete ramp
(Non-Critical Repair)

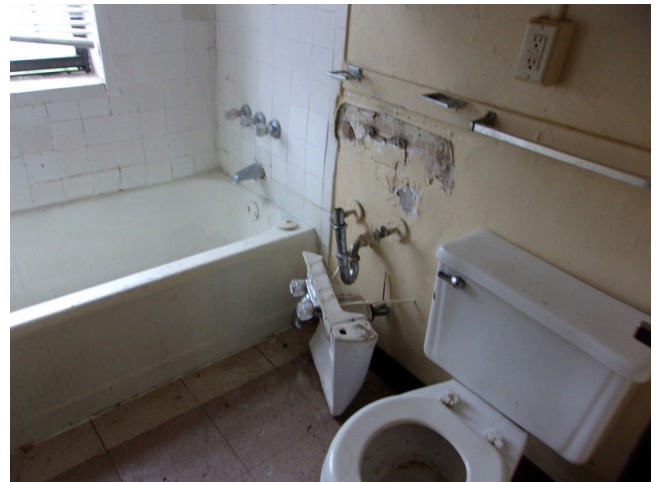
64. 260-268 Yamacraw Village - Unit 264 - 2-bed/
1-bath TH - Damaged plumbing fixtures and plaster
wall (Non-Critical Repair)

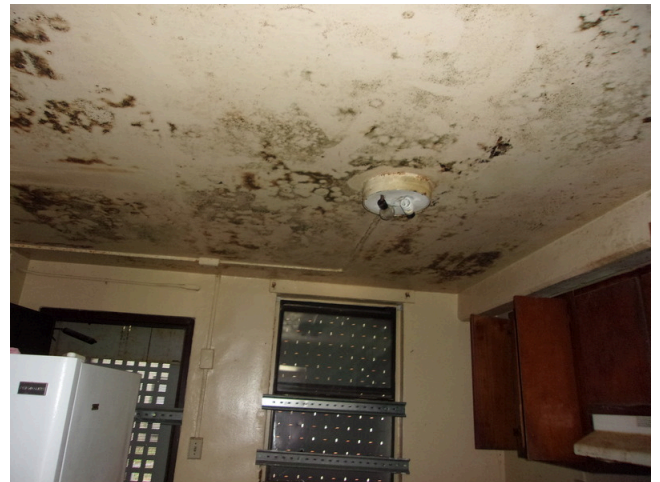
68. 460-467 Yamacraw Village - Unit 461 - 1-bed/
1-bath - HC unit/Down unit - Mold growth
throughout (Non-Critical Repair)

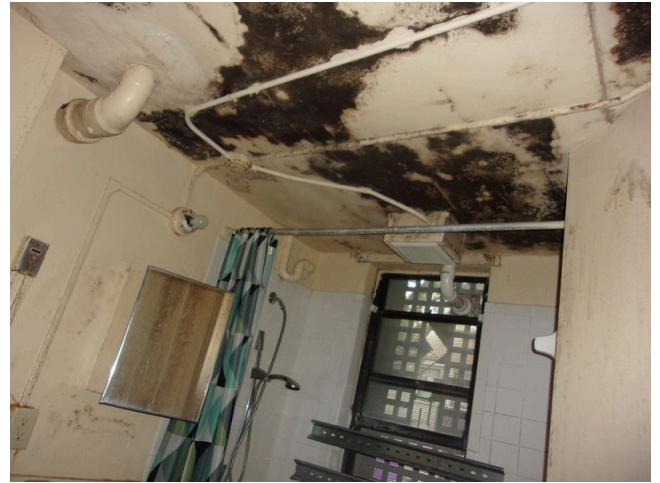
70. 460-467 Yamacraw Village - Unit 461 - 1-bed/
1-bath - HC unit/Down unit - Mold growth
throughout (Non-Critical Repair)

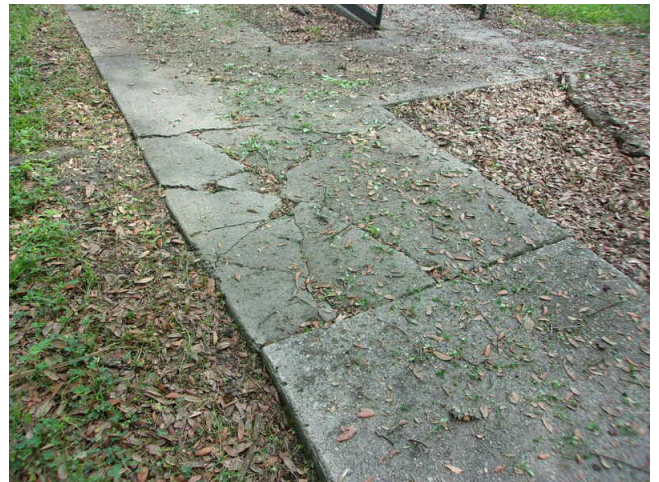
4. Typical damaged concrete sidewalk with trip hazards (Critical Repair)

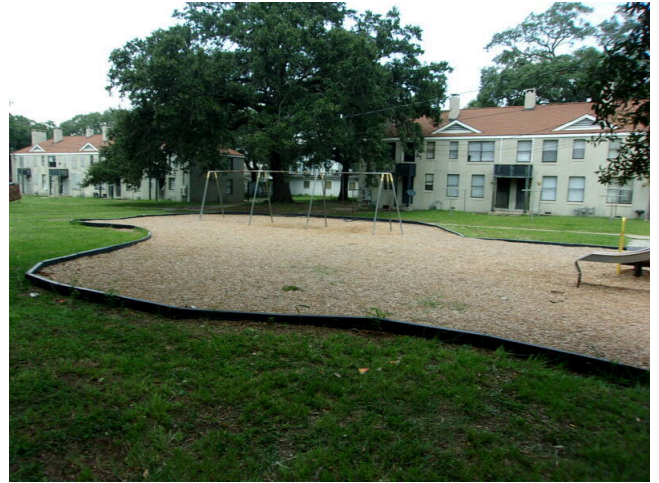
6. Playground equipment is past its EUL (Non-Critical Repair)

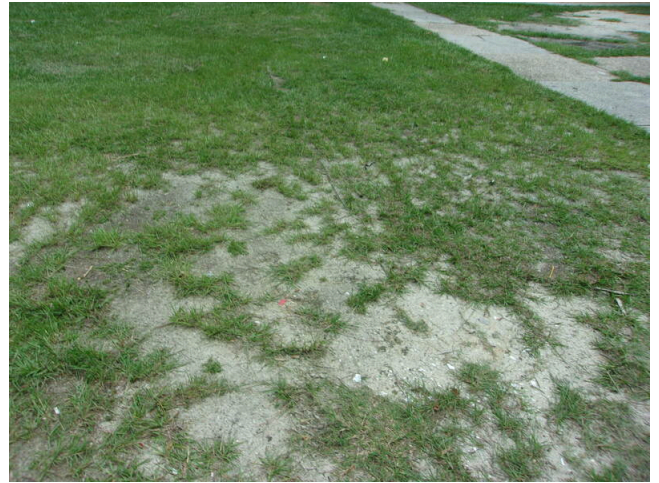
10. Bare ground throughout site (Non-Critical Repair)

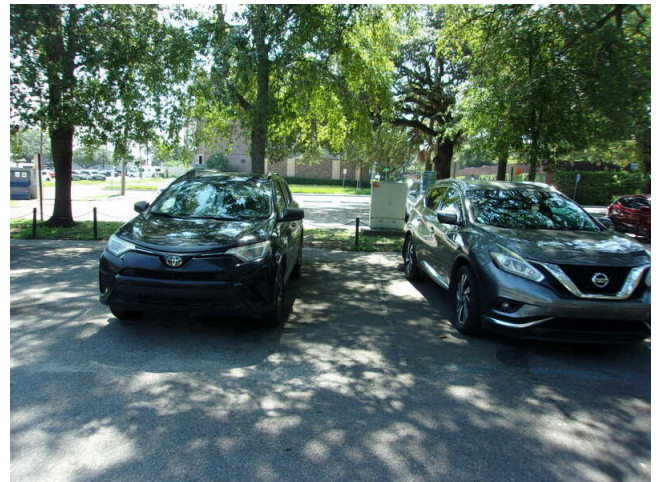
15. Replace heaving and cracked concrete parking lot (Non-Critical Repair)

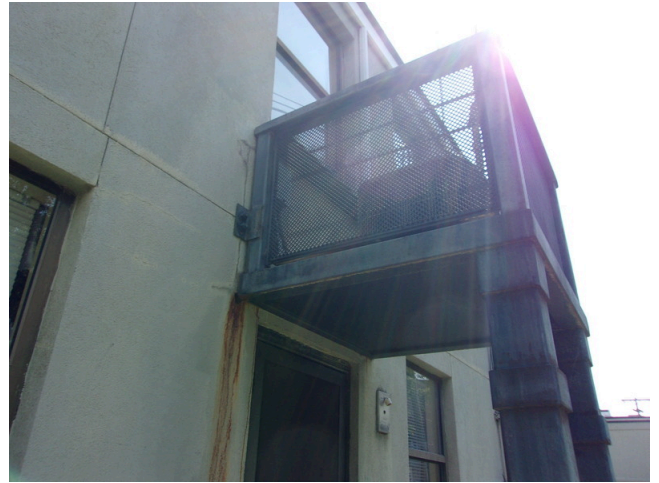
18. Replace metal AC canopies, rusting and causing water infiltration issues (Non-Critical Repair)

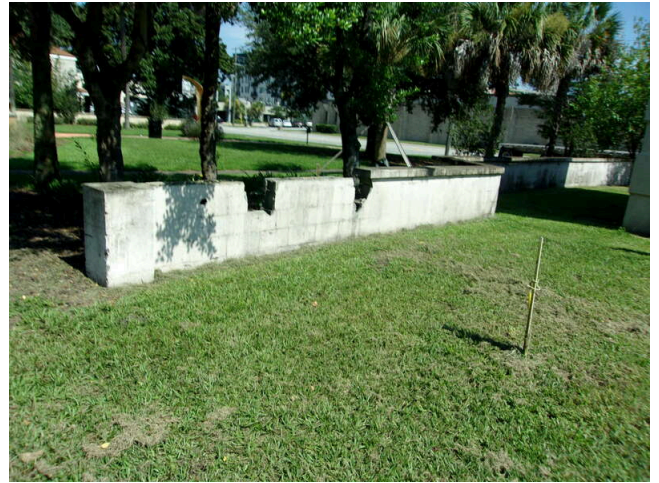
22. Replace damaged CMU retaining walls (Non-Critical Repair)

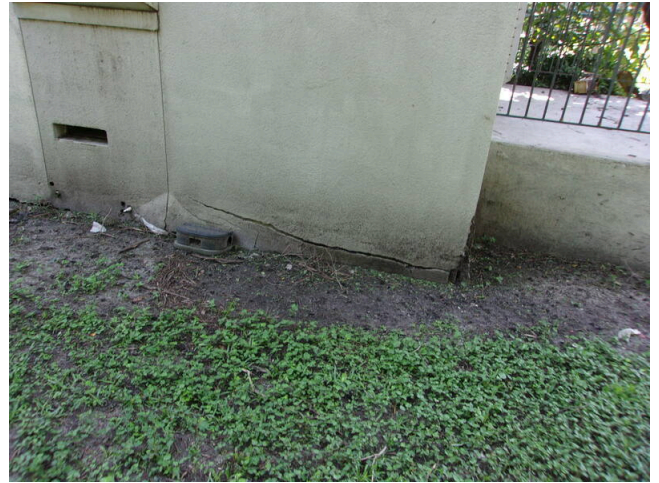
26. Evidence of foundation settling, damaged stucco siding (Non-Critical Repair)

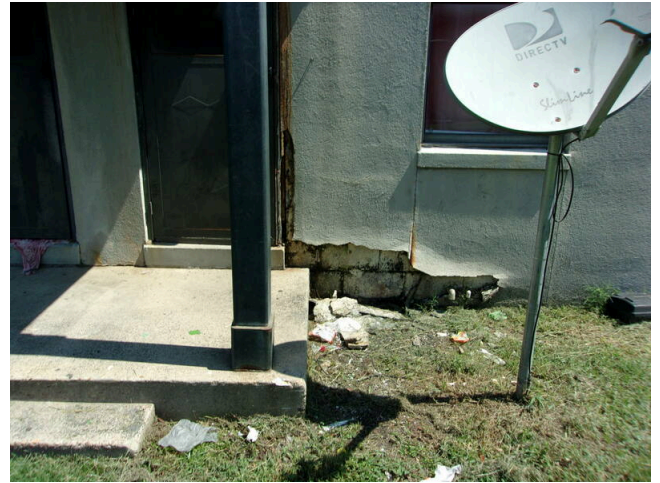
37. Damaged stucco siding (Non-Critical Repair)

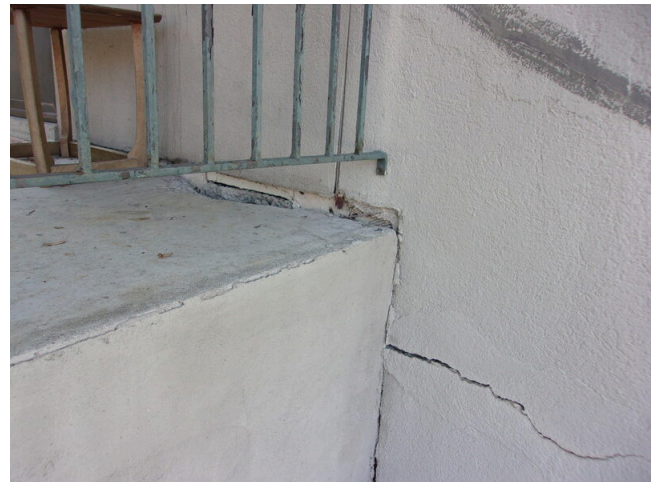
40. Front porch sinking (Non-Critical Repair)

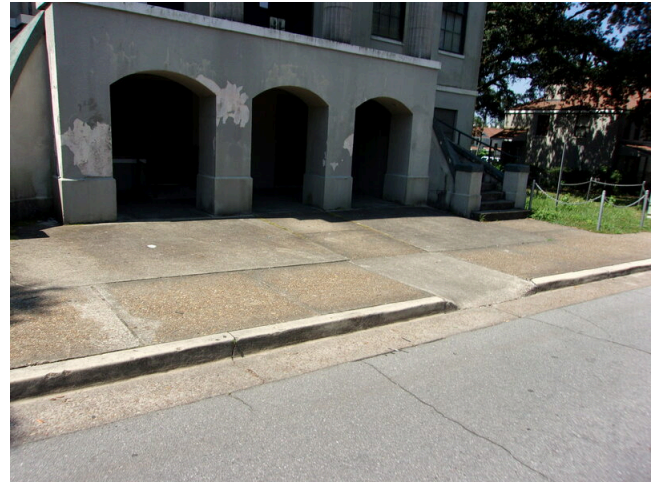
46. Repair and wash stucco siding at 349 West Bryan Street (Non-Critical Repair)

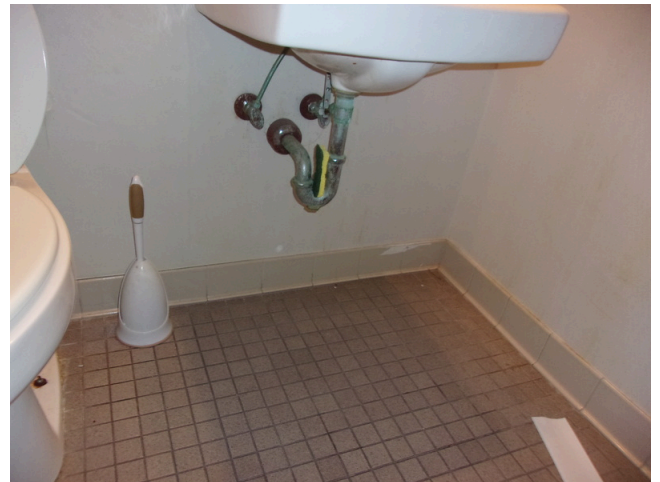
68. 555 West Bay Street Office - Women's restroom
- No scald and abrasion protection (Critical Repair)

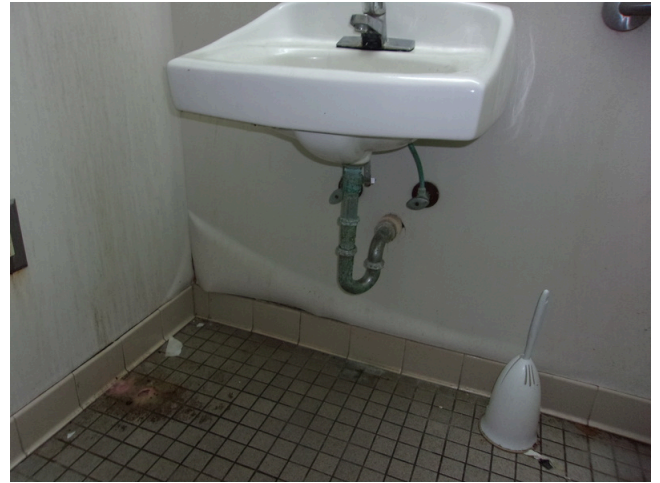
70. 555 West Bay Street Office - Men's staff restroom - No scald and abrasion protection (Critical Repair)

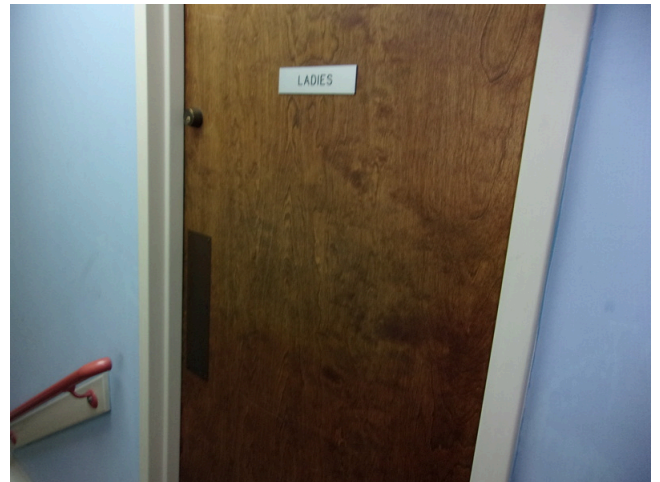
72. 555 West Bay Street Office - Women's public restroom - No ADA signage (Critical Repair)

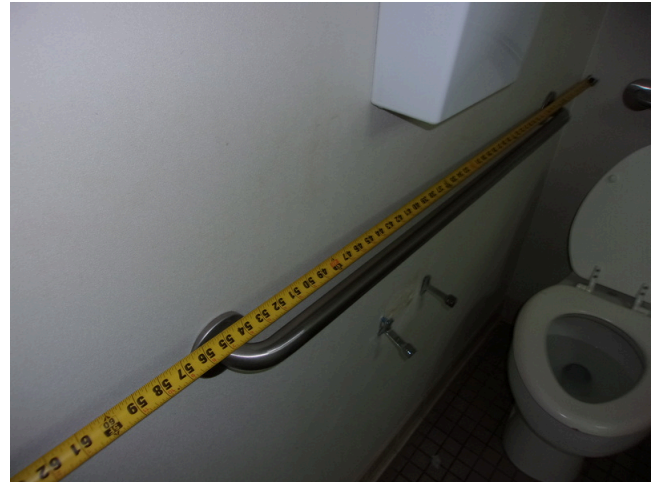
77. 555 West Bay Street Office - Women's public restroom - Move toilet to 18 inches from centerline to side wall (Critical Repair)

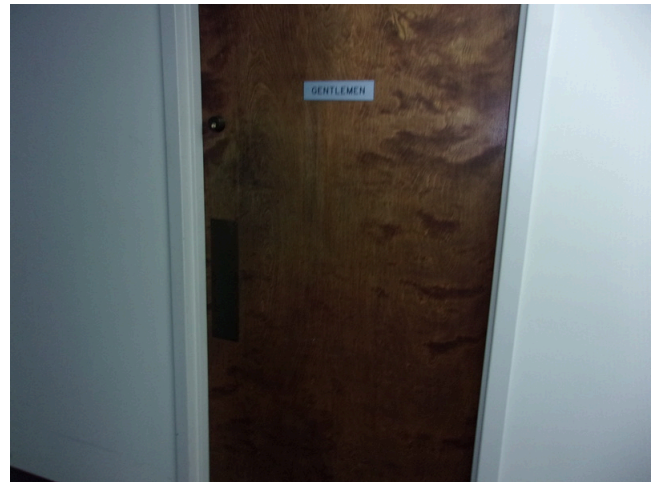
80. 555 West Bay Street Office - Men's public restroom - No ADA signage (Critical Repair)

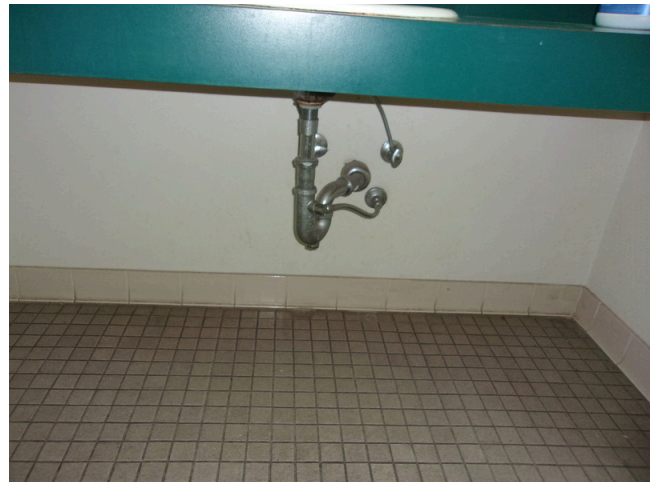
84. 555 West Bay Street Office - Men's public restroom - No scald and abrasion protection at sink (Critical Repair)

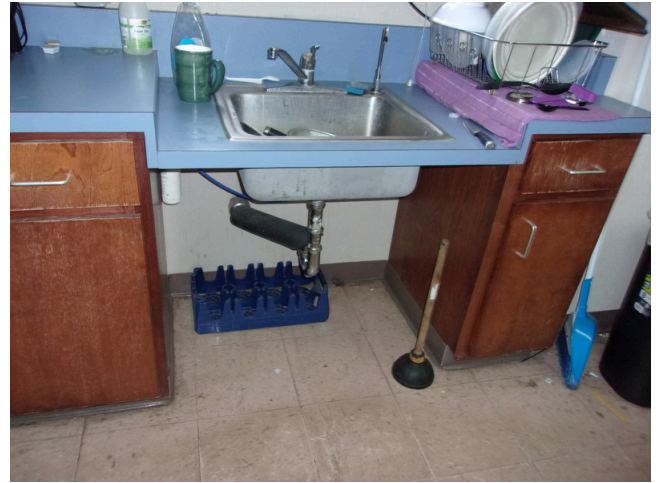
90. 555 West Bay Street Office - No scald and abrasion protection at kitchen sink (Critical Repair)

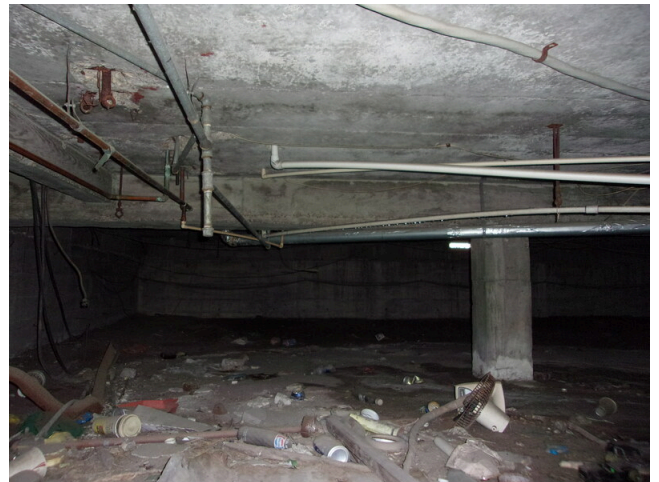
96. Spalling raised concrete slab (Non-Critical Repair), galvanized water supply lines

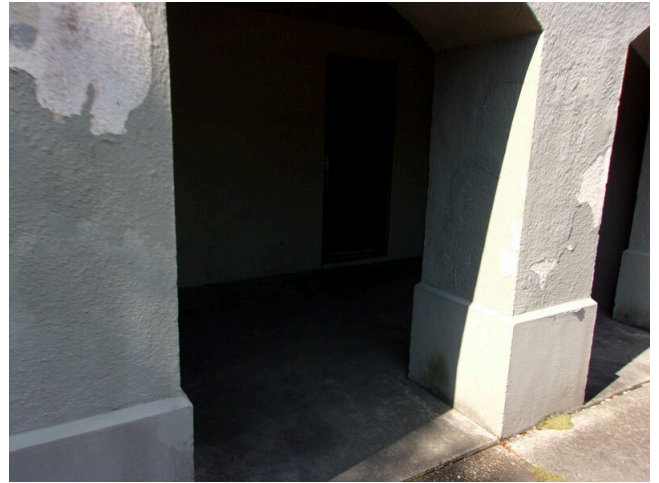
130. Repair and paint stucco siding at 349 West Bryant Street (Non-Critical Repair)

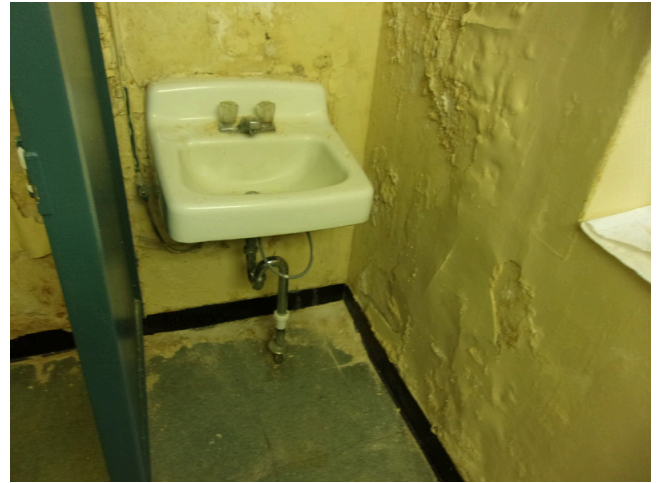
134. 349 West Bryan Street - Community center - Staff restroom with no scald and abrasion at the sink (Critical Repair)
