DOWNTOWN SAVANNAH HISTORIC DISTRICT

Re: COA application for the Demolition of 9 Lincoln St., Savannah, GA 31401

Re: Review of #9 Lincoln Street
Savannah, Georgia
Project No. 21085

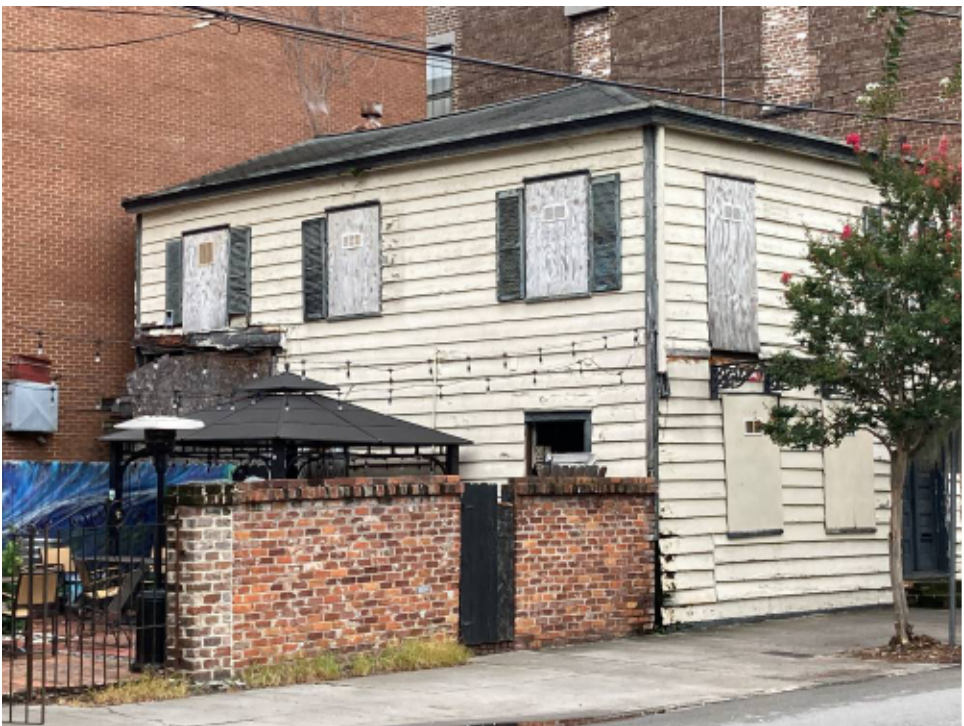
Photograph #1	Remarks

The existing structure is a 2-story timber framed building supported on a shallow foundation system. The exact date of construction is unknown. See Photos 1 and 2. The two floor levels and the roof framing are timber framed using heart pine material. The first floor is framed over an approximately 12-18 inch deep crawl space. See Photos 3 and 4. The condition of the foundation is unknown.

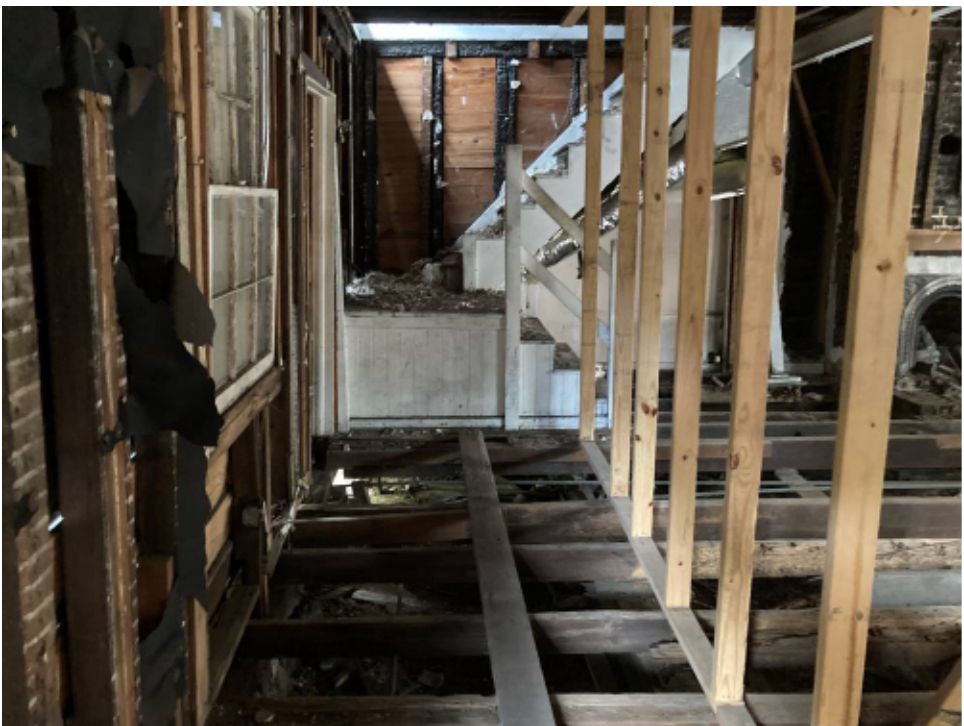
Photograph #5	Remarks

The building is in very poor structural condition. The entire building is leaning toward the north and toward the west. Much of the first floor framing and all of the first floor decking have been removed. A new timber stud wall shoring system has been added along the north and south side of the structure at both levels approximately 4 feet away from the north and south walls in an effort to relieve loads on the north and south walls which are in extremely poor condition. See Photos 5 and 6.

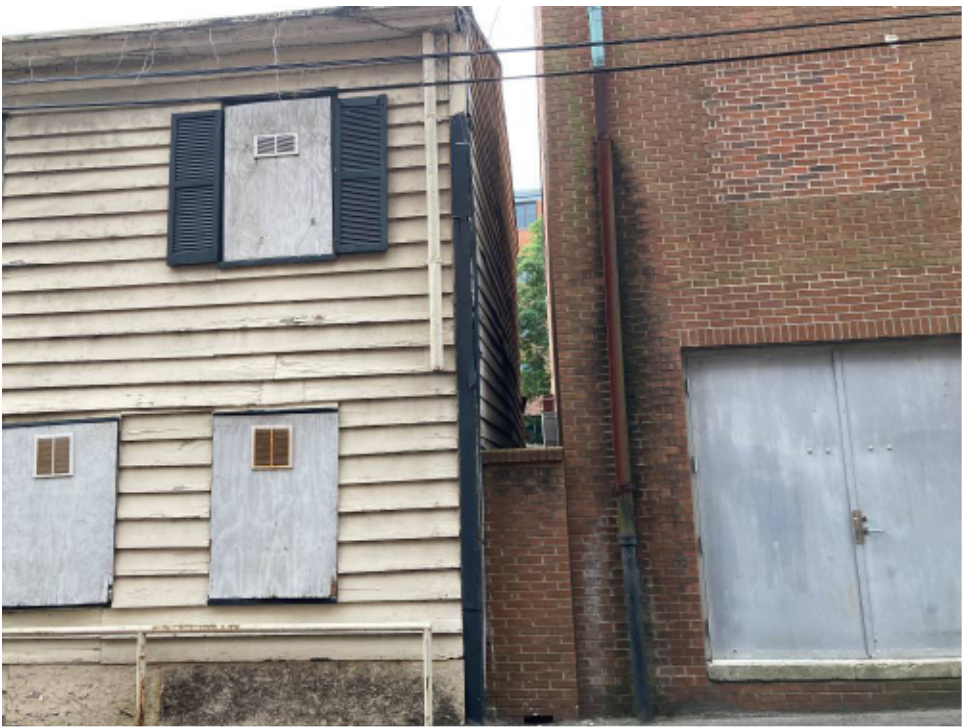
Photograph #7	Remarks

- leaning of the structure is due to a combination of many interior framing failures and a failure of the exterior siding/sheathing to provide lateral stability to the overall structure. See Photos 7, 8, 9, and 10.

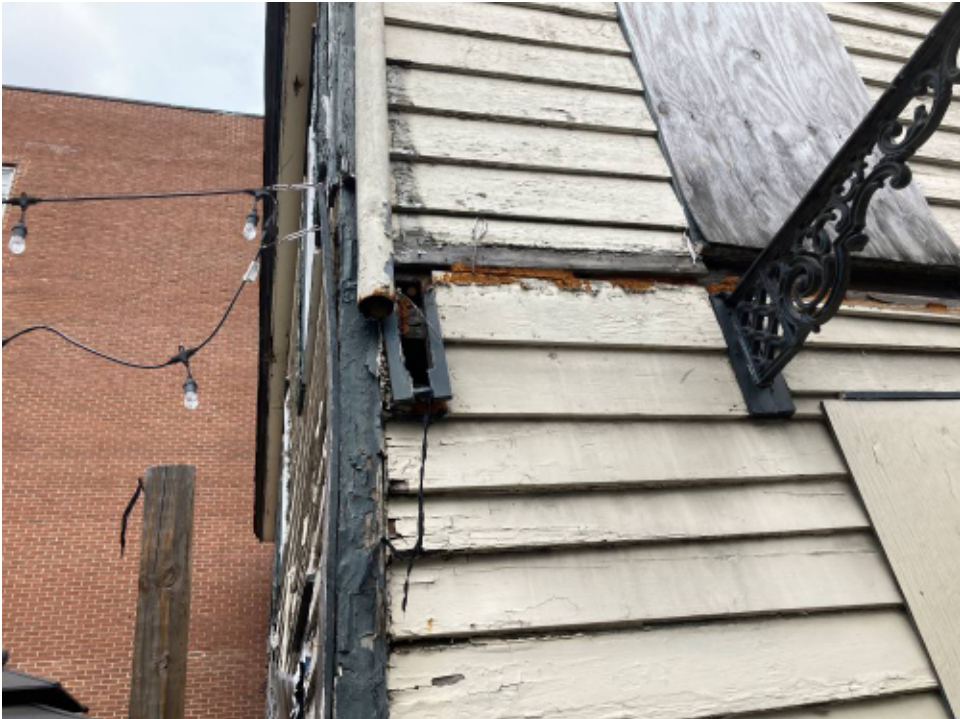
Photograph #10	Remarks

5. Locations observed at the perimeter of the building where the siding has rotted due to water contact. See Photos 10, 12, 18, 19, and 20.
 6. There is a large displacement in the west exterior wall at the second floor level. See Photo 21. A review from the interior of the building indicates a two to three inch gap between floor framing and the wall studs at the one location where there is visible access. See Photo 22.

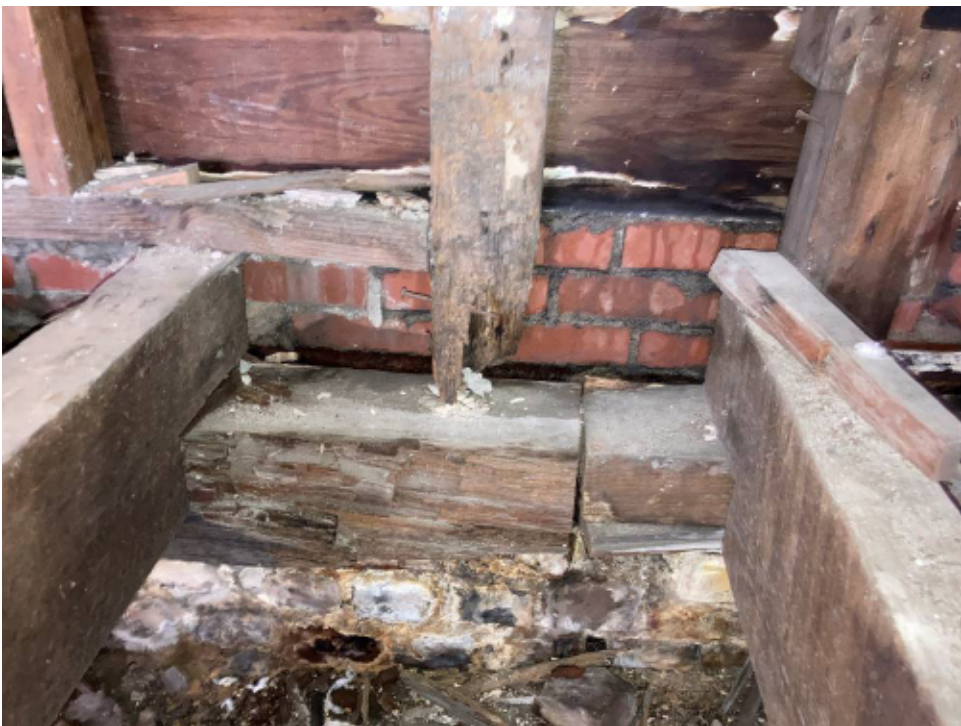
Photograph #11	Remarks

2. Many of the wall studs at the first floor are rotted at their base. See Photos 11 and 12. The floor decking of the first floor has been completely removed and many of the floor joists are removed or are rotted at their ends due to water damage and/or termite damage which was observed at many locations. See Photos 13 and 14.

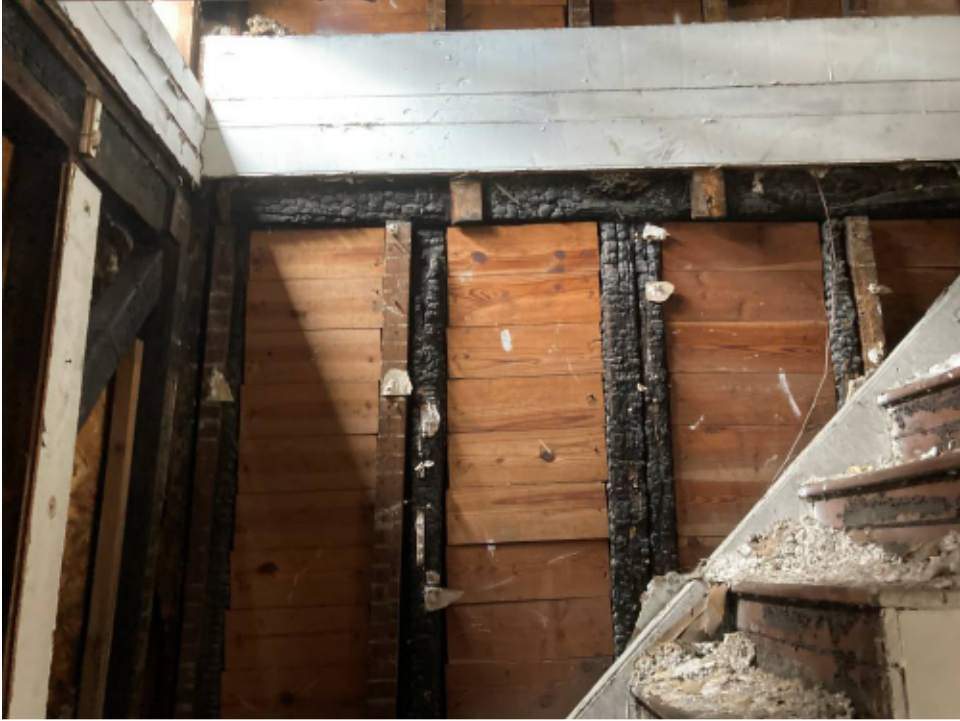
Photograph #15	Remarks

3. Sections of the west wall at the first and second floor levels have been damaged by a fire. The members which are visible are severely charred. See Photos 15 and 16.

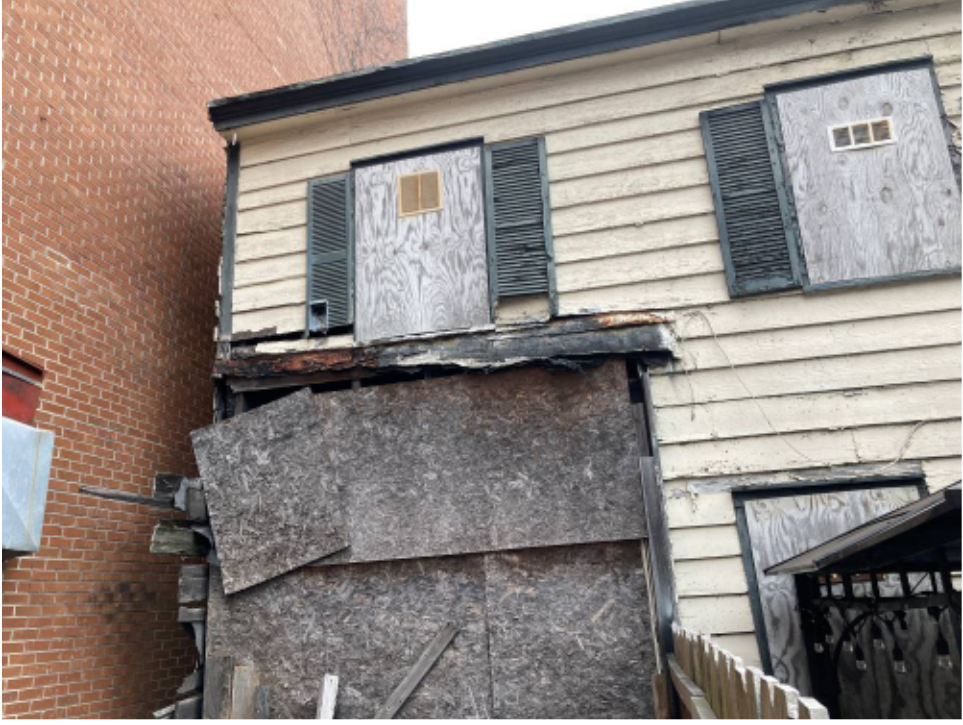
Photograph #17	Remarks

4. A large section of the wall on the south elevation at the southwest corner is missing at the first floor level. See Photo 17. There appears to be extensive water rot of the framing at the perimeter of the opening which has been temporarily sheathed with plywood.
