# SAVANNAH CITY HALL INTERIOR CONDITION ASSESSMENT AND RESTORATION PLAN

Completed June 2018 for the City of Savannah

Lominack Kolman Smith Architects  
301 W Broughton Street  
Suite 301  
Savannah, GA 31401  
912.232.5561

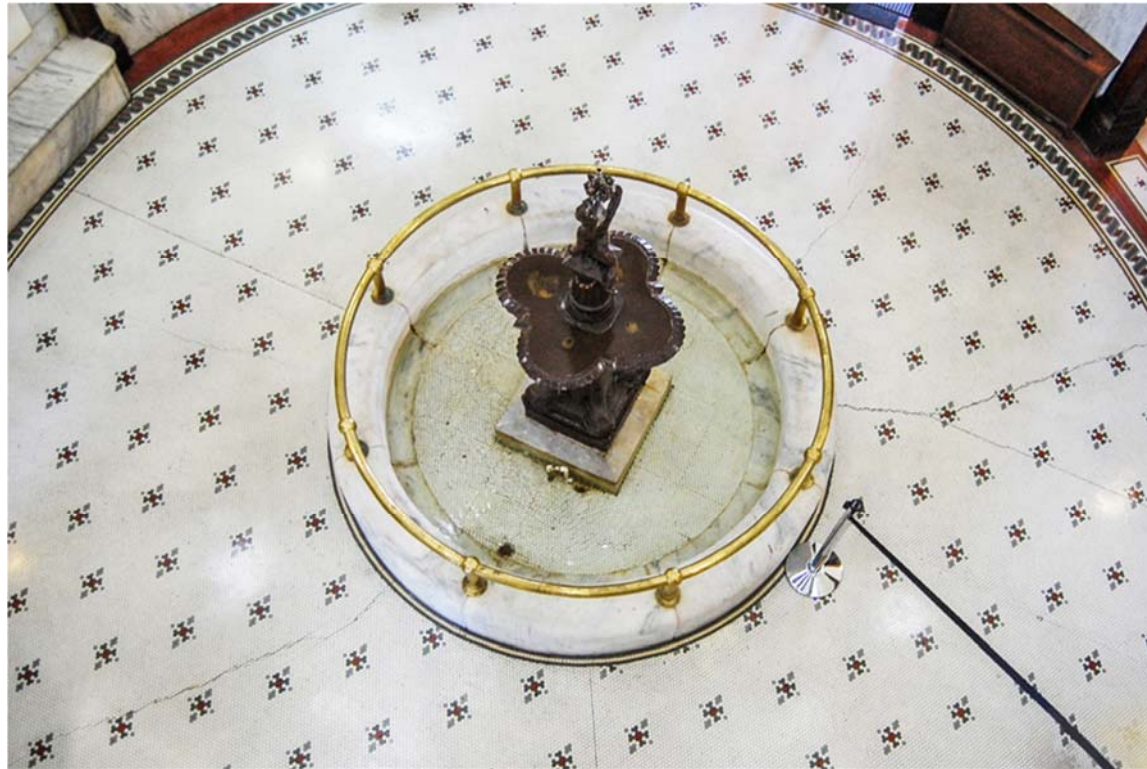
*View of first floor Rotunda from second floor mezzanine  
Figure 6*

The flooring of this space is laid in polychrome penny round tile set in a decorative pattern around a central fountain. Similar to the Lobby, the flooring in the Rotunda is suffering from cracks which run east and west centered at the fountain (Figure 6). There is a very small amount of tile loss on the first floor; however, it should be noted that there is a significant section of missing tile along the eastern wall of the northeast alcove (Figure 7). Along the edges of the floor, where the tile meets the marble wall panels, the panels are stained where floor polishing equipment has brushed against the wall at the base of the marble. Additionally, the marble panels in this space show some discoloration, particularly at the edges (Figure 8). Likewise, the circular marble base of the foundation is showing discoloration, particularly at the seams where the brass handrail is connected to the marble base.

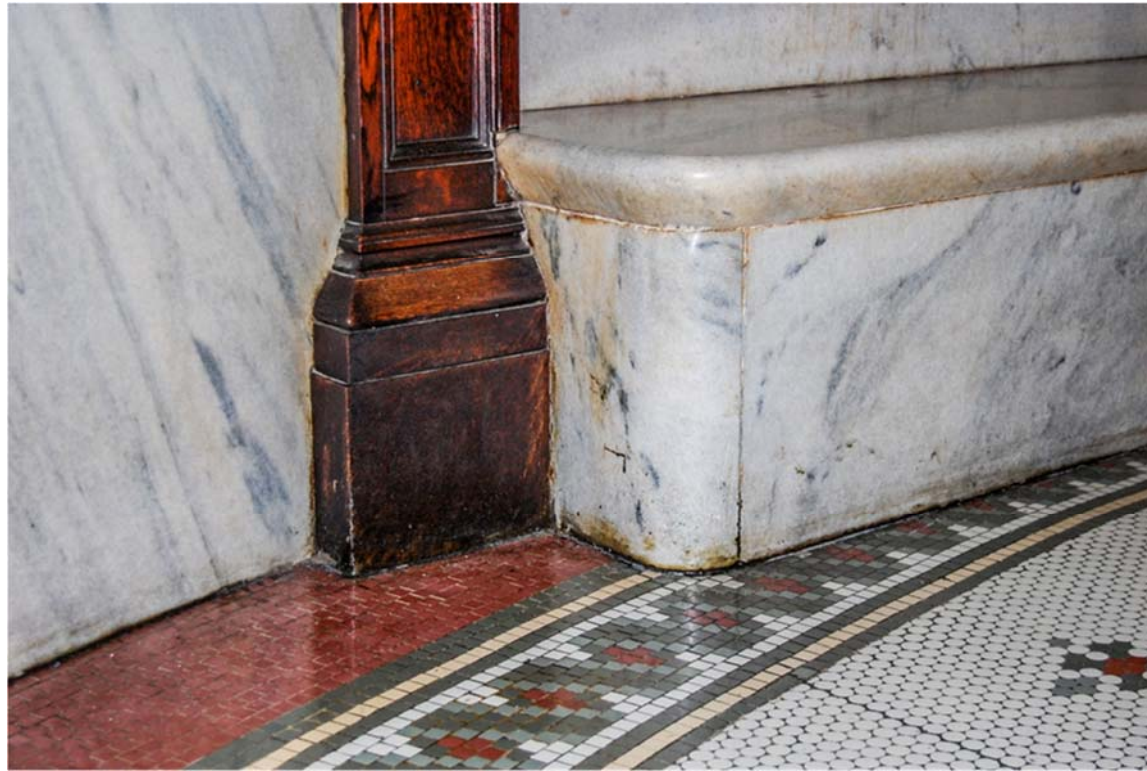
*First floor Rotunda detail of wall panel and bench, mosaic floor tile, and engaged column woodwork intersection*  
*Figure 8*

As evidenced in delaminating wood panels, gaps at panel seams, and surface chipping, the wood at the base of the Rotunda's door frames is worn and disintegrating where floor polishing equipment, passersby, and other elements have led to significant deterioration (Figure 8). The majority of the woodwork in the space is in fair condition overall, however the finish, which has failed and subsequently been reapplied over the years, has darkened with time and oxidization. It should also be noted that the door frame lintels significantly extend out from the plaster and subsequently collect dust, which is visible from the mezzanine floors above.

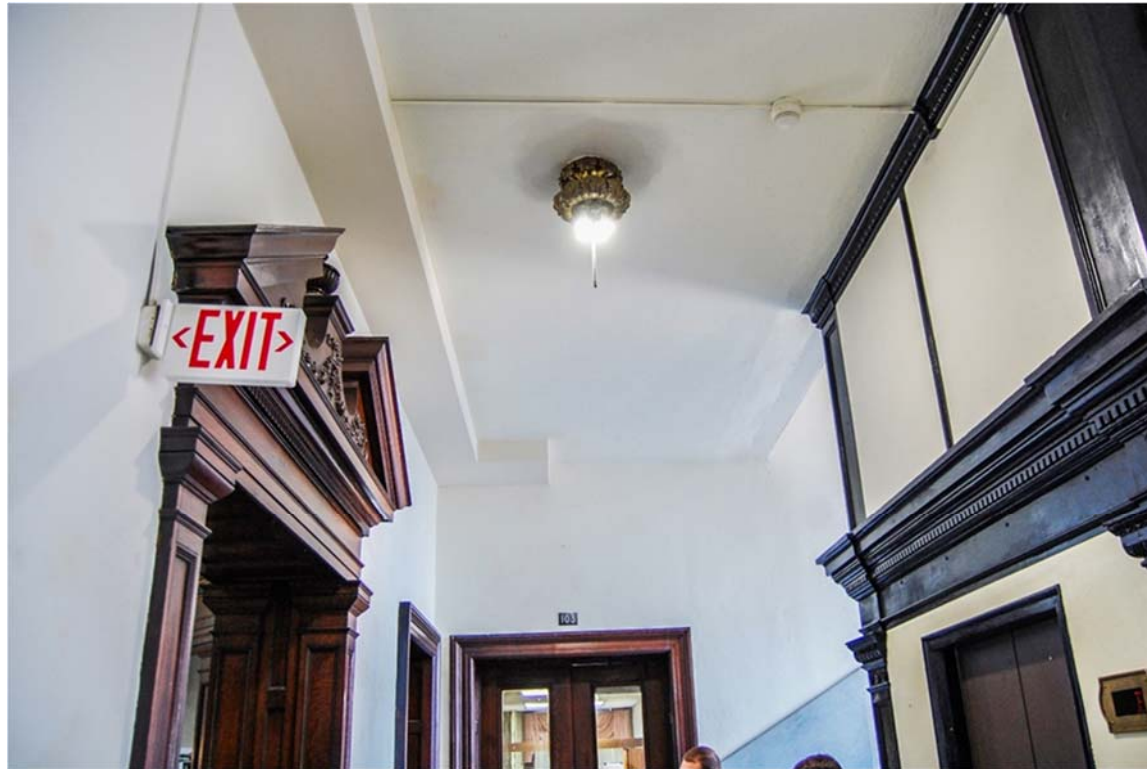
*Ceiling of First Floor Corridor, looking west.  
Figure 12*

The plaster walls above the marble panels have suffered from minor drilling and adhesives from signs and exhibits. Room numbers, which are likely unoriginal, have been added above the entrances to the offices on the east and west sides of this space (Figure 12).

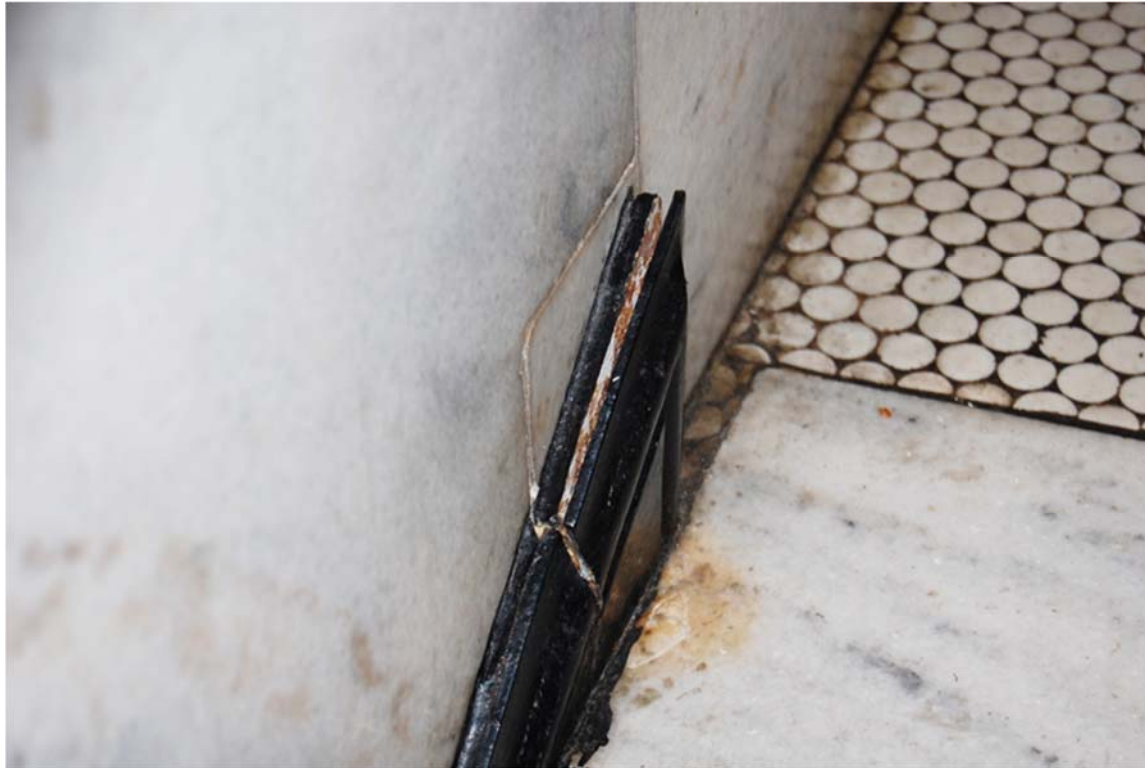
*Detail of wood trim at side of Stair.  
Figure 14*

The staircase is built of marble slab stair treads set within iron framing. The iron framing shows some signs of wear in chipped paint, scrapes, and scratches from use but is generally in good condition. Attached to the framing at the sides of the stair is rounded wood trim that has been painted black to look like the metal used in the elevator enclosure. In some locations this trim is delaminating and separating from the wall (Figure 14). The stair treads are overall in good condition; however, a couple slabs have cracks that run the length of the tread from nosing to nosing. While not confirmed, these cracks could date to the year the building was constructed as described in *The Birth of City Hall*. Marble wall panels follow the stair along its outer edges. Although minor, some discoloration has occurred along these marble elements from their consistent use, concentrated on the nosing of the stairs and the lower edges of the wall panels.

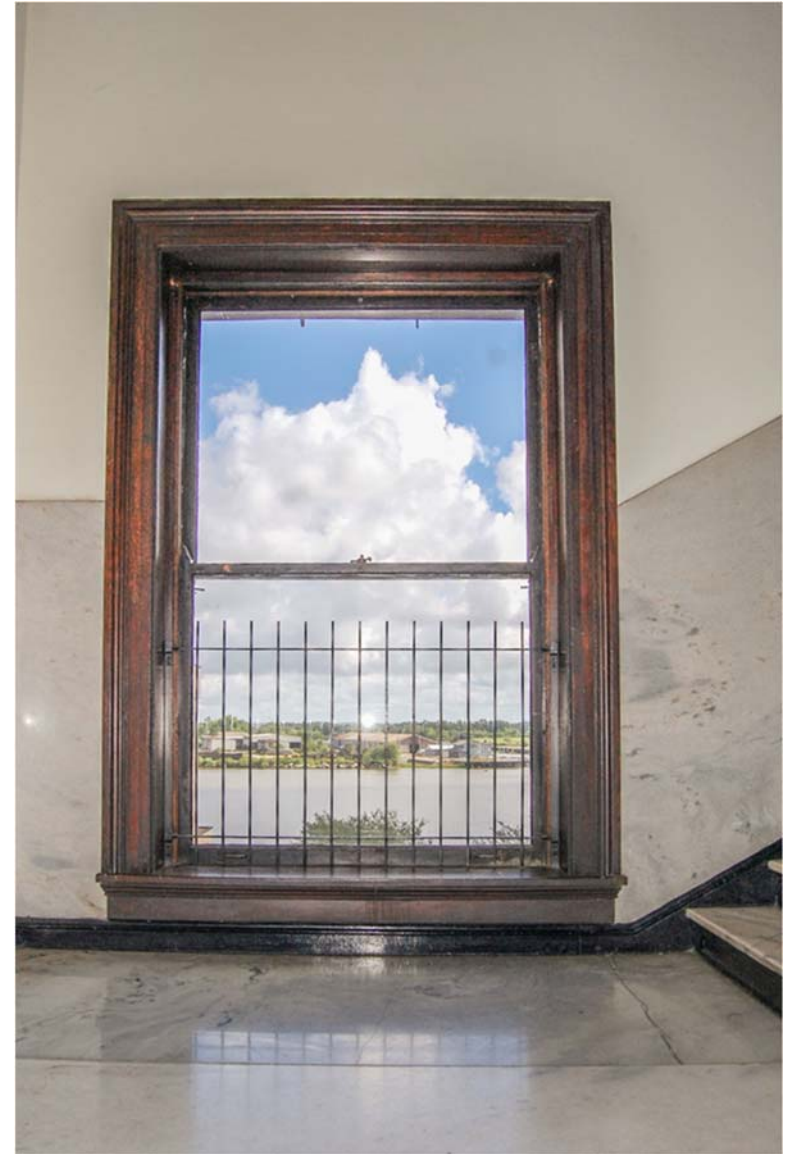
*Figure 16*

*Window at stair landing leading from first to second floor on north wall.*

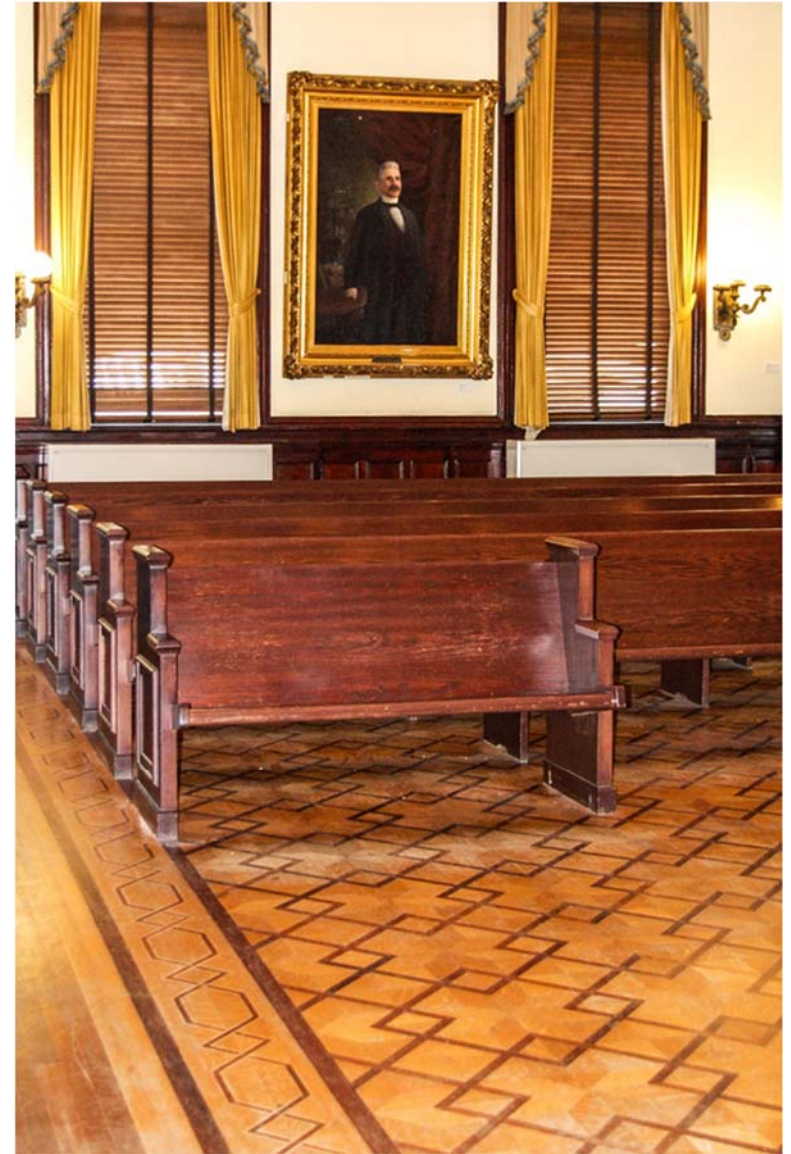
*Council Chambers interior, looking south.  
Figure 17*

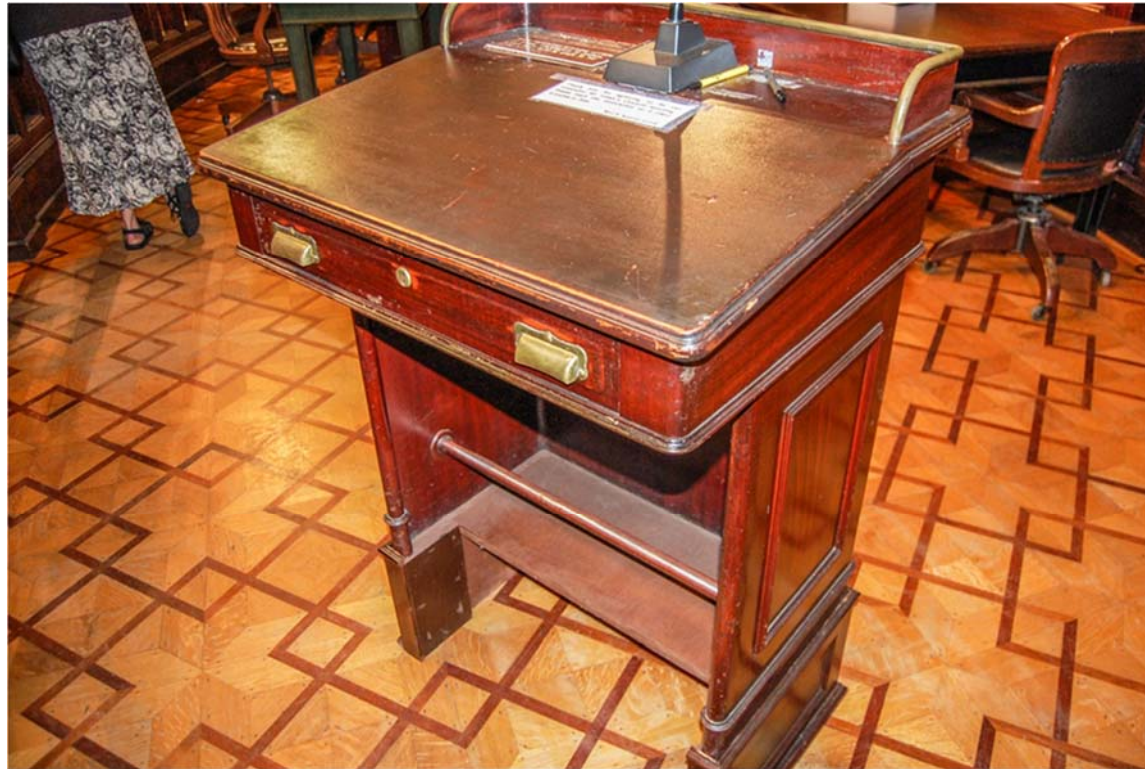
*Figure 20*

*Original desk converted for use as podium in Council Chambers.*

The most noteworthy damage to this original furniture has been the adhesion of various notes, nametags, and other elements to the surface which has left adhesives and abrasions. Other surface wear such as scrapes, scratches, and discoloration is present but minor.

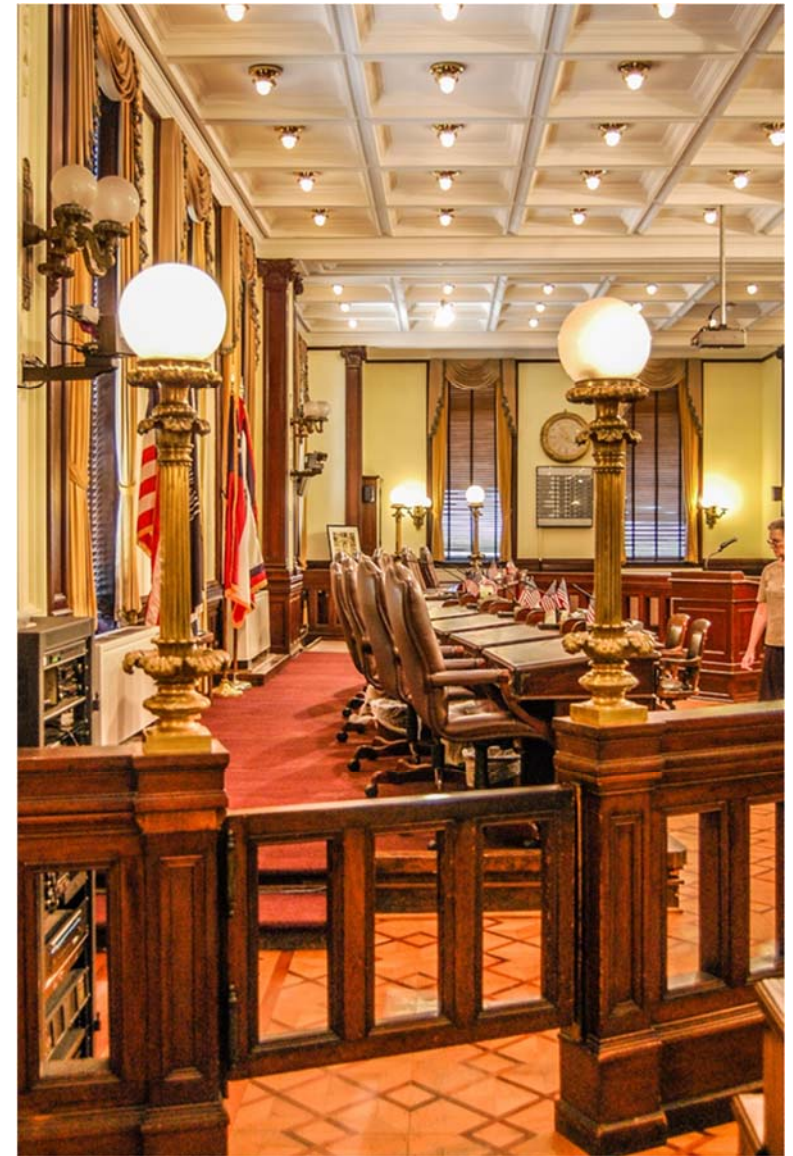
*Looking north in Council Chambers at City Council circle southern entrance. Figure 22*

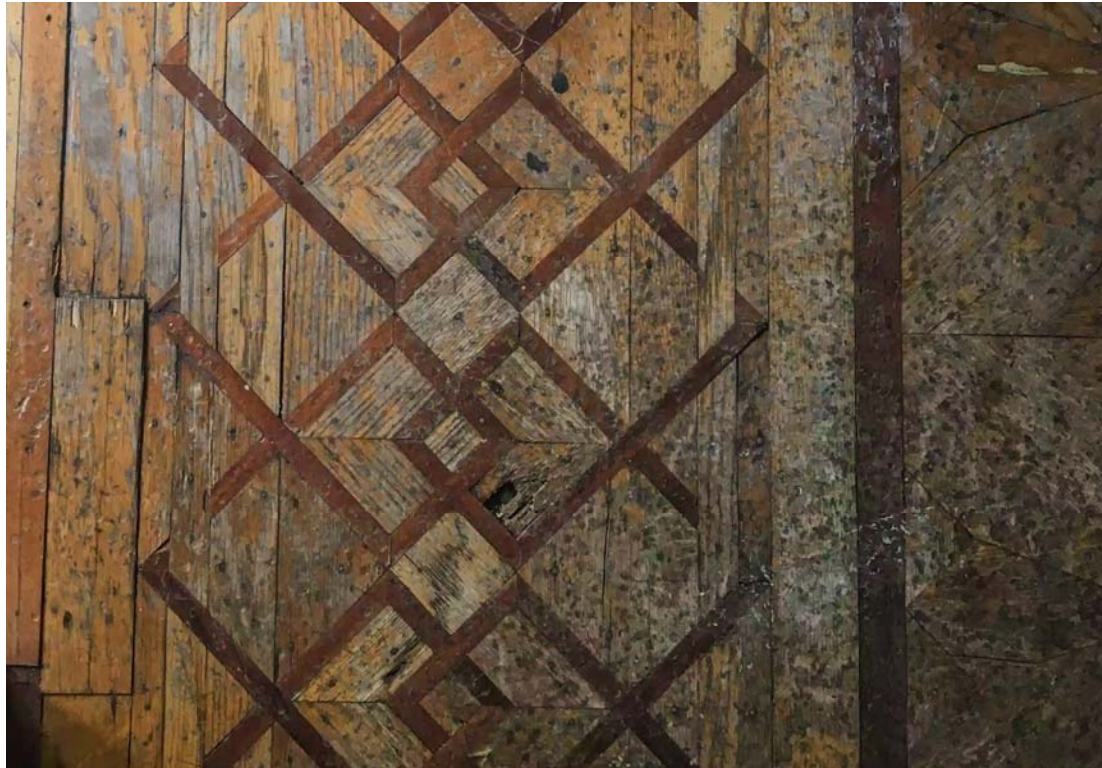
*Parquet floor detail in Reception Room.  
Figure 23*

The original parquet floors are one of the building's most unique features, but also one of its most deteriorated historic elements. Filling the entirety of the Reception Room and Council Chambers, the building's parquet floors were laid in a decorative star pattern set in squares. The Reception Room's floor is framed by a lattice detail border laid in multiple types of wood. The flooring has suffered significant deterioration from its use resulting in frequent puncture wounds, stains, and scrapes, which have removed and discolored the wood (Figure 23). Puncture marks range in size from 1/8 of an inch to 1 inch. In some locations this has led to the exposure of original nails which were used to secure the flooring. Unoriginal circular metal electrical covers roughly 4 inches in diameter have also been added to the floor. The areas of the floor that remain the most intact and show the least amount of wear are below a central table and entry rug by the northern entrance.

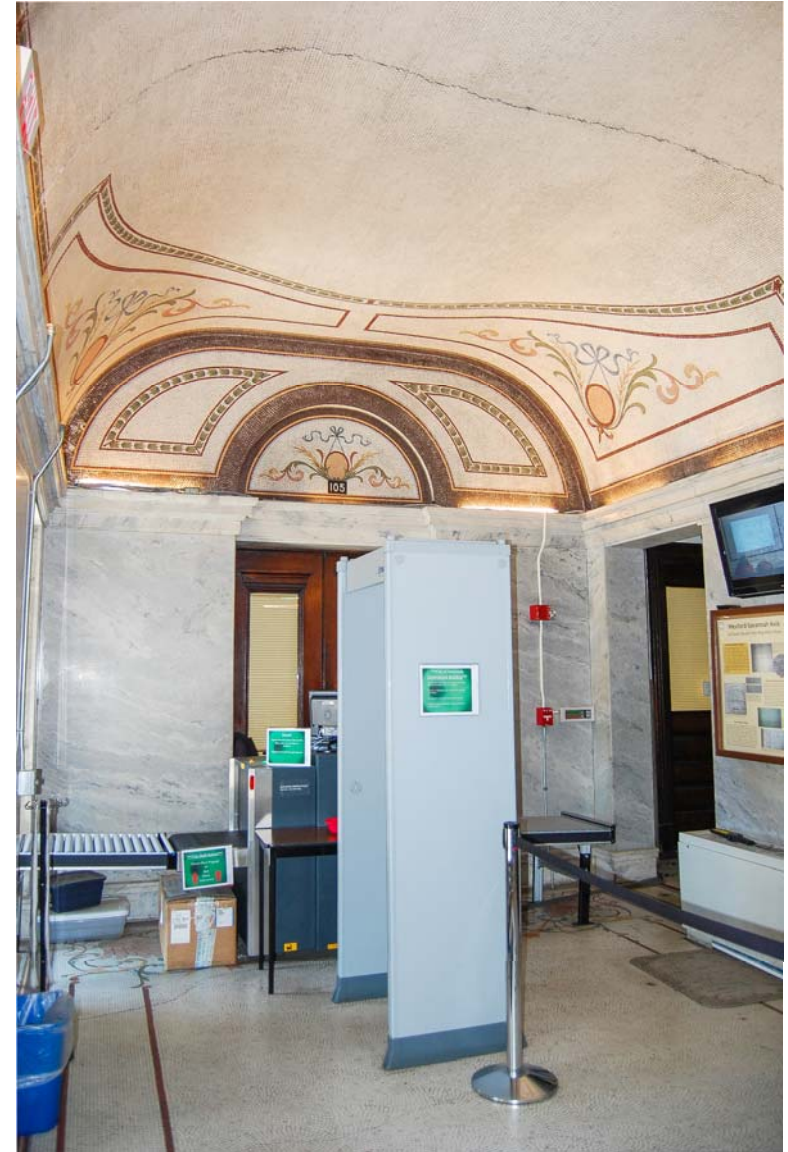
Originally, the centerline of the Lobby was intended to receive the highest use, allowing visitors to pass over the City seal, which is laid in mosaic tile and is the centerpiece of the Lobby floor design, leading visitors through the central of three openings into the building's Rotunda space via the shortest path from the central entrance. Currently, however, traffic through the space is directed through the westernmost entrance, via the Rotunda's southwest alcove, to facilitate visitor passage through security equipment (Figure 27).

*Interior of Lobby looking west, showing security equipment and television. Figure 27*

The best solution for relocating the security equipment is to move the equipment and direct visitors through the Lobby and into a room to the east, formerly the Assessor's office (Figure 29). This space is easily accessed through double doors off of the Lobby. Once inside, there is enough space to perform the necessary security functions currently housed in the Lobby, which include metal detection, bag scanning, identification and sign-in. Visitors could then re-enter the Lobby before entering the Rotunda and beyond. While this does not restore the original intended traffic flow from the main entrance through the central Corridor, it provides the necessary security measures to the building while removing the equipment from the Lobby, an important restoration measure. Visitors, however, will need to be directed via ropes, personal guidance, or other free standing directional signage. No signage should be attached to any surfaces.

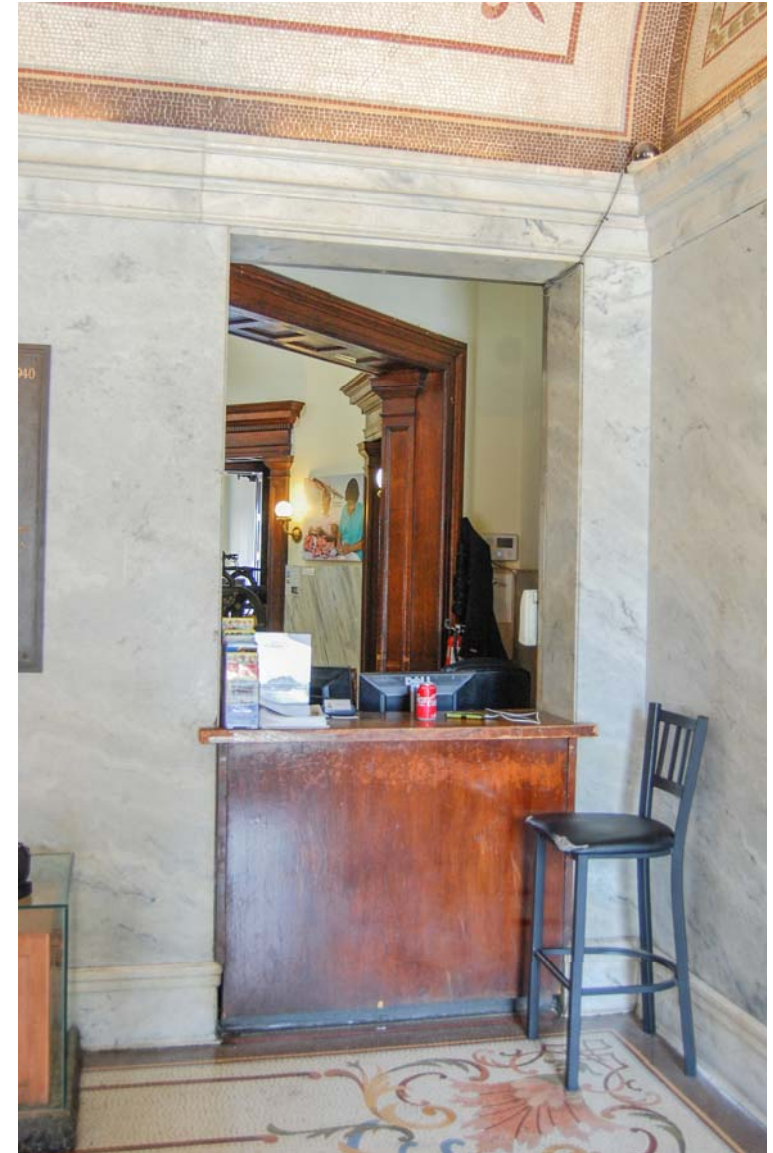
*Security desk added to entrance alcove in Lobby.  
Figure 28*

Relocation of the security equipment and desk would largely restore the room's emptiness as intended originally as well as provide for a quieting of the space. This would require the elimination of the desk in the southeast alcove of the Rotunda (Figure 28). This check point could be relocated with the security equipment, restoring this space's configuration as an empty passageway. Further, with the removal of these distractions, visitors are more likely to appreciate the space's architectural significance, historic materials, and detail.

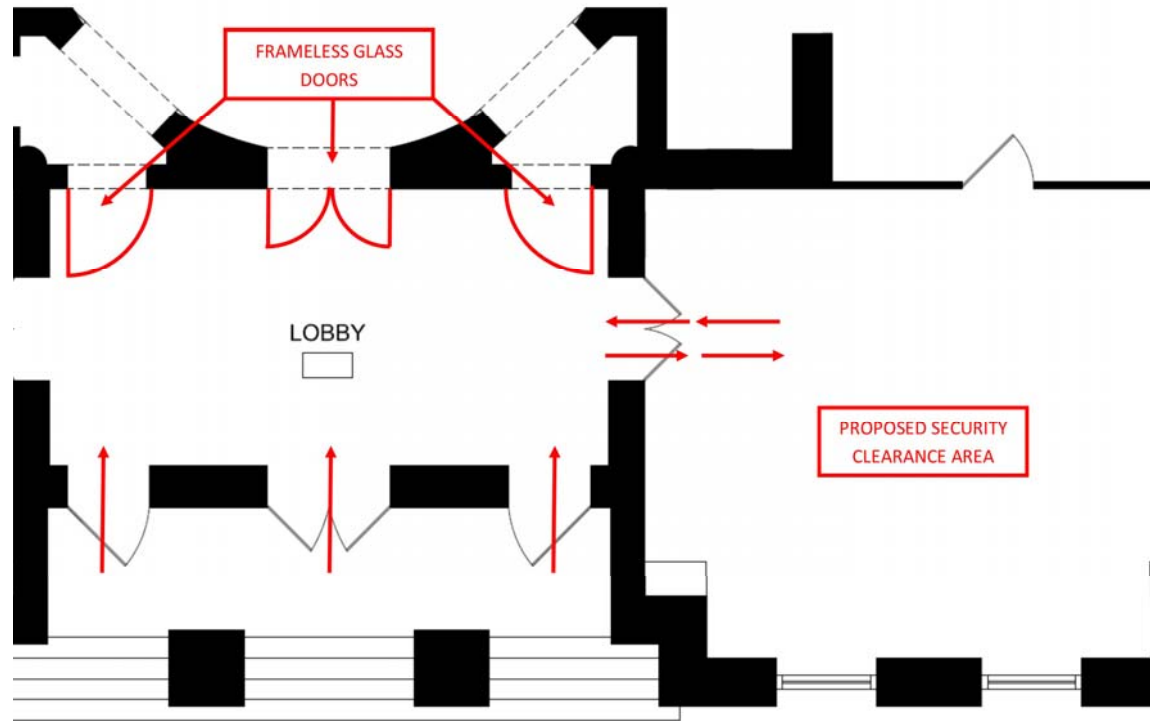
*Excerpt from existing plans showing potential first floor Lobby, Rotunda, and neighboring office space circulation. Figure 29*

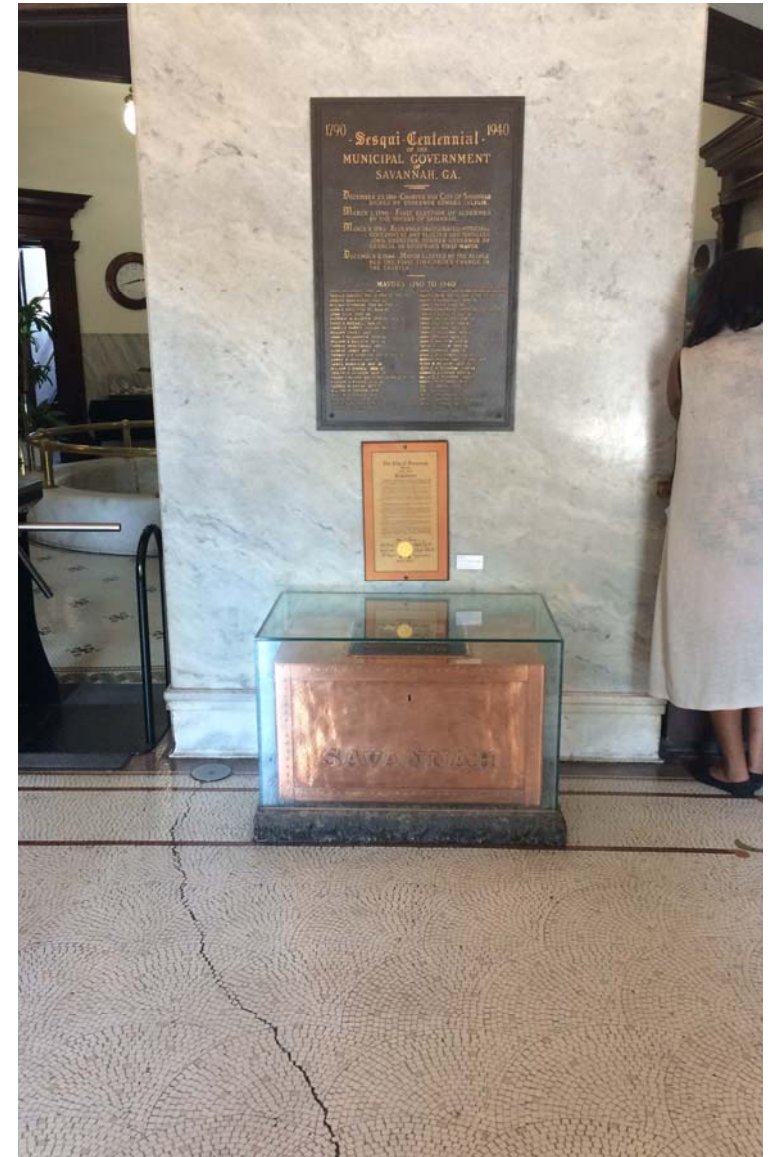
*Time capsule exhibit in Lobby on north wall.  
Figure 30*

It is preferred that tiles be utilized from areas within the space, salvaging original tiles that are currently hidden beneath the room's floor HVAC unit or the time capsule exhibit (Figure 30); if it is determined that these items or other items will remain in these current locations indefinitely. It can be assumed that the HVAC unit is more likely to remain in place as opposed to the time capsule, which is intended to be opened in 2076.

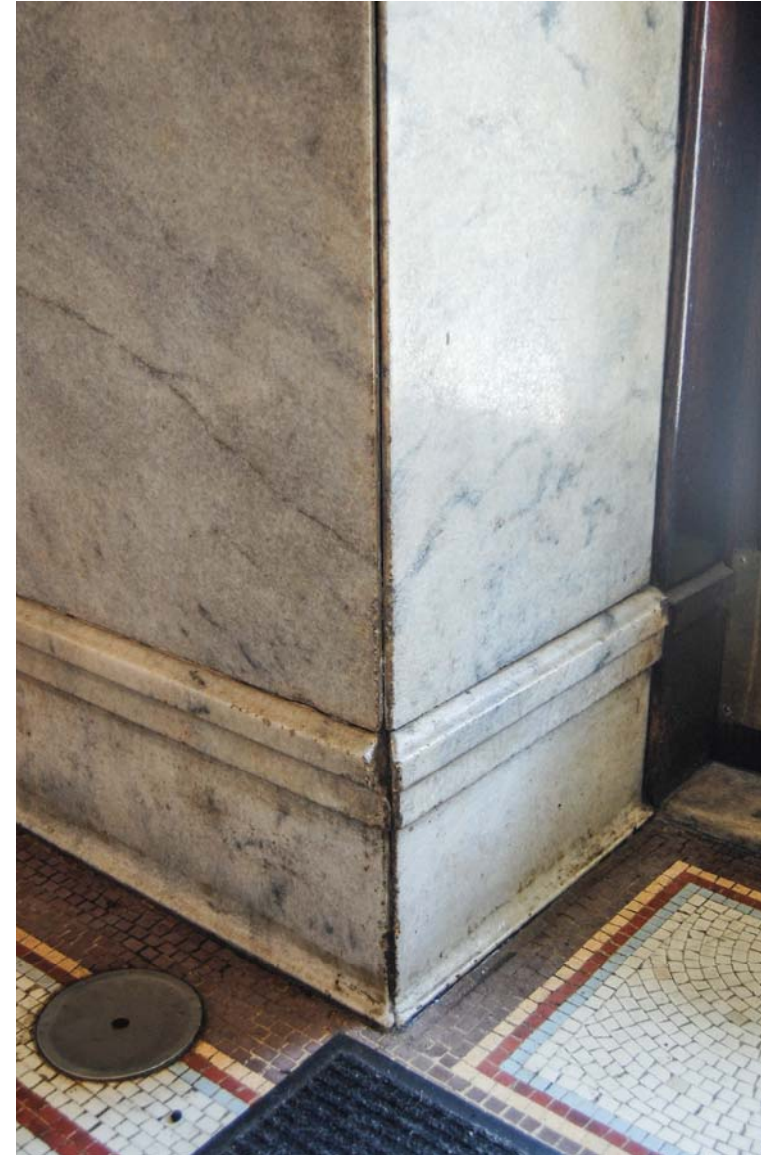
Figure 33

Within the Lobby, where the room's marble wall panels meet at the corners, the edges of the panels have become deteriorated and some areas are missing larger pieces. This is likely due to the abrasive movement of people and cargo through the space (Figure 33). Other areas where voids have been added, which are currently less visible, include the areas behind the television or exhibit and centennial panels, where holes have been made for the attachment and wiring of these elements.

Marble separation at corner of wall panels in Lobby.

1. Carefully remove dust and debris from cavity and fragments using a stiff fiber bristle brush.
2. Fill voids or seams with grout. Grout should match existing, historic mortar in color, texture, joint profile, and compressive strength as accurately as possible.
3. Follow manufacturer's specifications as written.
4. Faux finish the voids and seams to diminish their appearance, as needed.

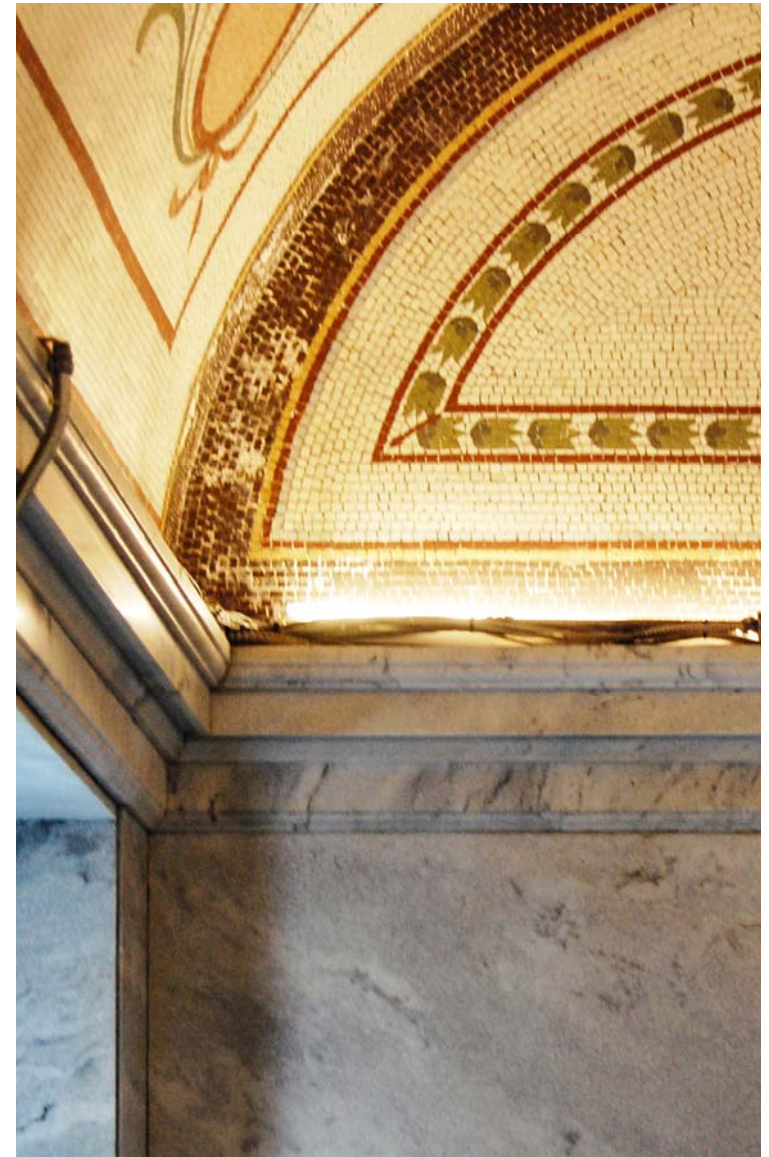
While minimal, efflorescence and tile staining in the Lobby exists and is visually apparent. Concentrated in the southwest corner, the efflorescence presents in a white powder-like fashion (Figure 35). Staining is also found on the floor tiles near the security equipment.

*Detail of mosaic tile in Lobby showing efflorescence.  
Figure 35*

In an effort to maintain a standard of care and ensure the preservation of the mosaic floor, it should be cleaned using the methods outlined above monthly, at a minimum.

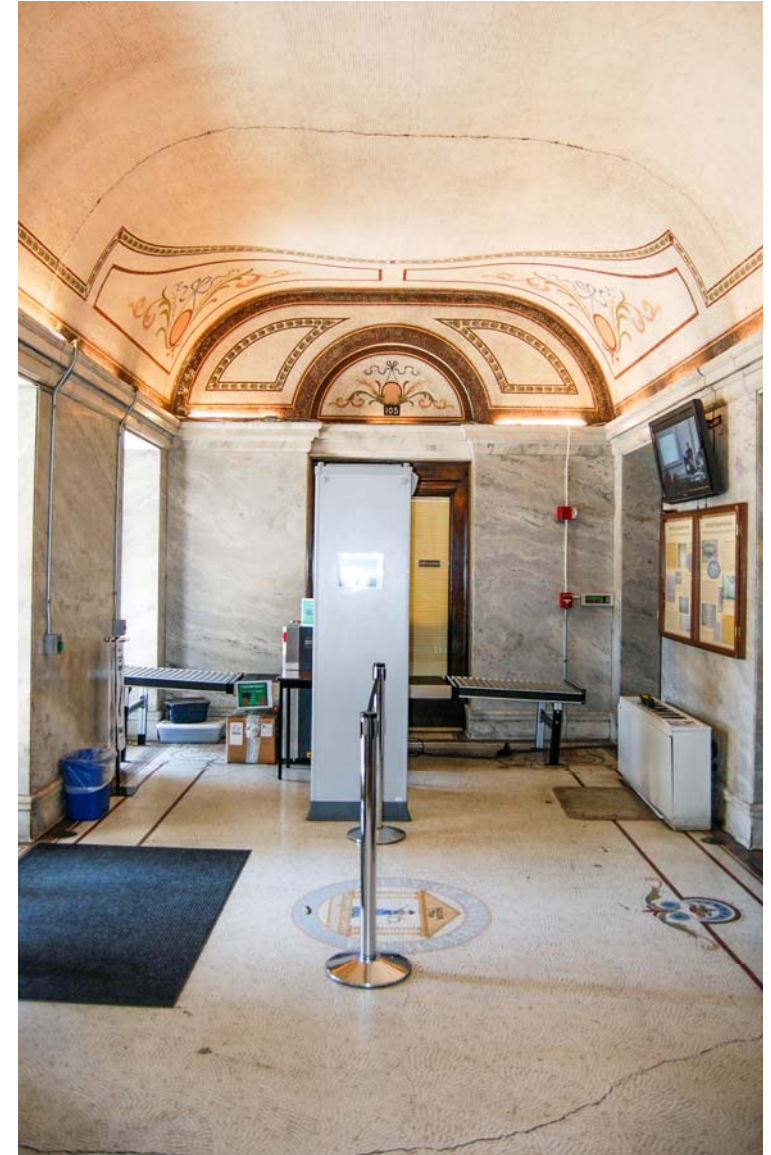
Throughout the building, televisions, exhibit panels, artwork, and signage have been attached or adhered to the building’s marble wall panels (Figure 36). While a complete restoration would require the complete removal of all of these items, it is acknowledged that this may be unrealistic. Some items, however, have been identified as items of greatest priority for removal due to their obtrusiveness or lack of necessity.

*View of Lobby interior looking west.  
Figure 36*

With the adoption of a work order review process, any additional appurtenances added to the space could be reviewed. The creation of new holes and use of adhesives should be prohibited.

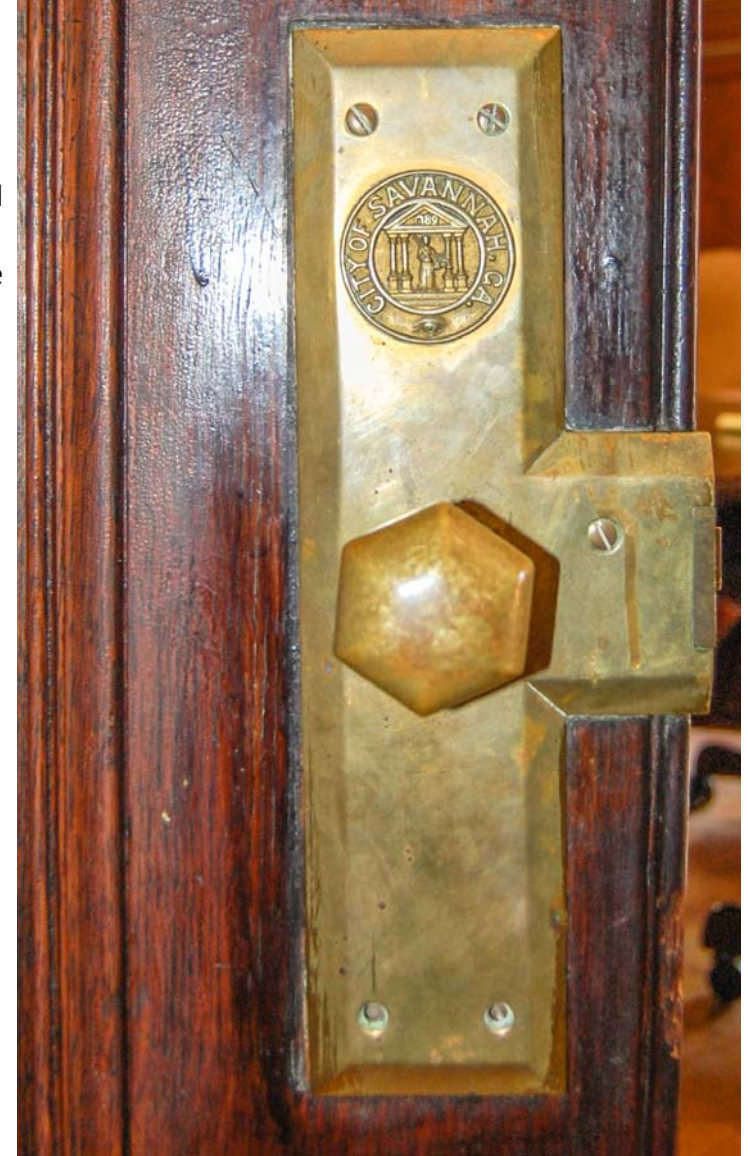
Throughout the building, historic brass door hardware featuring the City seal has been retained (Figures 39 and 40). One of the building's most valuable historic assets, these fixtures now have a patina from age. Also, a variety of maintenance and polishing solutions have been used in the past, leading to the build-up of cleaning agents on the surface of these elements. The restoration solutions provided can be applied to all spaces included in this scope, including Council Chambers, where a significant number of brass elements are located (Figure 41).

*Original City Hall brass door hardware.  
Figure 40*

Some commercial paste polishes are abrasive and can lead to scratching. Light polishing should be carried out using a jeweler's cloth containing rouge such as "Birk Cloth" or "Hagerty Glove." Below are museum-proven, safe polishing methods.

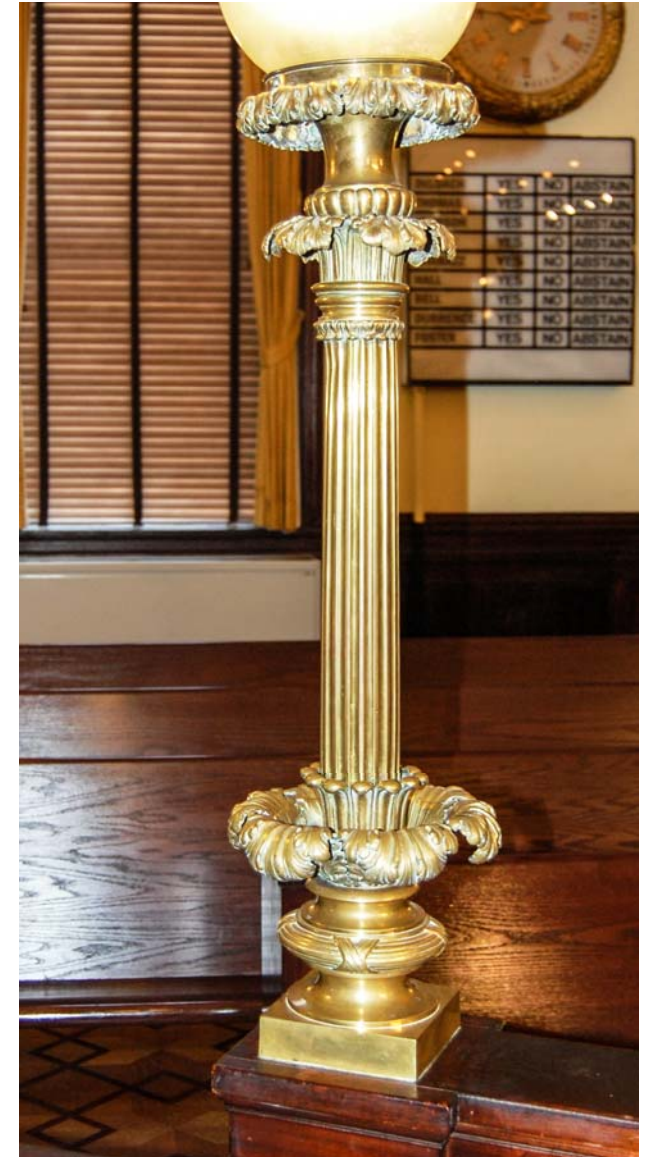
*Historic brass lamp in Council Chambers.  
Figure 41*

**Polishing Method 1:** A fine calcium carbonate, chalk, or whiting, worked into a slurry or runny paste with equal amounts of ethanol (denatured alcohol, ethyl alcohol) and distilled water. The paste should be rubbed across the surface, working a small area at a time, with cotton balls or clean cotton rags. Detail areas can be polished with q-tips, using the paste, or with cotton wadding at the end of a sharpened bamboo skewer. It may not be desirable to clean every crevice, as this decreases the overall contrast of the detailing. It is important that all residual polish is removed with distilled water. Drying can be accelerated by adding ethanol to the rinse water, or by wiping the object with ethanol.

**Polishing Method 2:** If the brass does not respond to Method 1, the oxidation layers present on the object may be too thick. Although more abrasive, “Autosol” is recommended in this instance. A general purpose polish, a test should be performed to determine the degree of polish you wish to achieve on a small inconspicuous part of the object. A clean rag should be used to buff the polish. The surface must be rinsed with mineral spirits after polishing, removing any polish residue. This polish contains less ammonia than other commercial brands. Ammonia causes long term damage to valuable copper alloy objects.

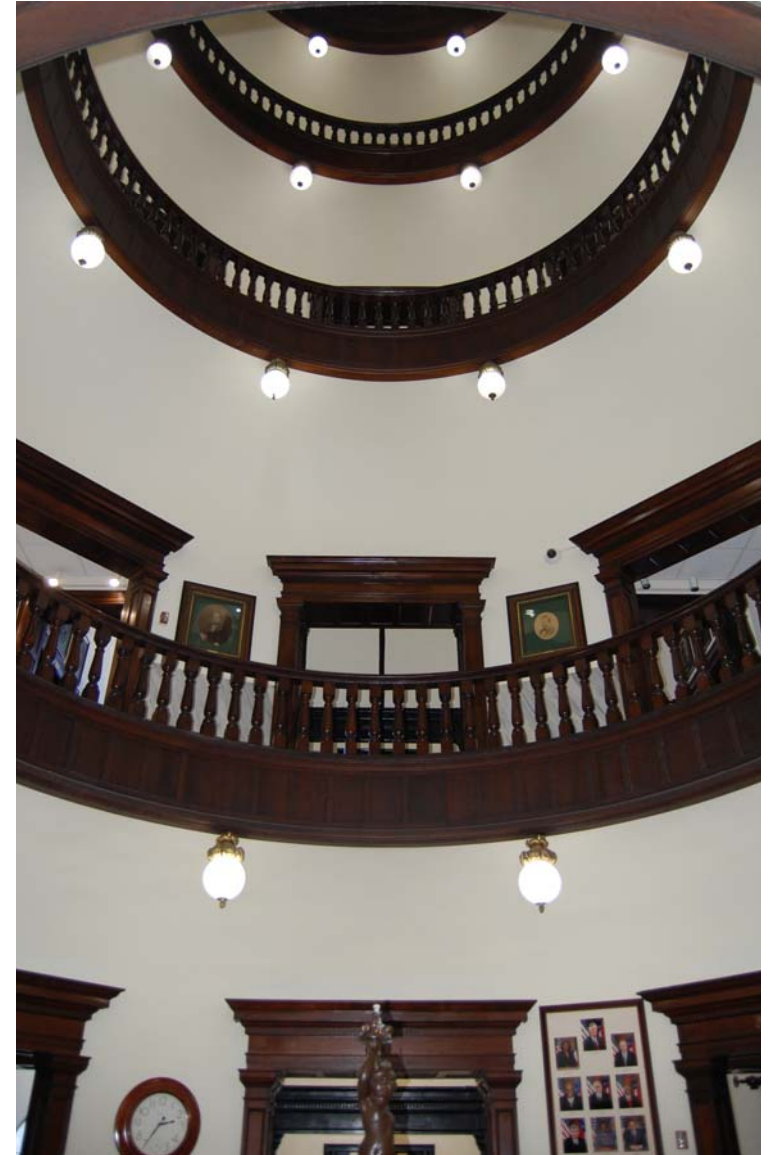
Throughout the building, historic brass light fixtures have been retained (Figure 46). One of the building's most valuable historic assets, these fixtures now have a patina from age. A variety of maintenance and polishing solutions have been used over time, leading to the build-up of cleaning agents on the surface of these elements. The restoration solutions provided can be applied to all spaces included in this scope.

*View of Rotunda brass light fixtures with glass globes.  
Figure 46*

Surface cleaning, if begun, should be performed weekly at a minimum or monthly at the very least. Polishing and coating requires significantly more time and attention in the continued maintenance of these finishes, requiring a skilled tradesperson or conservator.

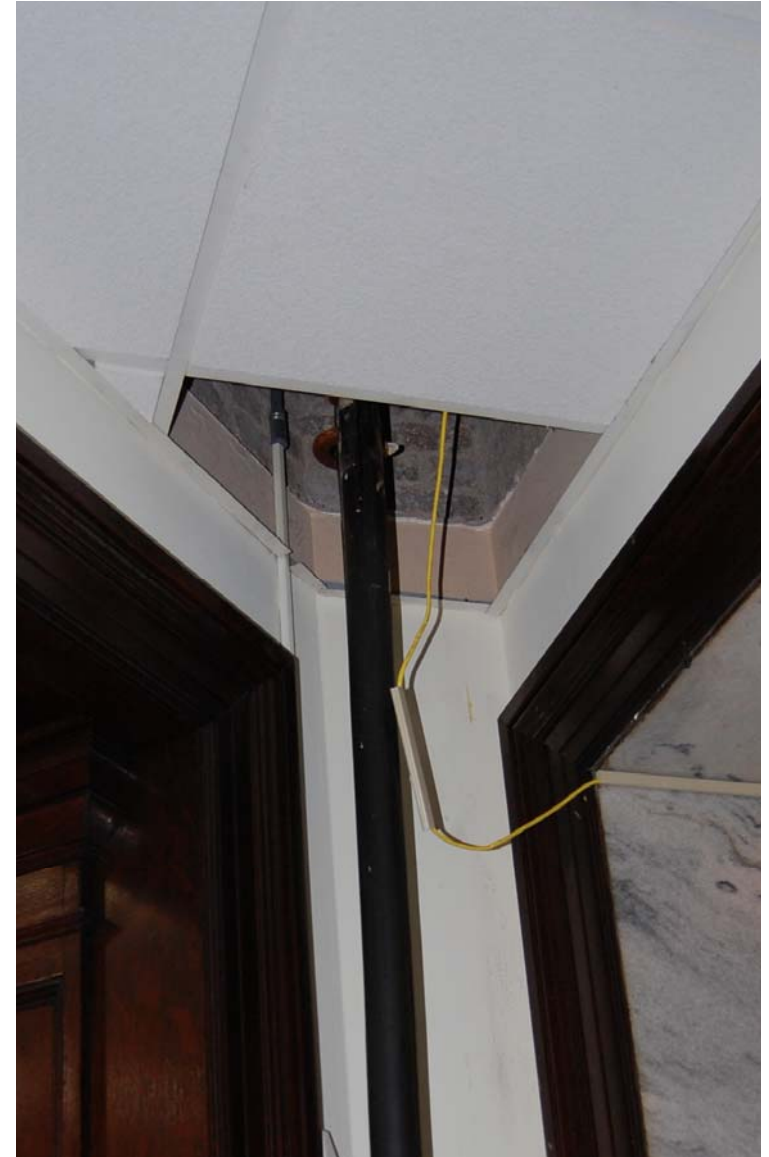
Evidenced on the section of plaster wall currently hidden above the drop ceiling in the Rotunda alcoves, there have been multiple paint colors used in this location (Figure 47). From a Savannah Evening Press article dated August 22, 1905, "The walls will be colored a very pretty tint of light green, while the ceiling will be of a still lighter shade of the same color. The rotunda, council chamber and the mayor's suite will be left a plain white.." (Figure 1). The original paint colors should be identified through paint analysis, performed in an inconspicuous location. Typically this consists of 1 inch square scrape test in succession until all layers of paint have been identified. As part of this analysis, any wear, dirt, or other staining should be considered as part of the overall patina of any colors found. Once an original color has been identified, a fresh coat of paint in the original color should be applied to the area examined. This method should be repeated in all painted areas within the scope.

*Detail of multiple paint colors above drop ceiling in Rotunda alcove corner. Figure 47*

## BEST SOLUTION: PERFORM A PAINT ANALYSIS TO IDENTIFY ORIGINAL PAINT COLOR, COLOR MATCH, AND REPAINT.

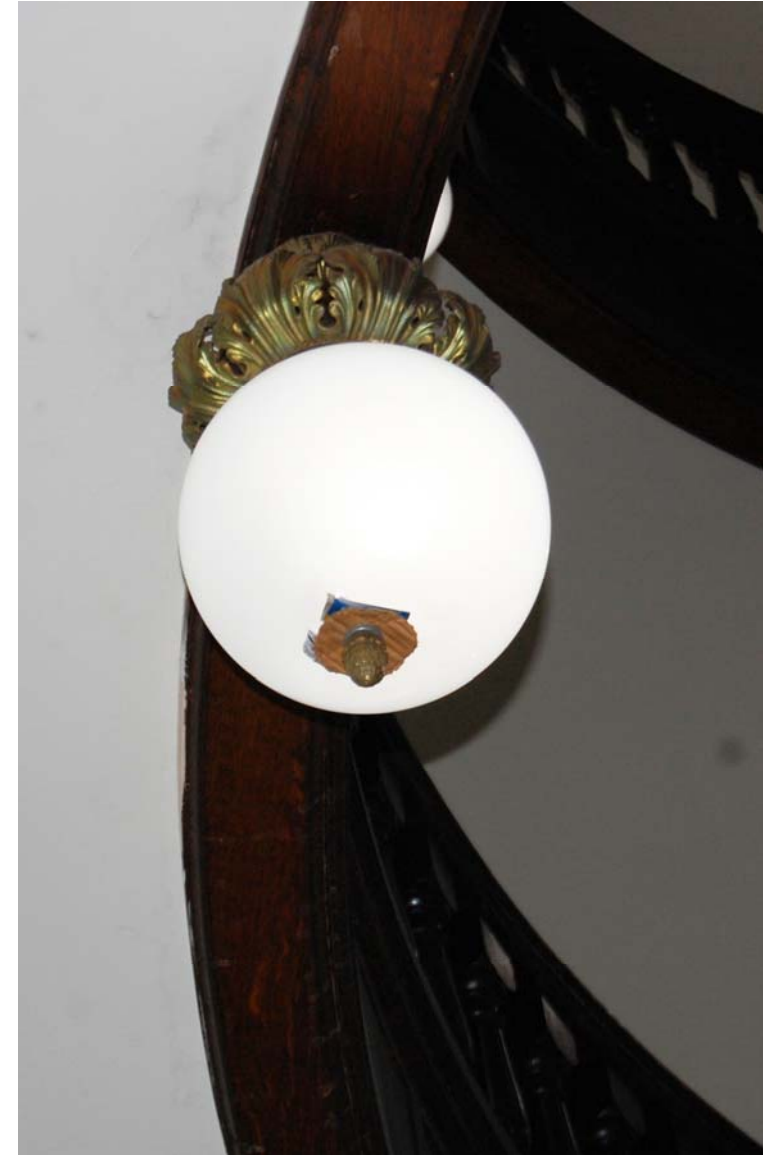
Throughout the Rotunda, the room’s many hanging electric light globes and brass hardware are not uniform in detail, material, or light temperature and hue (Figure 49). Fortunately, however these inconsistencies are not found in the majority of the fixtures. Therefore, it is possible to examine the majority of the existing fixtures to determine the original elements and configuration of all the fixtures.

*Original brass globe light fixture that has been altered.  
Figure 49*

Continued monitoring of the light fixtures, their configuration, temperature, and hue should be examined as part of an annual building inspection (Appendix E).
