# SAVANNAH CITY HALL INTERIOR CONDITION ASSESSMENT AND RESTORATION PLAN

Completed June 2018 for the City of Savannah

Lominack Kolman Smith Architects  
301 W Broughton Street  
Suite 301  
Savannah, GA 31401  
912.232.5561

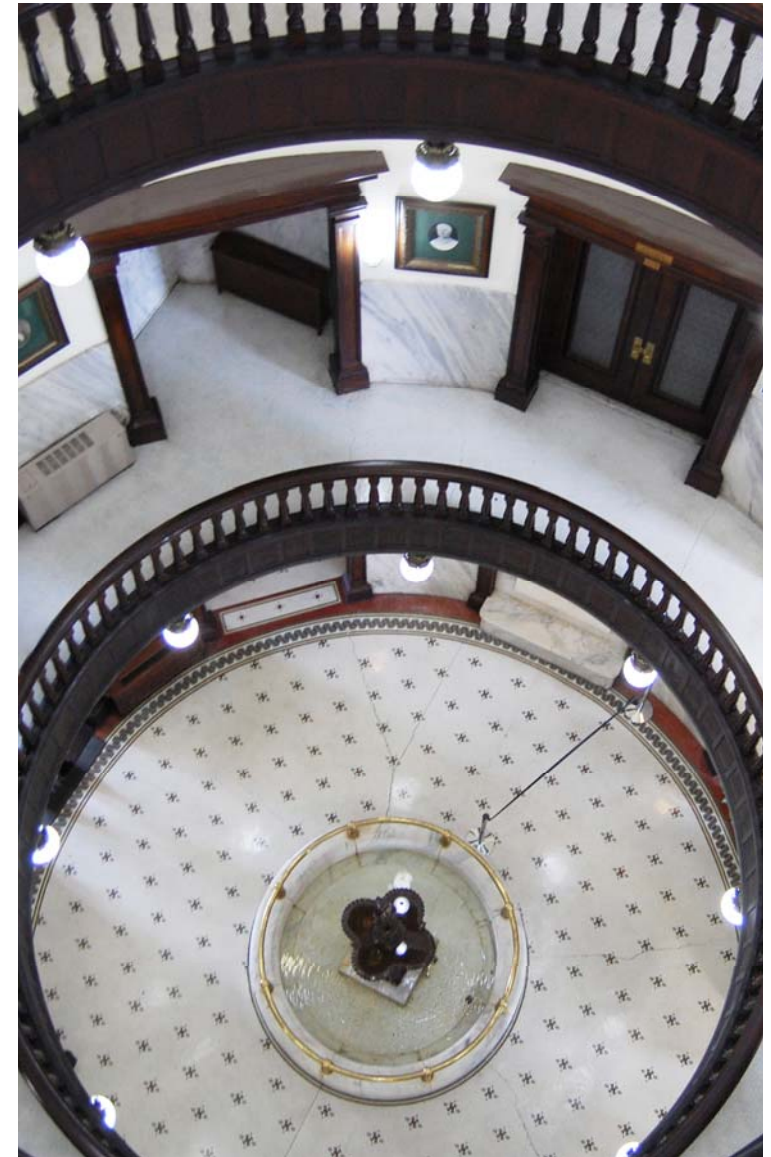
Within the building’s circulatory spaces, specifically the first floor and the Rotunda, City staff have struggled to keep the building cool during the hottest months and warm during the coldest months (Figure 52). While this is not attributable to one issue or element, there are some measures that could assist in its regulation. The solution outlined below should apply to all spaces included in the scope of this report.

*View of Rotunda looking down from the third floor.  
Figure 52*

Further, it is recommended that a barrier be installed to minimize the flow of hot and cold air from Bay Street into the Rotunda. Frameless glass doors sized to fit each of the three door openings leading from the Lobby to the Rotunda are recommended as part of a larger plan which also incorporates the removal of the security desk in the southeast alcove as outlined on page 42-44. This will provide a barrier and create an “air lock” vestibule in the Lobby, reducing air infiltration into the Rotunda and beyond when an exterior door is open. Utilizing glass provides a barrier while remaining minimally visually obtrusive. Further, this allows for more than one, if not all, of the building’s entrance doors along the Lobby’s south wall to be operational during business hours as greater control of traffic inside the building can occur on the interior.

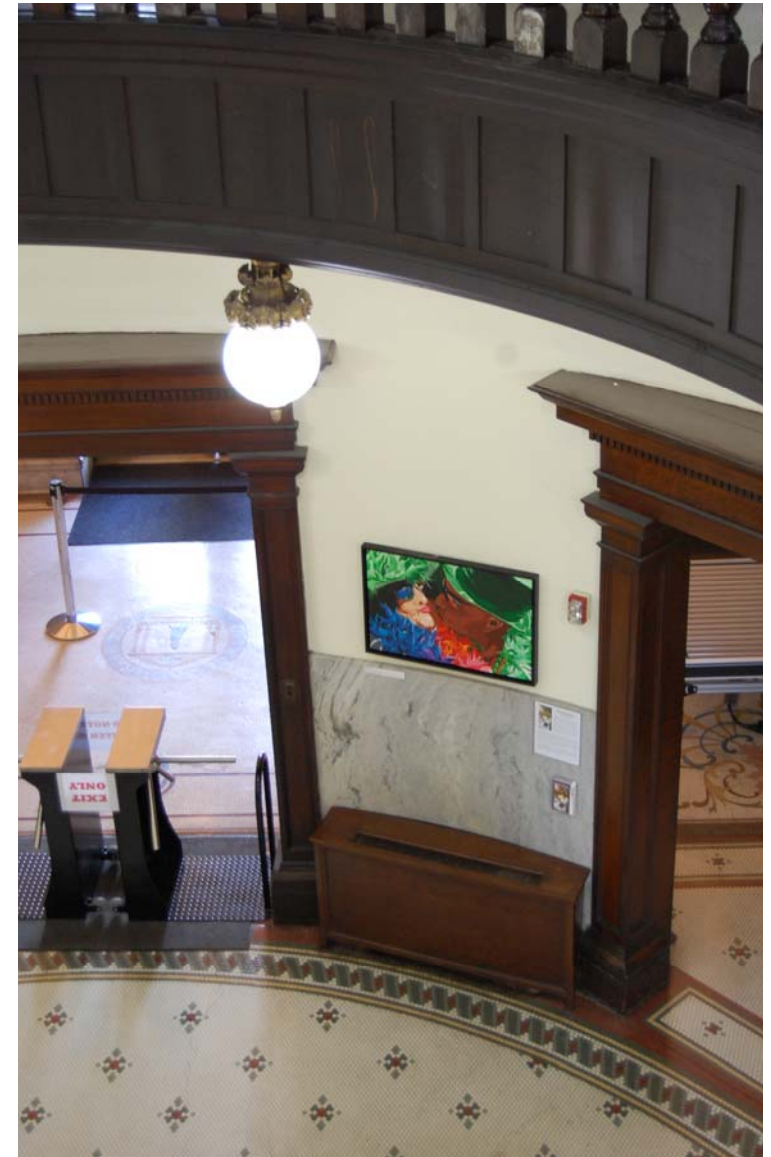
*Figure 53*

Throughout the Rotunda, exhibits have been periodically attached to the room's plaster walls (Figure 53).

*View of Rotunda looking down from the second floor.*

The use of traditional adhesives that will cause damage to the building's interior plaster walls should be prohibited. A review of the use of space annually should occur as part of an annual building inspection (Appendix E).

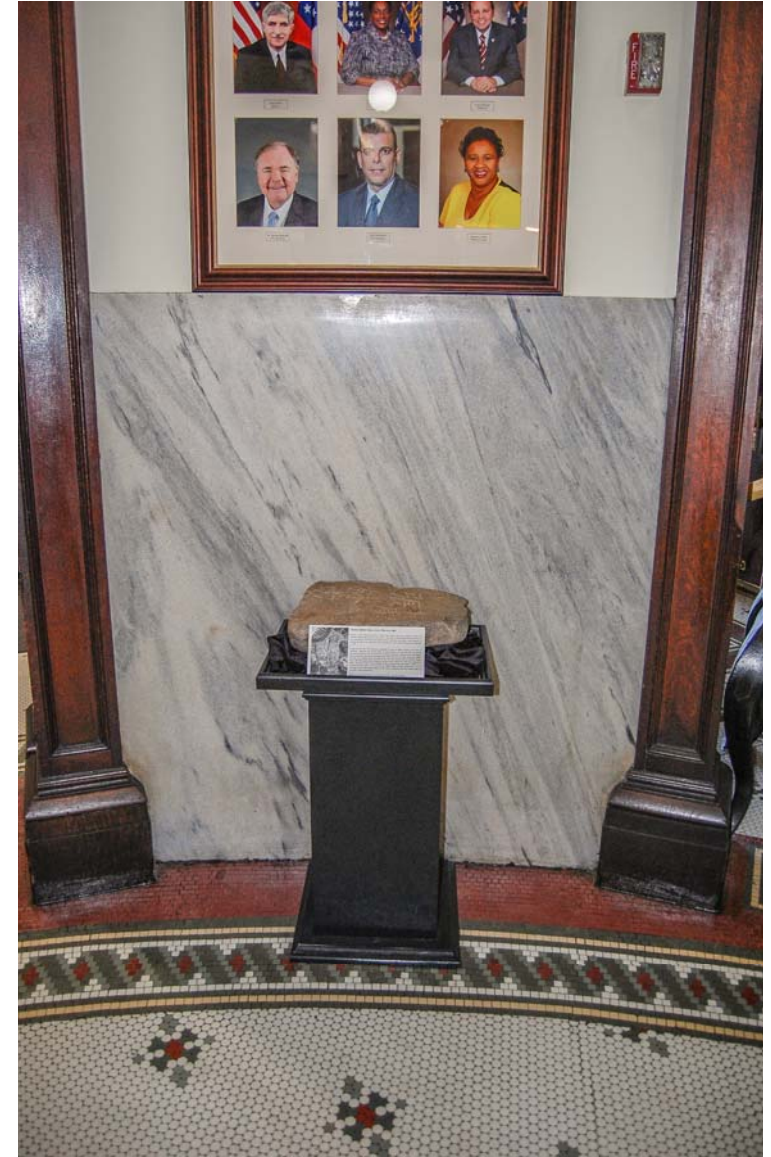
Displayed on a table in an open-air setting, the Chinese cobblestone exhibit has, for all intents and purposes, become a permanent exhibit in the City Hall Rotunda (Figure 54). A true restoration would call for its removal as it is unoriginal to the space. If retained, however, the solutions for its retention and preservation outlined below should be followed.

*Chinese cobblestone found on River Street that is now housed in the Rotunda. Figure 54*

The cobblestone could be relocated to a more secure location since it is not integral to the historic and architectural integrity of City Hall. Since the City currently has no other exhibition space in as close proximity to the stone's origin, River Street, this is not the best solution.

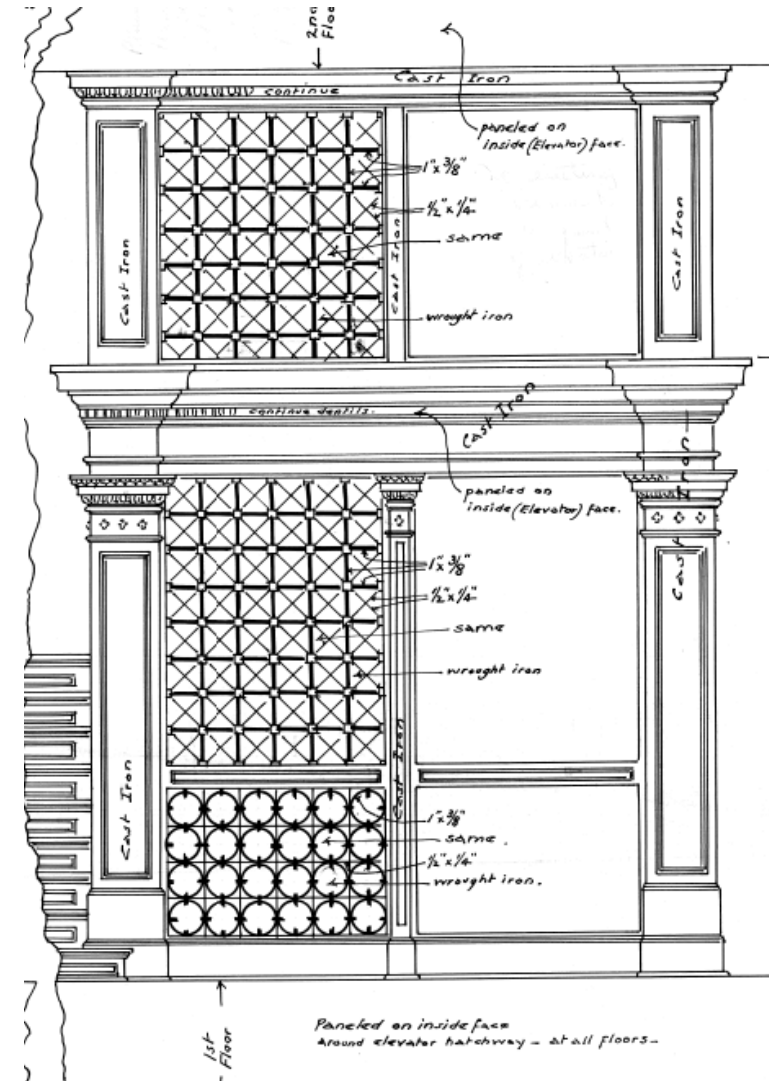
## ISSUE: SOUTH ELEVATION ELEVATOR SHAFT ENCLOSURE (PRIORITY A, SEVERITY 2).

The wall system currently in place on the south elevation of the elevator shaft includes an enclosure that was added when the elevator car was first replaced in 1941 (A Century of History). This is repeated on all floor levels. The original elevator entrance was located to the right of center along the elevator box's south face (Figure 55). The current elevator car opens in the center. The installation of the wall system removed the original iron casing which had a similar but unique design to the sides and north elevations of the elevator, which was applied to both the upper and lower portions, and are currently enclosed. This change also removed a central iron column. Currently, a modern water fountain is attached to the southwestern cast iron column and the wall system at the base of the elevator cage.

Excerpt from the 1905 Annual Report detailing south wall of elevator shaft. Figure 55

In order to address the removal of unoriginal elements and restore the elevator shaft, the water fountain must be removed (Figure 56). Care should be taken during removal, specifically in relation to the cage's original cast iron column. Once the fountain is removed, the cast iron should be inspected for damage or detriment. Likewise, the wall system on both the upper and lower portions should be removed followed by the installation of a replica cage as outlined in the original drawings (Figure 55).

The upper portion should replicate the iron casing that was originally installed. The lower portion will be a modified design, to accommodate the modern elevator that has been installed, with the replica cage elements filling the plastered areas. The central iron column will not be recreated due to the elevator entrance now being located in the center. A consultation from the elevator manufacturer may be required.

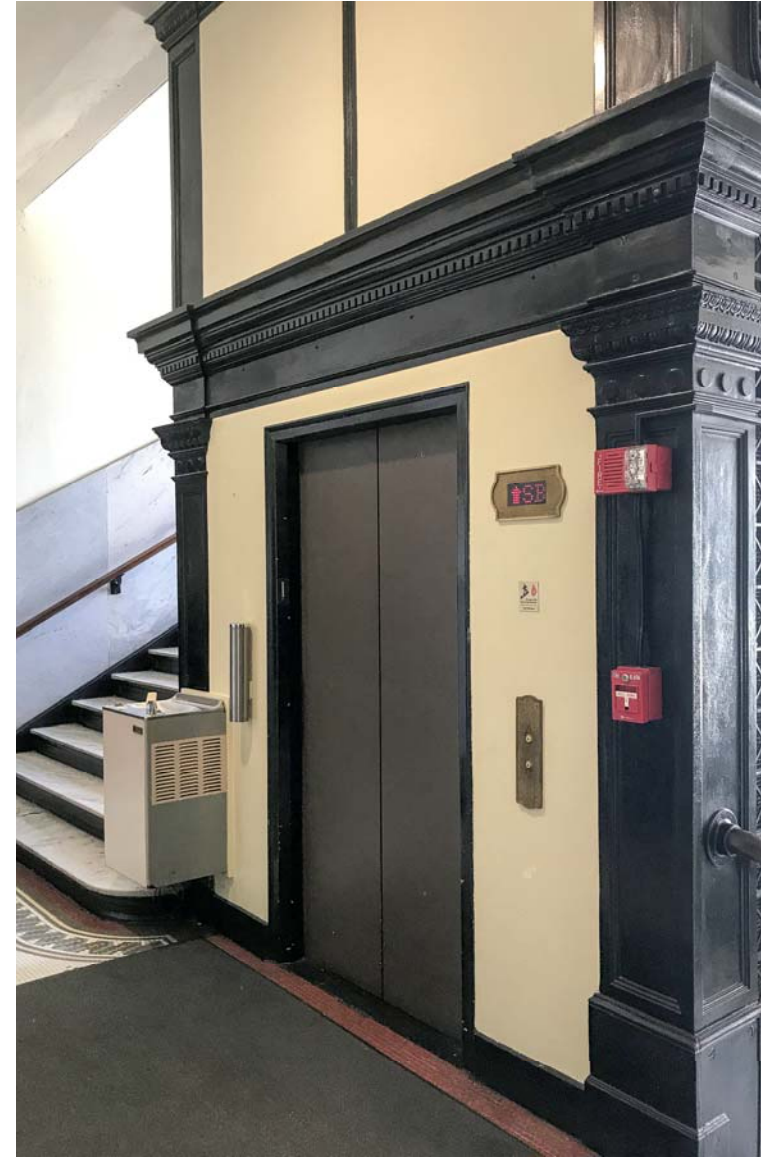
*Detail of elevator entrance on the first floor in its current configuration. Figure 56*

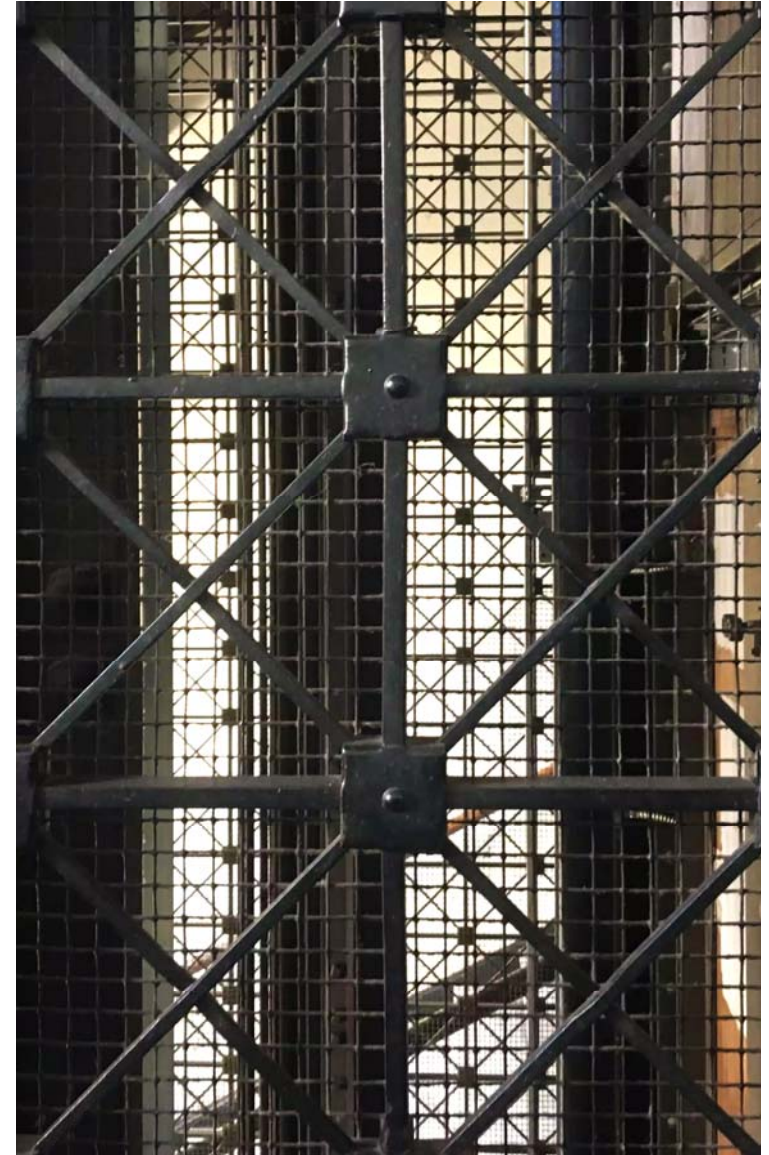
Unoriginal to the space, a small gauge square wire mesh has been inserted within the elevator shaft and attached to the inside face of the exterior iron framing (Figure 57). This hinders the historic and architectural integrity of the elevator, which has been significantly altered on the south face for the conversion from historic to modern elevator car use. The applied wire mesh collects significant dust and is not routinely cleaned.

*Detail of wire mesh attached to elevator shaft.  
Figure 57*

Wire mesh should be removed from the interior of the elevator shaft. This should be done carefully as not to damage surrounding historic elements.

Superficial dust can often be vacuumed whereas dirt can be washed off well, painted and caulked cast iron with low-pressure water. Non-ionic detergents may be used for the removal of heavy or tenacious dirt or stains, only after they have been tested to determine they will not have an adverse effect. Thick grease deposits and residue can be removed by hand scraping. Water and detergents or non-caustic degreasing agents can be used to clean off residue. Before re-painting, all oil and grease must be removed so that new coatings will adhere properly (Preservation Brief 27).

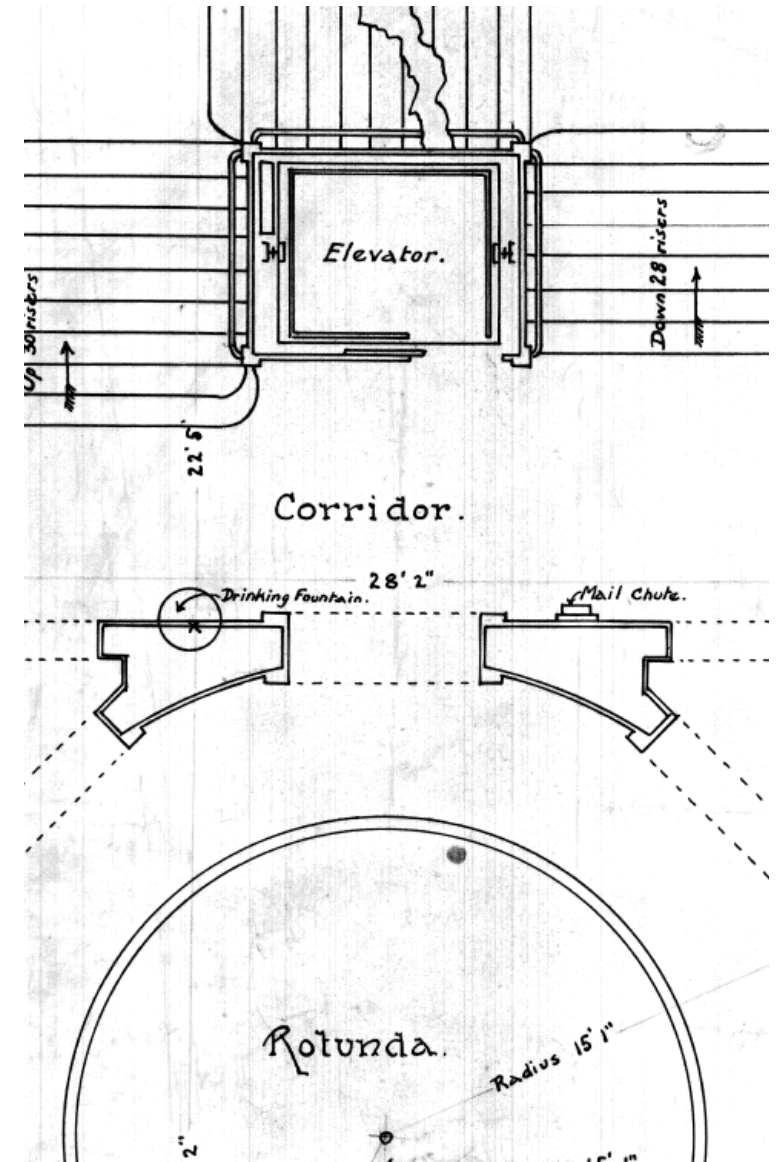
As noted on the original drawings, the Corridor originally housed a mail chute on every floor at the south wall which carried mail from all floors to a central location for later retrieval (Figure 58). No physical evidence remains of the mail chute's size and material. Further, no historic images have been found of these areas. On the second floor, a marble water fountain opposes the mail chute on the south wall and is likewise shown on the original plans. The fountain remains but is not operational.

Detail of second floor plan as originally drawn by Hyman Witcover  
Figure 58

Due to the lack of evidence that remains regarding the original size, material, and appearance of the mail chute, it is not recommended to be reinstalled. Understanding that the building is, however, routinely open to visitors for historical interpretation, it is recommended that the mail chute become a part of these discussions for a more comprehensive historical interpretation.

The marble water fountain should remain and likewise be included as part of the building's historical interpretation. Restoration of the fountain's operability is not recommended due to the extensive and possibly invasive work needed to examine and repair the plumbing associated with the fountain.

Important for the retention and interpretation of the water fountain is periodic cleaning of the marble. This is particularly important as a rust stain currently surrounds the fountain drain. Marble cleaning procedures are outlined on page 52.

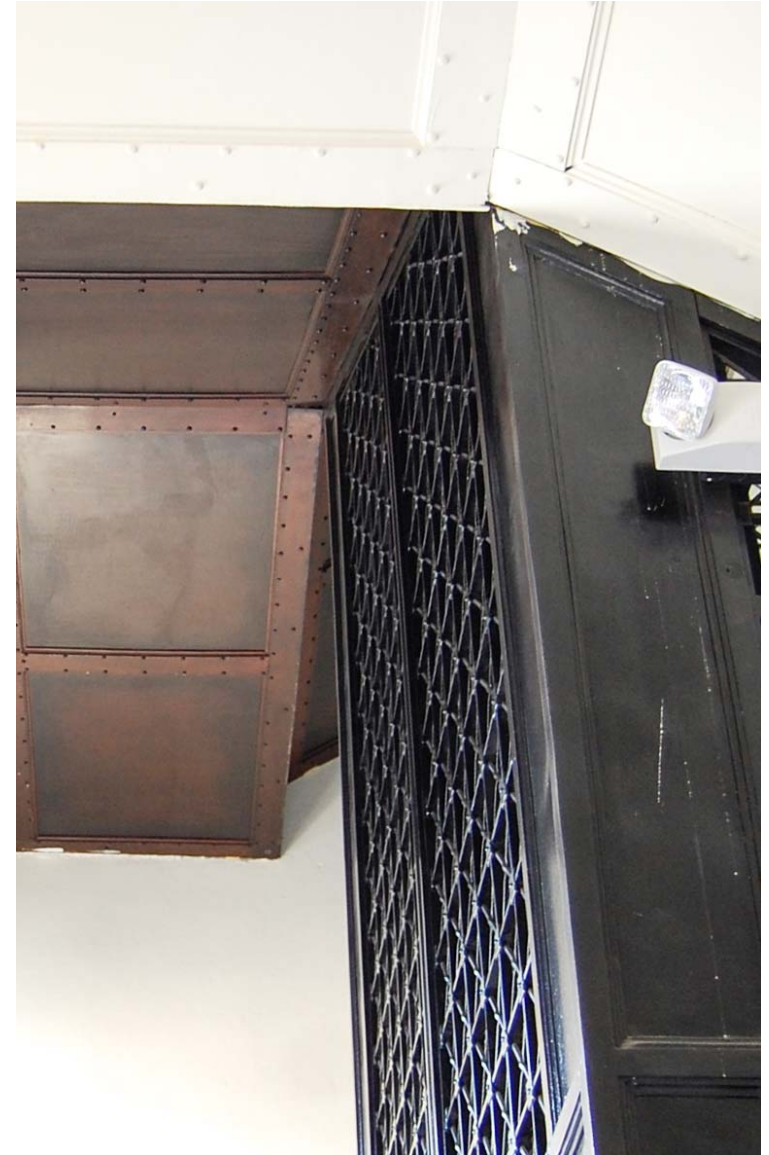
The ceiling of the stair is laid in a riveted pattern. In an effort to emphasize this metallic aesthetic, these panels have been faux finished to look like copper. In the section connecting the first and second story, however, this area has been painted cream to match the neighboring plaster walls (Figure 59). Likewise, on additional floors the wall’s recent coats of paint have scathed the edges of the brown faux finish of the panels.

*Contrasting faux finish and cream colored paint on Stair ceiling.  
Figure 59*

Since it is not possible to know if either of these finishes were the original finish, it is recommended that a paint analysis be performed to determine the original color and finish. Methods for this analysis are outlined on page 72. Once confirmed, the stair ceiling should be repainted with color and finish to match the first layer found, with care taken to create clean edges against neighboring surfaces.

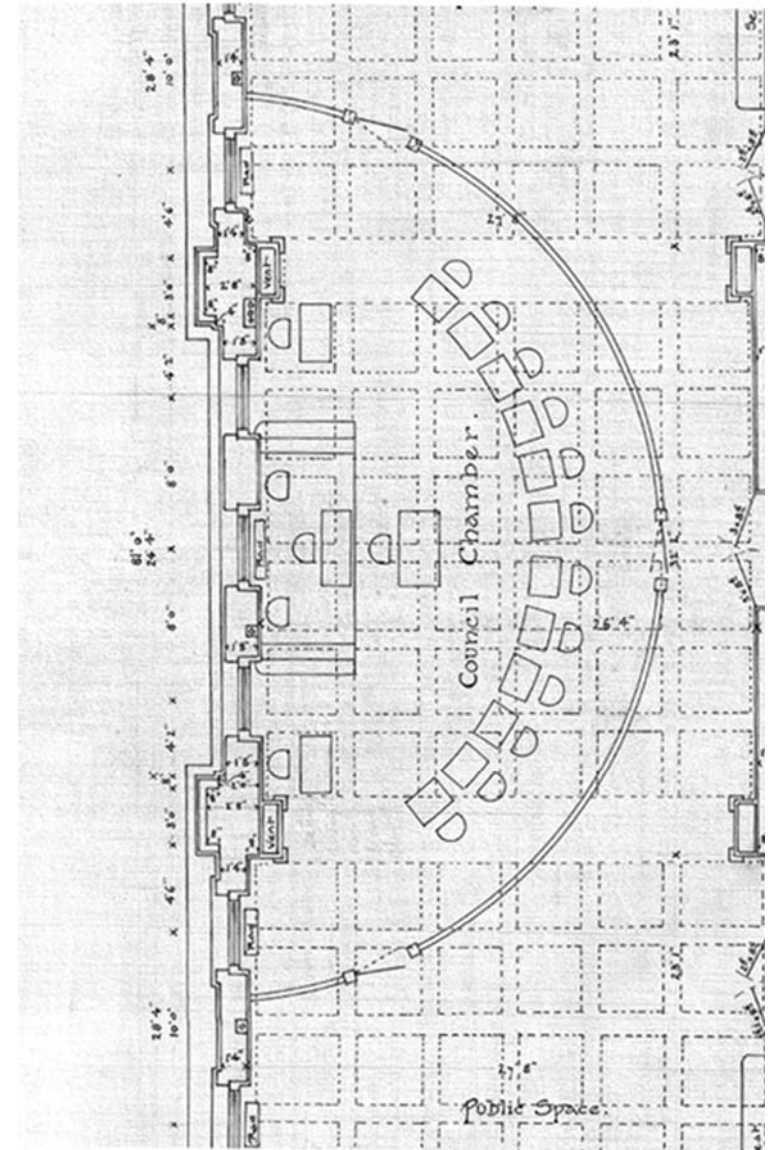
The most significant and lasting change that has occurred within the space has been the result of the City's conversion to the council-manager form of government, which resulted in the reorganization of the semicircular chamber portion of the room to situate the alderman and Mayor facing east toward the audience, whereas council members previously faced the Mayor, looking west (Figure 63).

Excerpt from original second floor plan for Council Chambers by H. W. Witcover, Library of Congress. Figure 63

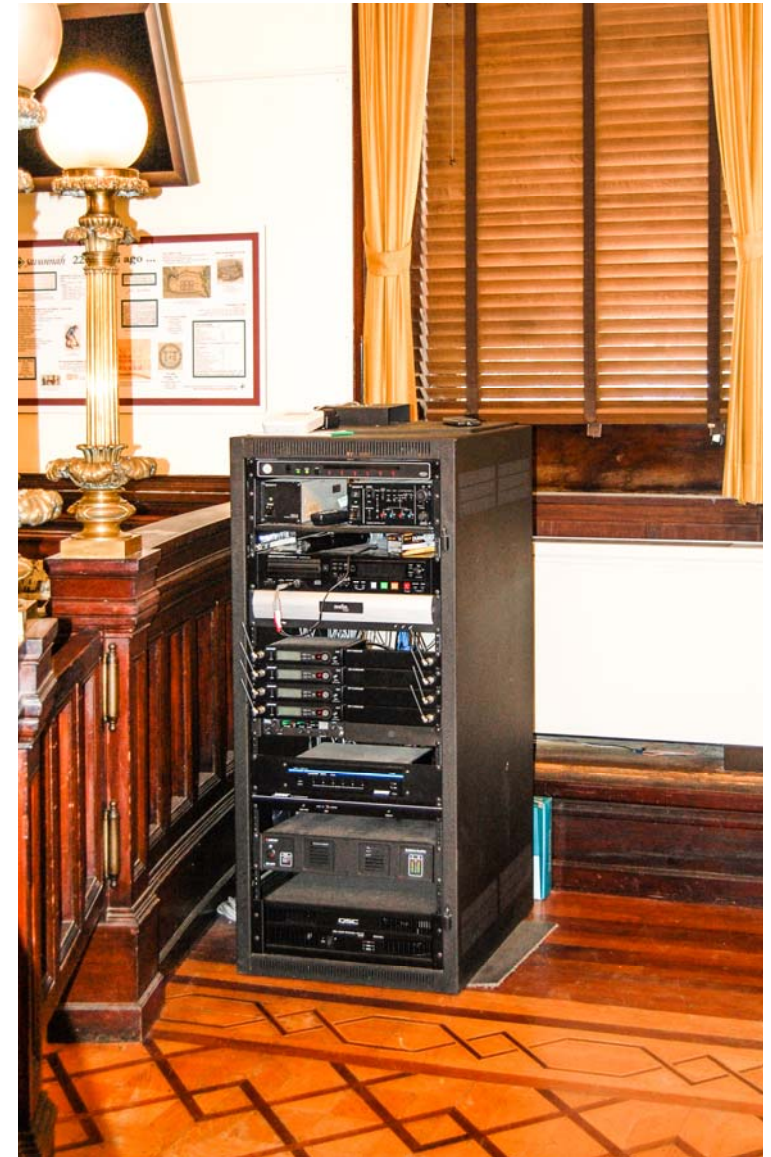
*AV systems box currently housed in Council Chambers.  
Figure 67*

The electronic systems should be updated to utilize wireless technologies whenever possible in order to remove the current visually obtrusive, bulky technology. Wiring and other equipment elements should be hidden or sensitively placed in order to maintain the architectural visual quality of the space. Outlined in Appendix C, there are several upgrades which can assist in adapting the space, such as adding “air media” for wireless video connectivity and replacing the existing equipment rack (Figure 67) with a credenza style rack in wood, stained to match the existing wood elements in the space.

Periodic examination of the usefulness and efficiency of equipment in Council Chambers with regards to new technologies, clarity, and ease of use is important. Equally important in this governmental and historic space is the preservation of the room’s historic and architectural integrity. Frequent examinations must be performed as part of an annual building inspection (Appendix E).

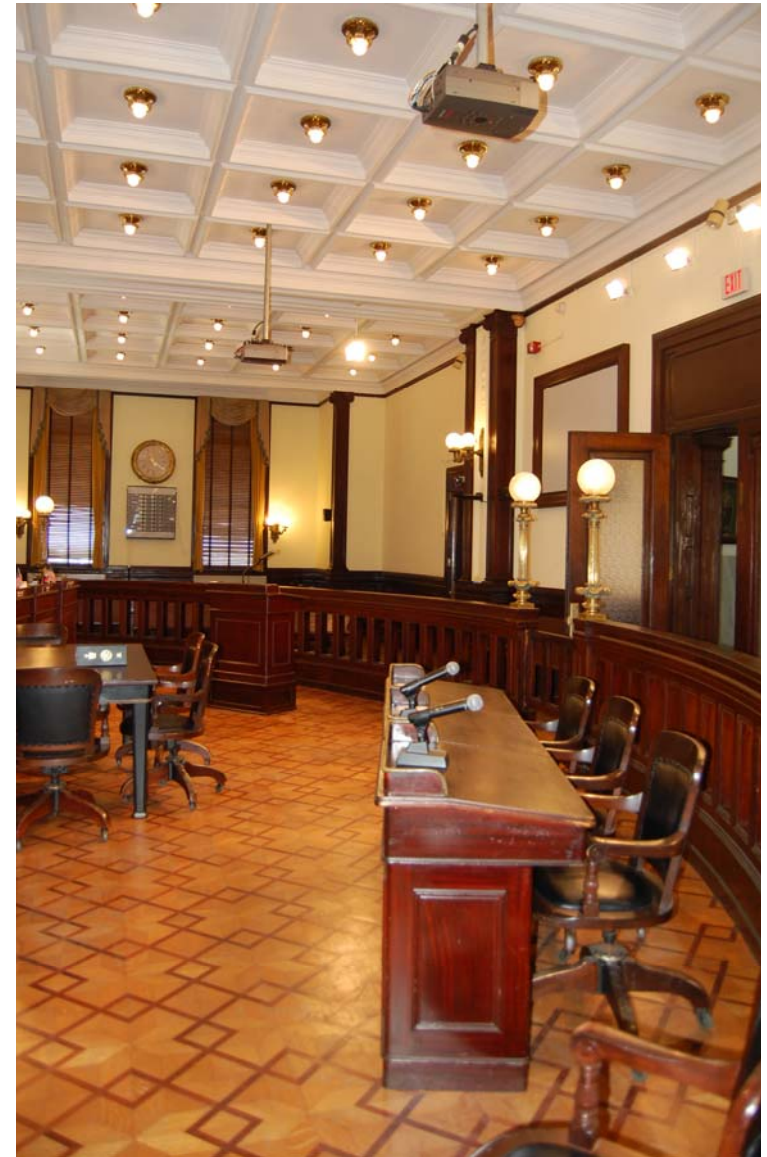
Included in original building plans drawn by H.W. Witcover, much of the furniture in Council Chambers is original (Figures 69 and 70). All of the original desks have metal bases faux finished to look like wood and stained wood table tops. The original table bases are painted black but were originally shades of green with a stained tiger maple wood top. While all of the tables currently in use have replacement tops, two of the three original table tops are in storage. The podium was originally a desk. While the desk top is original, it now sits on an extended base in wood.

*Original furniture utilized in Council Chambers.  
Figure 69*

It is recommended that all of the building's original furniture be restored. Recent efforts by the Savannah Technical College have shown the complexities associated with matching the original wood stain of the furniture as the finished table top of the restored piece does not accurately match what is believed to be the original stain or the stain of the furniture extant in the space. Utilizing a professional conservator and the building's original furniture plans, an agreed upon finish should be selected, respectively, for the restoration of all of the original tables, chairs, and desks. If at all possible, the furniture's coatings should be retained and minimally altered as opposed to stripped and refinished, as some degradation occurs every time a piece is refinished (Smithsonian). It should be noted, however, that finishes that have been added can be removed. Shellac is alcohol soluble and stains are oil soluble. Solvents such as mineral spirits, can assist in identifying the original finish layer. All furniture to be restored should be cataloged, inventoried, and photographed prior to restoration.

If the missing table top is replicated, tiger maple wood should be used to match the existing table tops.

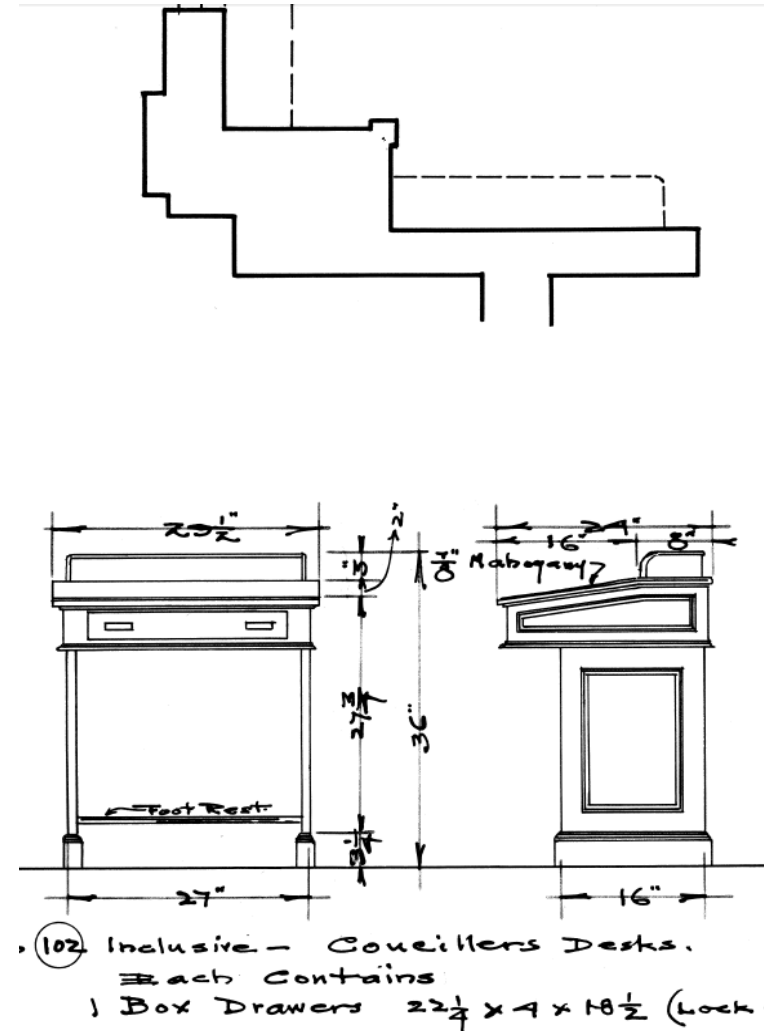
Excerpt from original furniture plans.  
Figure 70

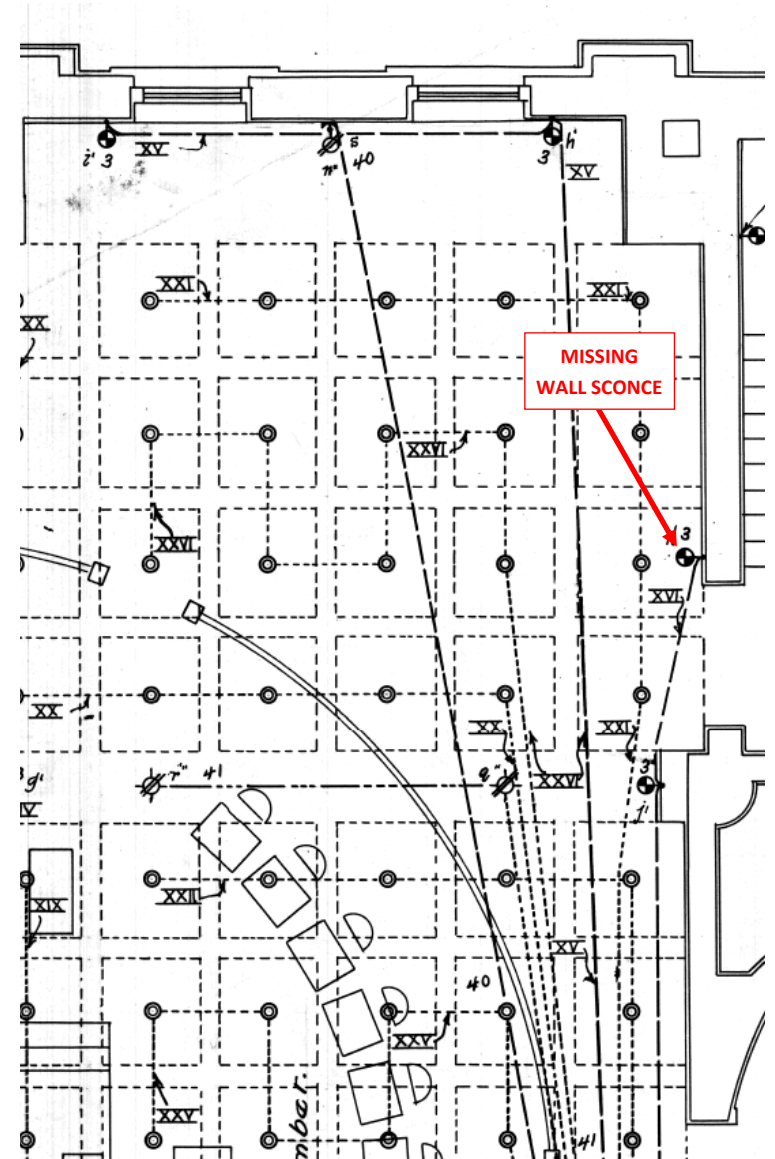
Figure 71

All of the room's original brass fixtures are suffering from minimal tarnish and wear. An examination of the original second floor electrical plan revealed that there is one wall sconce on the east wall that is currently missing (Figure 71). This is evidenced in the presence of an outlet connected by conduit, painted to match neighboring walls, but is covered by a circular plate in this location. The wall sconces that remain in Council Chambers, were removed at one time and reinstalled upside-down (Figure 72). Further, when the room is in use the space's wall sconces are often left off, the reason unknown.

Original second floor wiring plan excerpt showing Council Chambers.

It is recommended that all of the brass elements in Council Chambers be cleaned following the methods previously outlined for brass on page 61. Utilizing one intact fixture for the creation of a mold, it is recommended that the room's missing sconce be recreated in brass to match the existing sconces; to be installed in its original location, hung correctly, and utilized. Brass lamps mounted to the room's baluster should be cleaned in place. Extant wall sconces should be removed, cleaned, and reinstalled to their original placement with unified glass globes undermounted. Lastly, all of the room's lighting should be utilized when the room is in use, as intended.

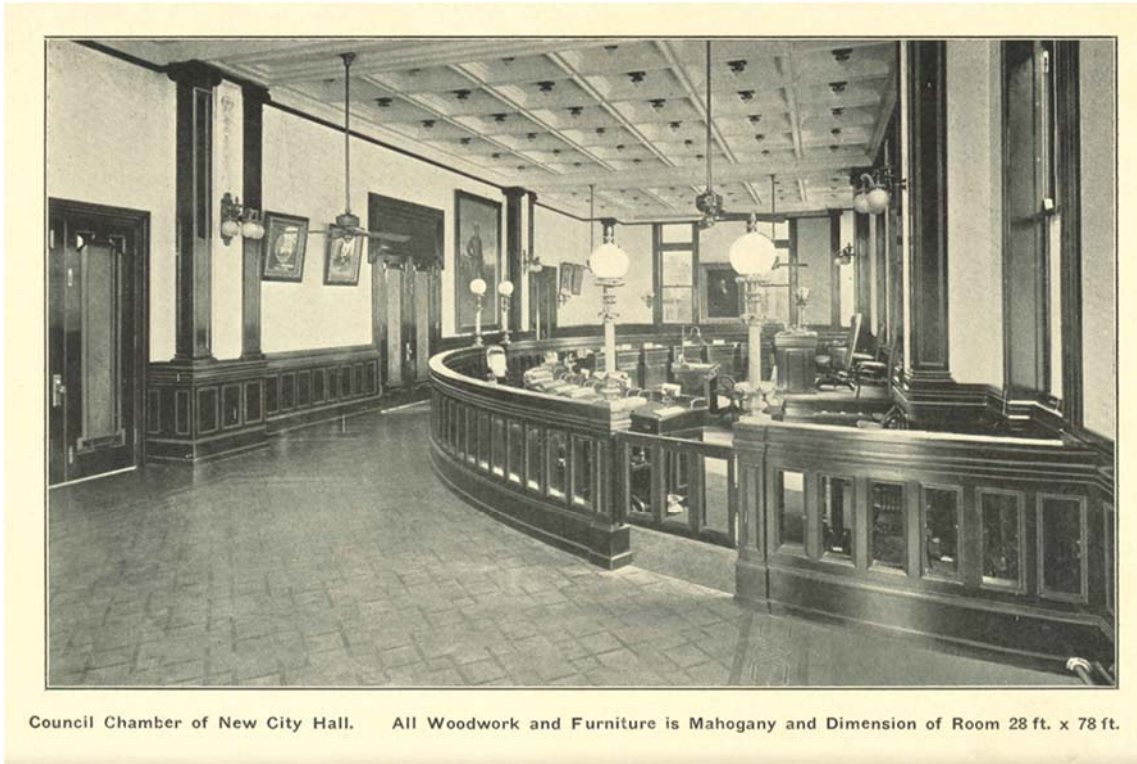
1905 view looking Southeast in Council Chambers in original configuration showing the open area for public standing and viewing, ceiling fans which have since been removed, portraits hung along the east wall, alderman desks facing West, and wall sconces mounted in their original configuration. *Figure 72*

According to historic photographs, Council Chambers originally had four ceiling fans that hung where the room's stage lights are currently mounted, along the room's two dividing ceiling beams that run east to west (Figures 72 and 79). The stage lights should be removed as they are unoriginal to the space, and replaced with fans of a similar aesthetic to the originals. Both the removal of the lights and the installation and use of the fans should be considered in overall temperature and condition calculations.

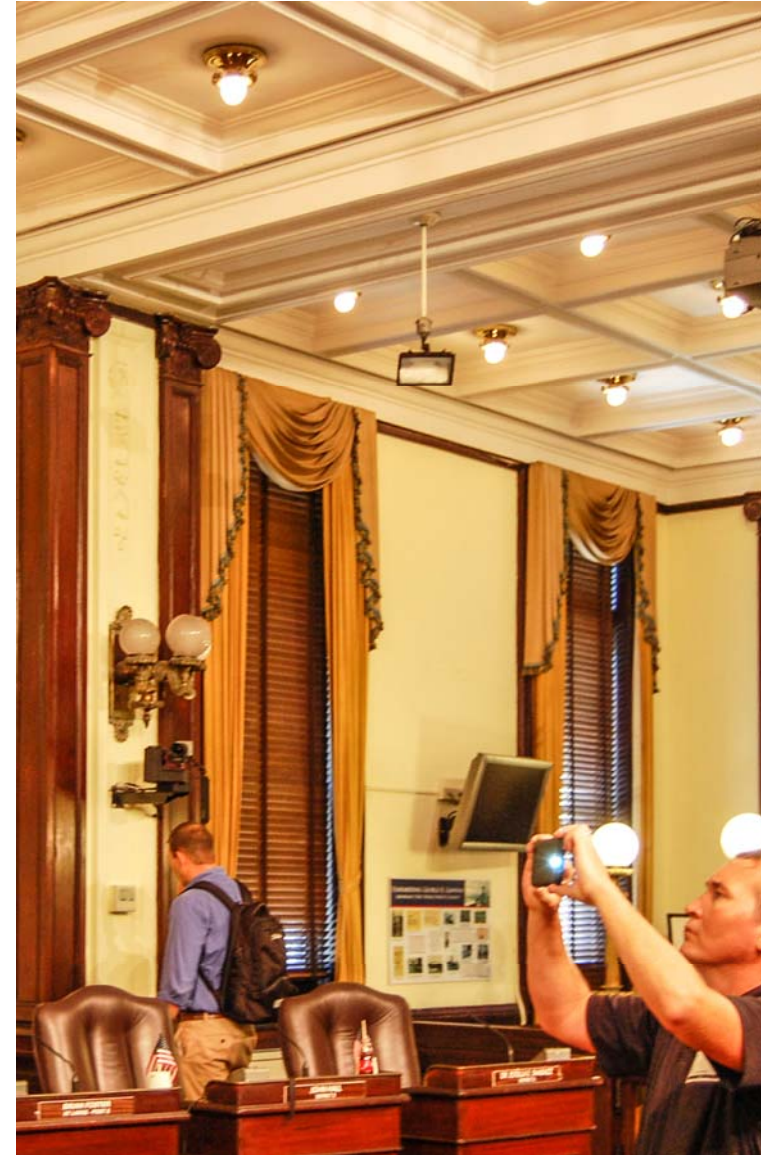
Reportedly added to the space for the filming of a movie in the 1970s, the curtains in Council Chambers are unoriginal to the space and conflict with the building's restoration period (Figure 75). Further, they are now deteriorated, rotting, and in need of replacement.

*Extant curtains in Council Chambers.  
Figure 75*

The restoration of roller blinds in Council Chambers is an important component to the space's overall historical integrity. The roller shades selected should be an olive green shade, as originally specified, as well as UV stable to avoid fading and discoloration. Shades should not have fascia boards or chains. Rather, shade operation can be set to be controlled electronically for greater accommodation of the room's continued use.

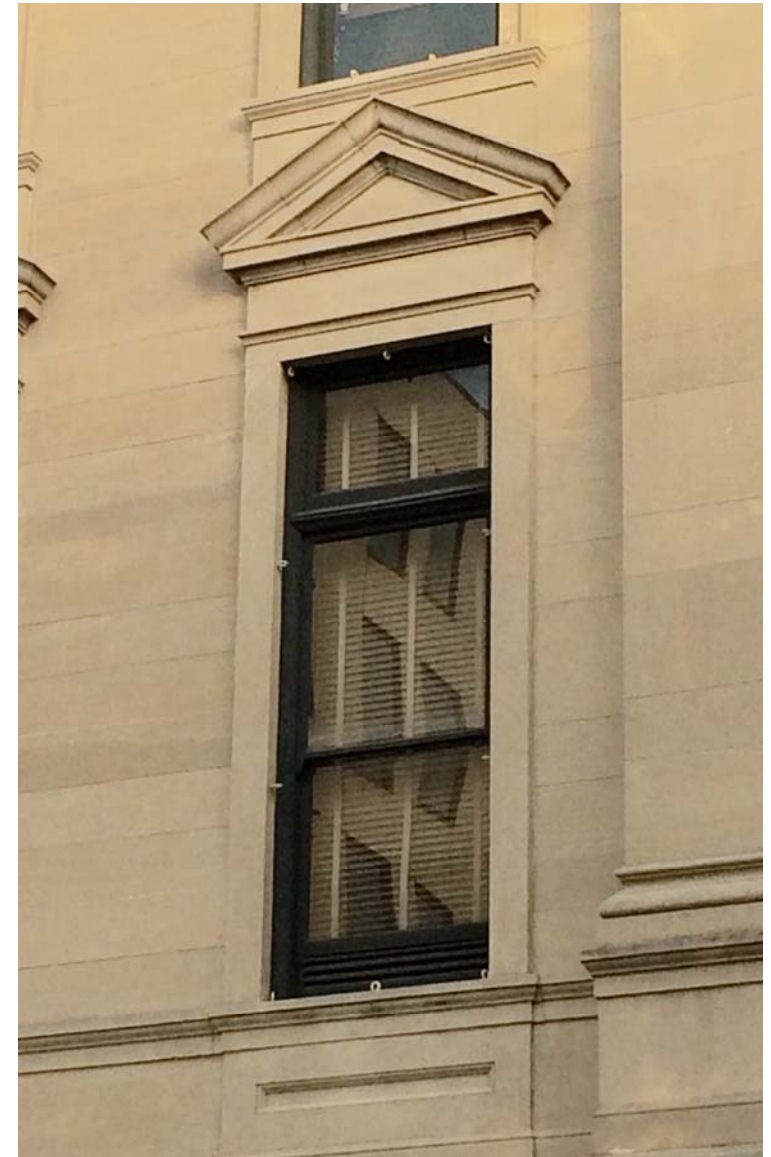
*Figure 77*

*Exterior view of Council Chamber windows.*

The southwestern most window sash in the Reception Room is shorter than the rest in the space due to a now abandoned direct outdoor air vent being placed at the bottom of the window. The vent has since been removed. Subsequently, a piece of wood sized to fit has been put in its place, since the bottom sash was never restored (Figure 80). This condition occurs not only in the Reception Room but also on two windows in Council Chambers (Figures 77 and 82).

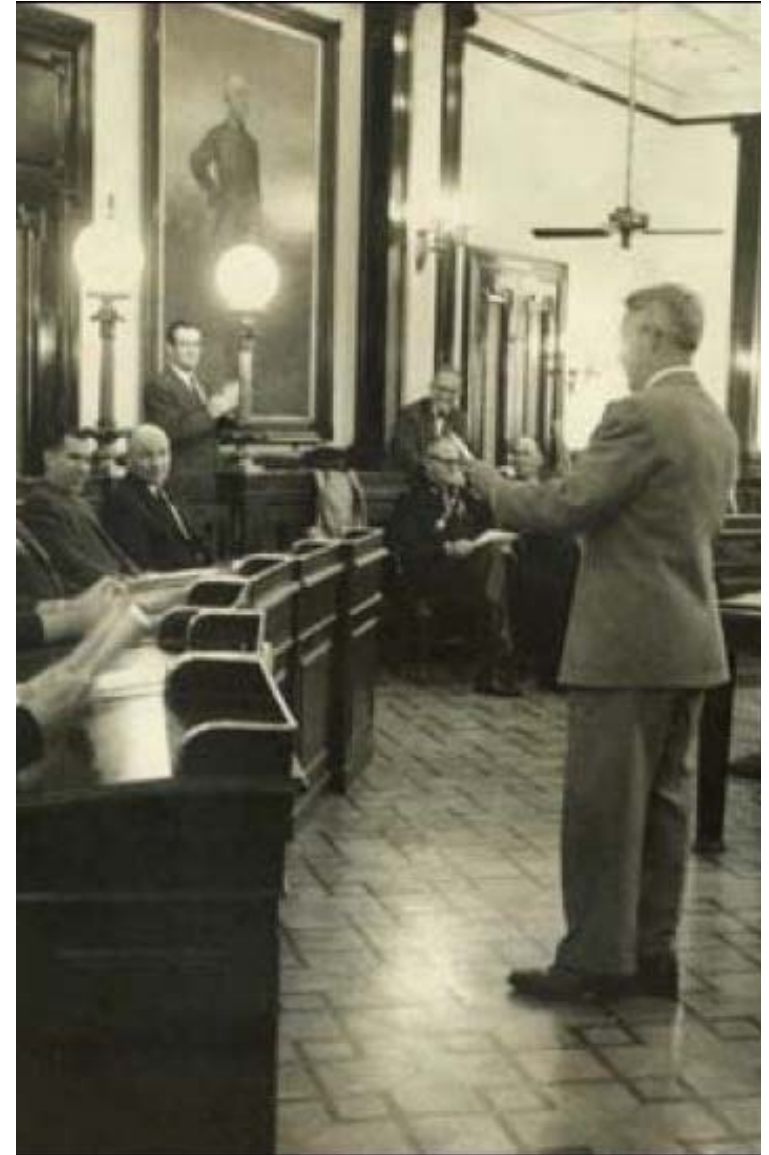
1962 photograph of Council Chambers showing original ceiling fans.  
Figure 79

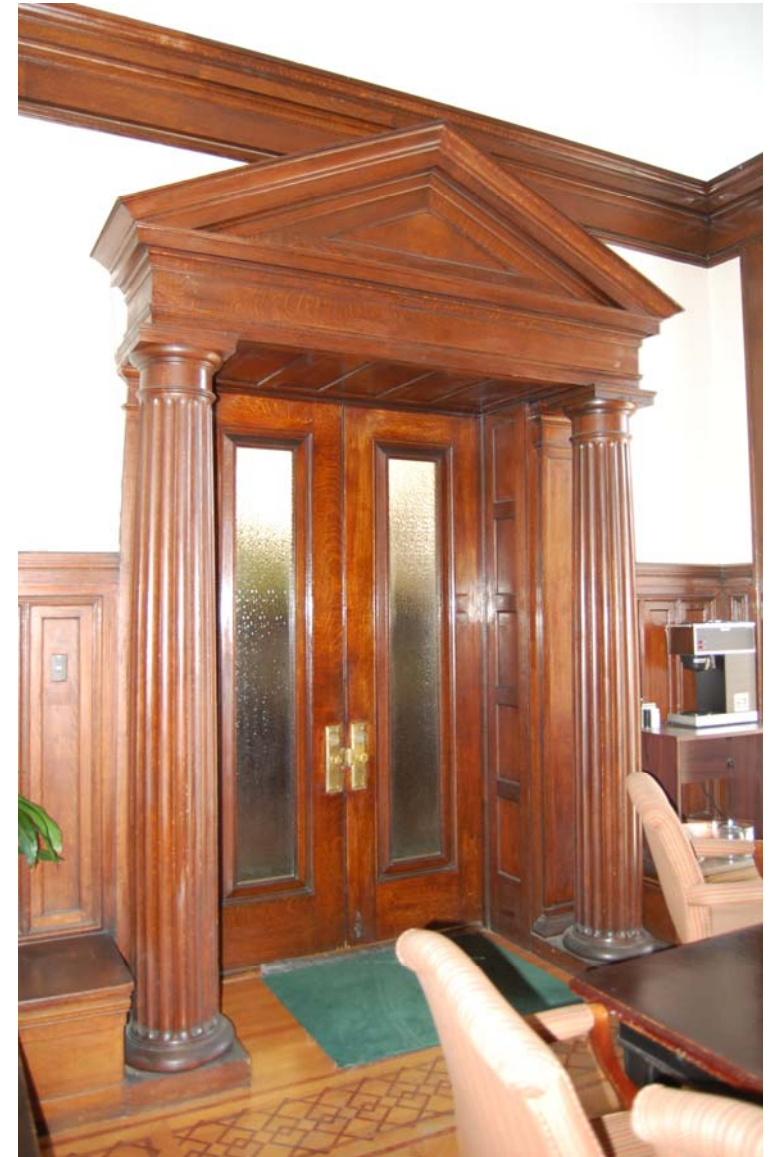
Within the Reception Room, there are two large pedimented openings that lead into neighboring spaces, the Mayor's office and Council Chambers (Figure 81). Characterized by large paired fluted columns in wood stained to match the space's other wood elements, the columns have cracked in some areas along the flutes possibly due to temperature and humidity changes in the space over time. The solution outlined below is applicable to all woodwork areas within the scope that have minor holes or depressions, including those along the engaged columns within Council Chambers.

*Pedimented entrance inside Reception Room leading to Mayor's Office. Figure 81*

Periodic examination of the space's column repairs should be made as part of an implemented preservation maintenance plan to ensure that no further splitting occurs.

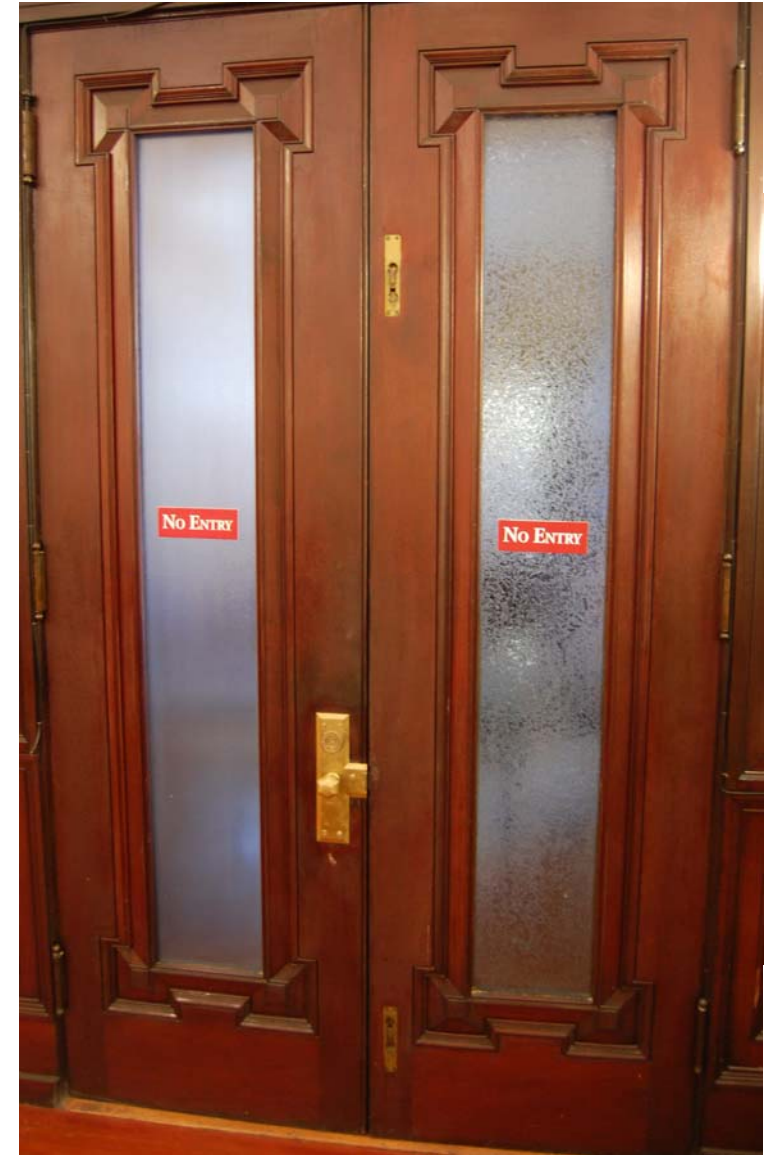
Throughout the second floor, in Council Chambers and the Reception Room, etched glass is present in the space's many wood doors as center panels. Multiple patterns of etched glass, exist (Figure 84). It is believed that the building would have originally used one pattern of etched glass for all locations.

*Doors leading from Council Chambers to the Reception Room, each of which has a different type of etched glass. Figure 84*

It is believed that a correlation between the number of panels associated with each pattern of etched glass and the original glass can be made. Upon performing an inventory, the panels that are most prevalent should be retained. Those that differ should be removed and replaced with etched glass to match the majority to create a uniform look throughout these spaces. Panels should not be removed until a replica manufacturer or architectural salvage option is identified and confirmed to have the correct size and pattern of glass. Only identical matches are acceptable.

This solution is applicable to both the glass panels in the doors of the Reception Room and Council Chambers.
