HUD MAP Capital Needs Assessment

REPORT DATE: August 21, 2023

Yamacraw Village
555 West Bay Street
Savannah, Chatham County, Georgia 31401

AEI Project No. 480855
Site Assessment Date: July 31 and August 1, 2023

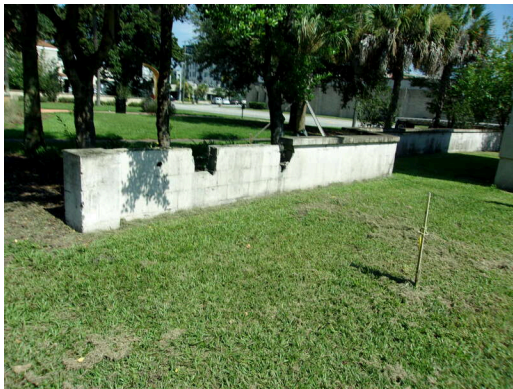
The CMU retaining walls were observed as deteriorating, missing blocks and past their Estimated Useful Life (EUL). In order to prevent further damage and to improve the condition of the property, the replacement of the CMU retaining walls is recommended (Non-Critical Repair).

Replace damaged CMU retaining walls (Non-Critical Repair)

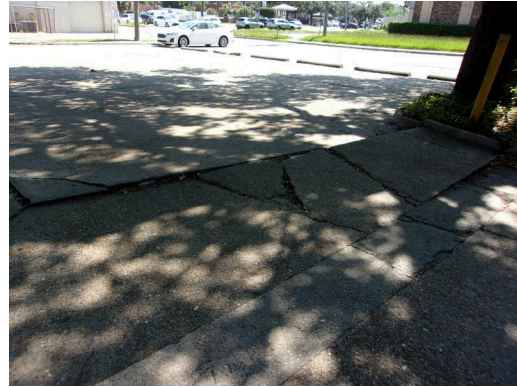
The concrete driveways, parking areas and pads were observed as deteriorating with cracked and heaving/sunken sections and past its Estimated Use Life (EUL). In order to maintain the driveways, parking areas and pads and improve the condition of the property, the replacement of the concrete driveways, parking areas and pads is recommended (Non-Critical Repair).

Replace heaving and cracked concrete parking lot (Non-Critical Repair)

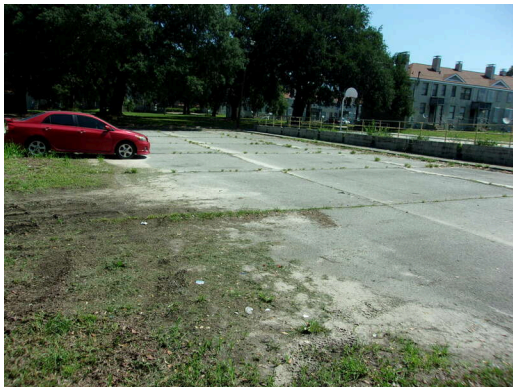
The asphalt driveway and parking areas were observed deteriorated with areas of damage and past Estimated Use Life (EUL). In order to maintain the driveways and parking areas and improve the condition of the property, the mill, overlay, and restriping of the asphalt driveways and parking areas is recommended (Non-Critical Repair).

Replace asphalt parking lot and restripe (Non-Critical Repair)

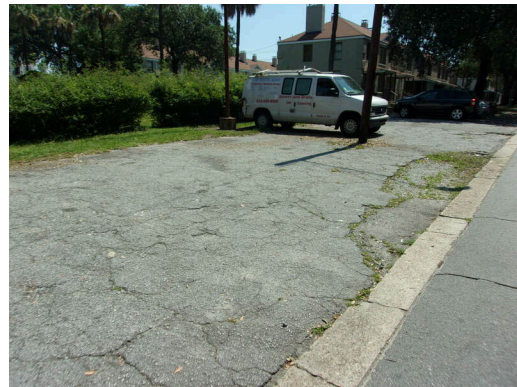
Replace and restripe asphalt parking surfaces (Non-Critical Repair)

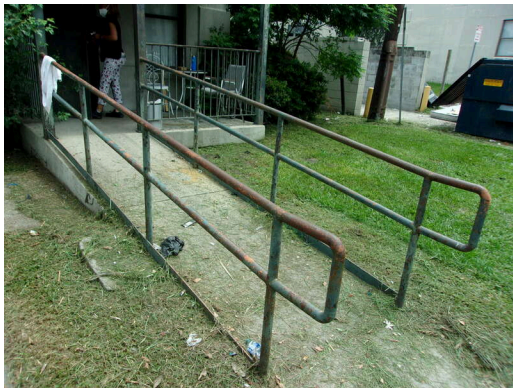
260-268 Yamacraw Village - Unit 261 - 1-bed/ 1-bath - HC unit - Replace metal/concrete ramp (Non-Critical Repair)

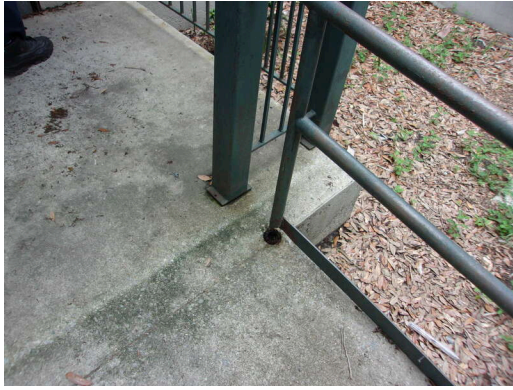
The exterior concrete and metal ramps at the designated handicapped units were observed with rusted railings, deteriorating supports and past its Estimated Useful Life (EUL). In order to prevent further damage and to improve the condition of the property, the replacement of the exterior concrete and metal ramps at the designated handicapped units is recommended (Non-Critical Repair).

Replace concrete and metal HC unit ramps (Non-Critical Repair)

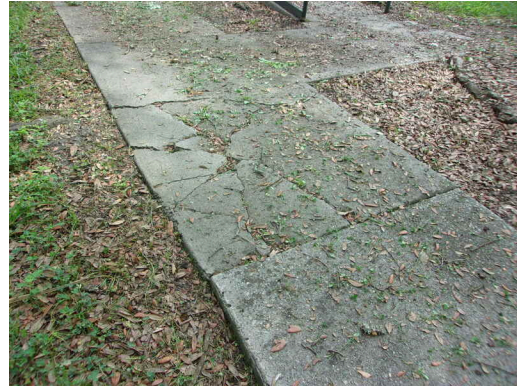
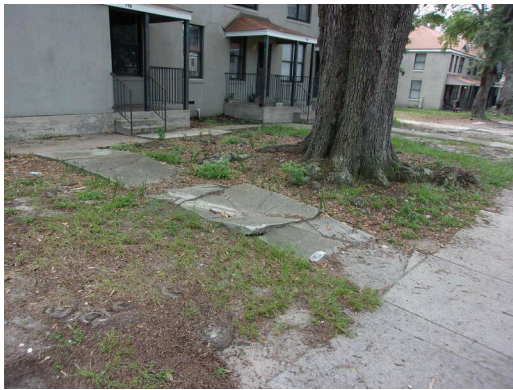
Concrete sidewalks throughout property were observed as cracking, deteriorating, heaving/sunken from tree roots and with abrupt elevation changes, resulting in tripping hazards. In order to prevent injury to a resident, replacement of the concrete sidewalks is required. It is also important to note that all playgrounds do not feature accessible routes; this issue should be addressed when designing the new concrete sidewalk network at this property (Critical Repair).

Typical damaged concrete sidewalk with trip hazards (Critical Repair)

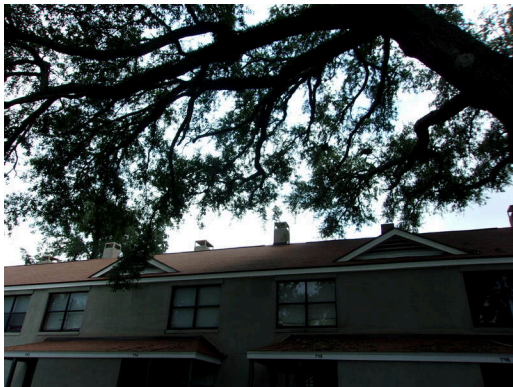
The mature trees throughout the site were observed to have been planted close to the buildings and the majority of trees were impacting the building perimeter at the roof line. AEI estimated this to include approximately fifty-six (56) trees. Based on the impact of the trees on the building potentially resulting in premature wear of cladding and roofing materials, the pruning of affected trees is recommended (Non-Critical Repair).

Typical trees touching apartment building roofs (Non-Critical Repair)

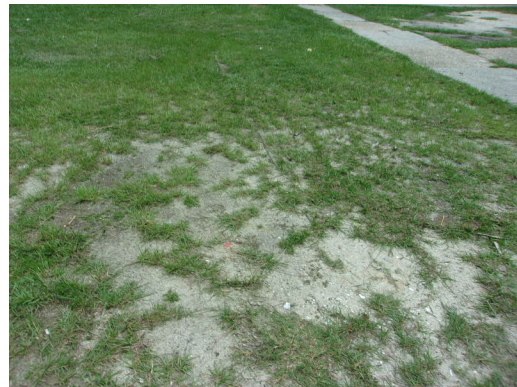
Areas of bare ground were observed throughout the property. In order to prevent further erosion and to improve the condition of the property, reseeding of the areas of bare ground is recommended (Non-Critical Repair).

Bare ground throughout site (Non-Critical Repair)

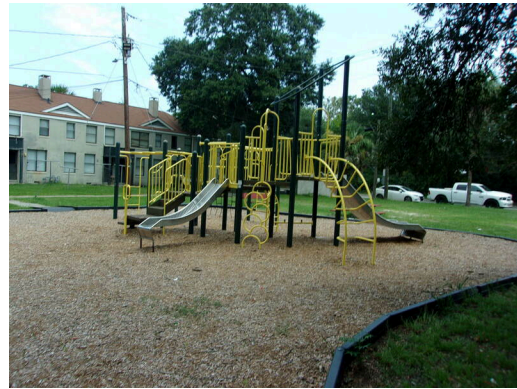
The playground equipment was observed as past its Estimated Useful Life (EUL). In order to prevent further damage and to improve the condition of the property, the replacement of the playground equipment is recommended (Non-Critical Repair).

Playground equipment is past its EUL (Non-Critical Repair)

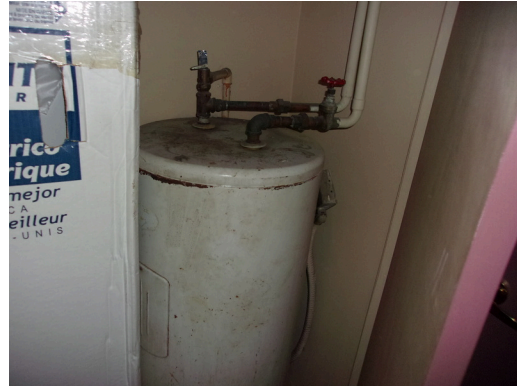
349 West Bryan Street - Community center -
Replace old 50-gallon water heater
(Non-Critical Repair)

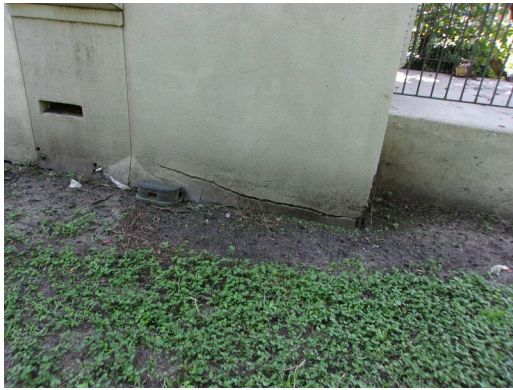
Evidence of foundation settling, damaged stucco siding (Non-Critical Repair)

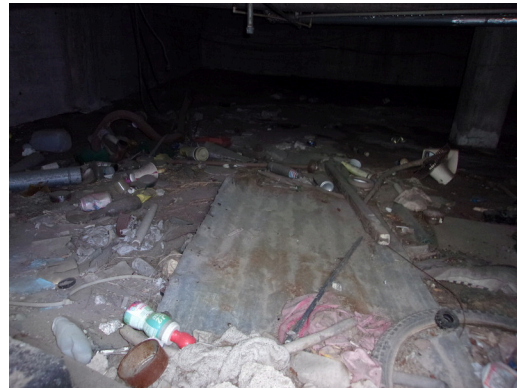
Crawlspace floor without vapor barrier

The floor of the crawl space is exposed dirt. The flooring of the level above is constructed of a raised concrete slab without insulation. A plastic polyethylene vapor barrier was not observed on the ground. Ventilation of the crawl space is provided by foundation vents located at regular intervals along the perimeter walls.

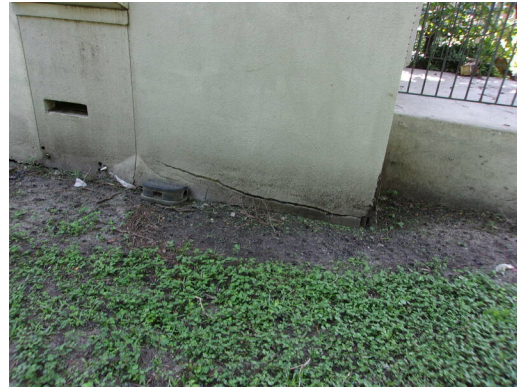
Item	Description	Action	Condition
Significant Signs of Deflection, Movement	Cracks in apartment building foundation and interior walls were observed.	IM	Poor

Evidence of foundation settling, damaged stucco siding (Non-Critical Repair)

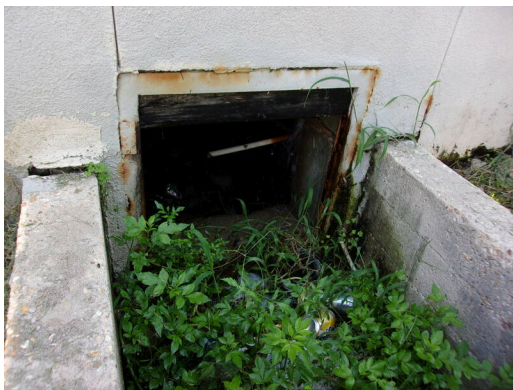
AEI observed the crawl space from the entrance. Moisture from plumbing pipe leaks and uninsulated water pipe condensation was observed.

Broken plumbing pipe within crawlspace (Non-Critical Repair)

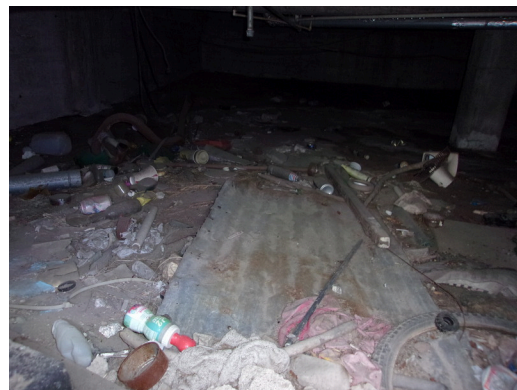
Crawlspace floor without vapor barrier

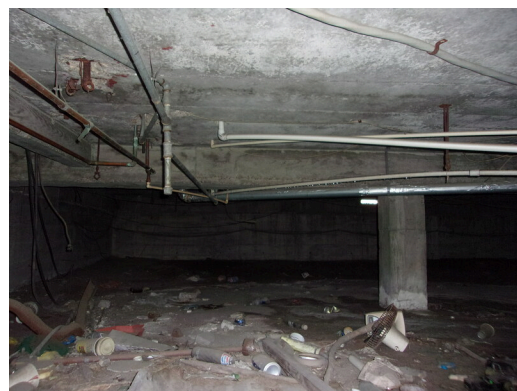
Spalling raised concrete slab (Non-Critical Repair), galvanized water supply lines

AEI recommends the substructure of the larger and smaller apartment buildings be demolished and rebuilt, due to the following issues: substructure components (CMU foundation walls, concrete piers/raised slab, porch foundations) are past their Estimated Useful Life (EUL), observed spalling concrete and rusting steel reinforcements within the raised floor concrete members, possible asbestos containing concrete deteriorating and causing tenant health issues, settling and cracking CMU foundation walls observed, porch/step foundations are settling and damaged. AEI utilized RS Means Square Foot Cost Estimator to create a report detailing the costs to rebuild this type of apartment building, and is the source of the listed cost (Non-Critical Repair).

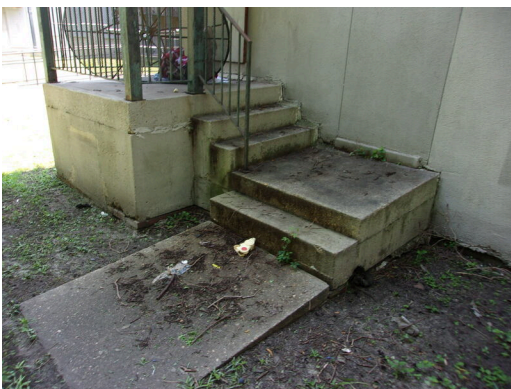
Sinking porch steps (Non-Critical Repair)

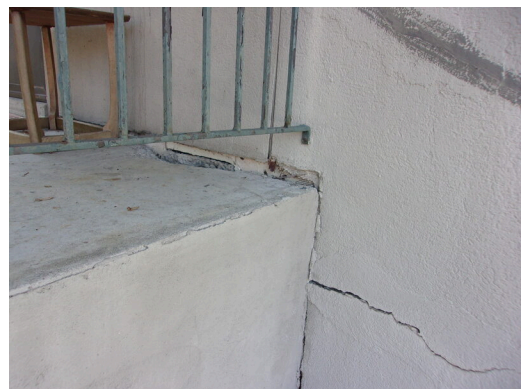
Front porch sinking (Non-Critical Repair)

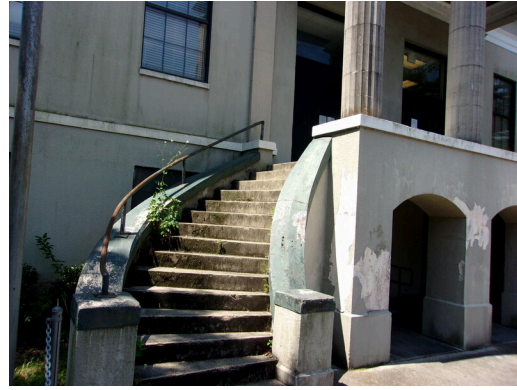
The exterior concrete steps at 349 W Bryan were observed as steeper than contemporary stair assemblies, with deteriorating steps and past its Estimated Useful Life (EUL). In order to prevent further damage and to improve the condition of the property, the replacement of the exterior concrete steps at 349 W Bryan is recommended (Non-Critical Repair).

Replace deteriorating concrete steps at 349 West Bryan Street (Non-Critical Repair)

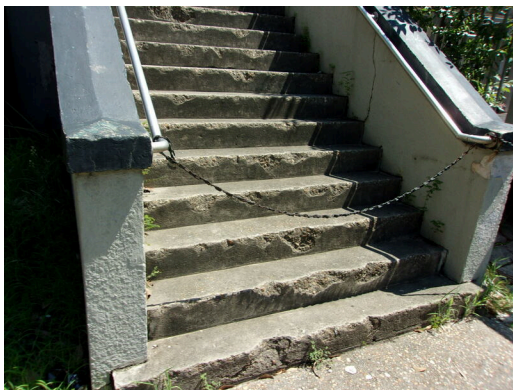
349 West Bryan Street - Replace steep and deteriorating concrete steps at rear (Non-Critical Repair)

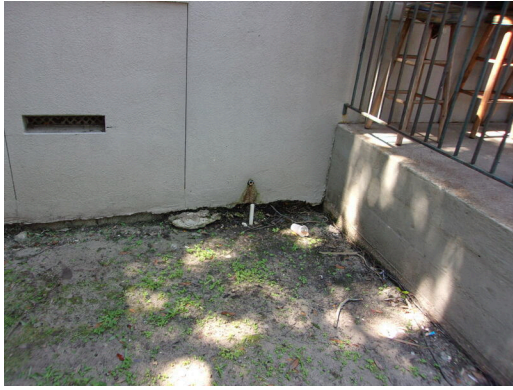
Damaged stucco siding (Non-Critical Repair)

AEI recommends the shell of the larger and smaller apartment buildings be demolished and rebuilt, due to the following issues: shell components (windows, doors, stucco siding) are past their Estimated Useful Life (EUL), broken windows throughout property, water-damaged stucco siding throughout site. AEI utilized RS Means Square Foot Cost Estimator to create a report detailing the costs to rebuild this type of apartment building, and is the source of the listed cost. It is important to note that the asphalt shingle roofing and soffits/fascia were replaced in 2019 and are in good physical condition, however, demolition and rebuilding of the roofs and soffit/fascia is recommended (Non-Critical Repair).

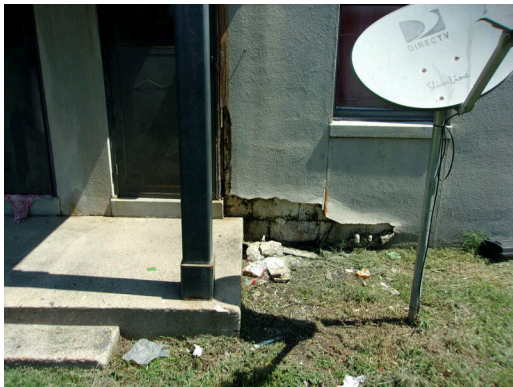
Damaged stucco siding near rear entry door (Non-Critical Repair)

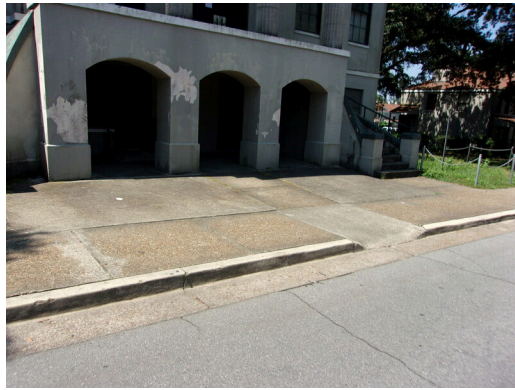
Repair and wash stucco siding at 349 West Bryan Street (Non-Critical Repair)

The stucco siding at 349 W Bryan was observed as dirty with algae growth and with peeling stucco/paint. In order to prevent further damage to the stucco siding and improve the condition of the property, the repair and and pressure washing of the stucco siding is recommended (Non-Critical Repair).

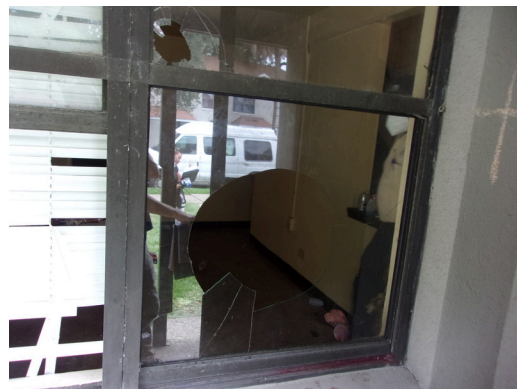
260-268 Yamacraw Village - Unit 264 - 2-bed/1-bath TH - Replace broken windows (Non-Critical Repair)

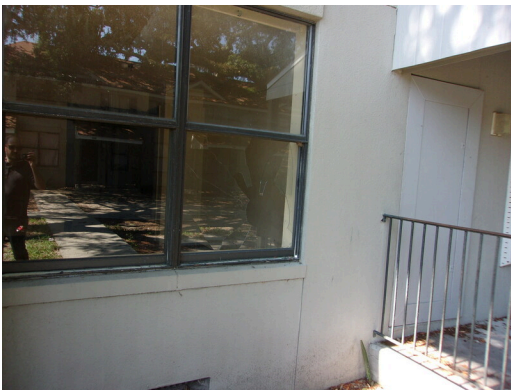
Typical broken window (Non-Critical Repair)

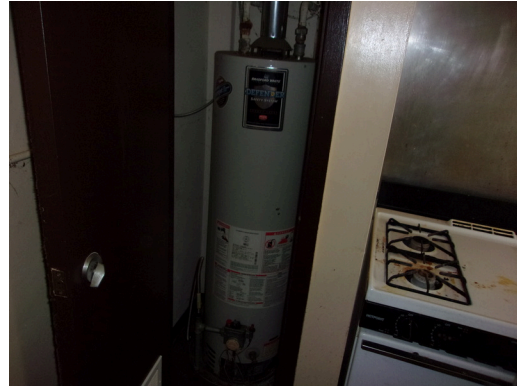
121-128 Yamacraw Village - Unit 126 - 2-bed/
1-bath TH - Replace gas-fired water heater
(Non-Critical Repair)

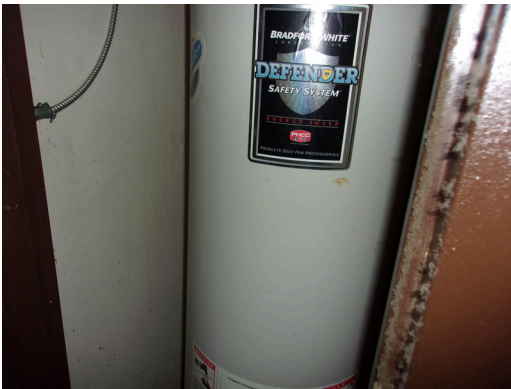
141-148 Yamacraw Village - Unit 142 - 3-bed/
1-bath TH - Replace old water heater
(Non-Critical Repair)

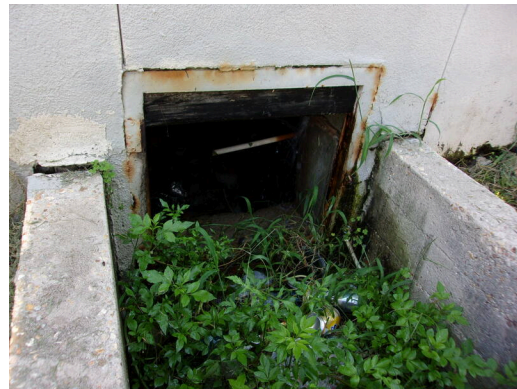
Broken plumbing pipe within
crawlspace (Non-Critical Repair)

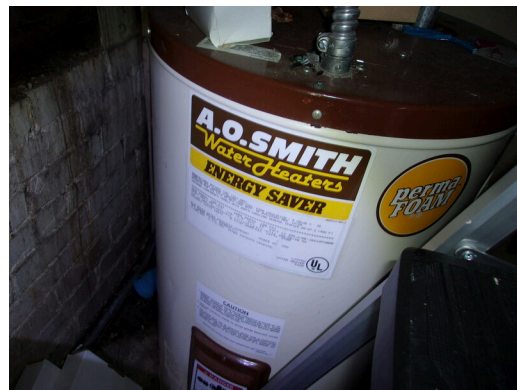
The 20-gallon electric water heater at the 555 West Bay Street office was observed as past its Estimated Useful Life (EUL). In order to maintain the system and to improve the condition of the property, the replacement of the water heater is recommended (Non-Critical Repair).

555 West Bay Street Office - Replace old
20-gallon water heater (Non-Critical Repair)

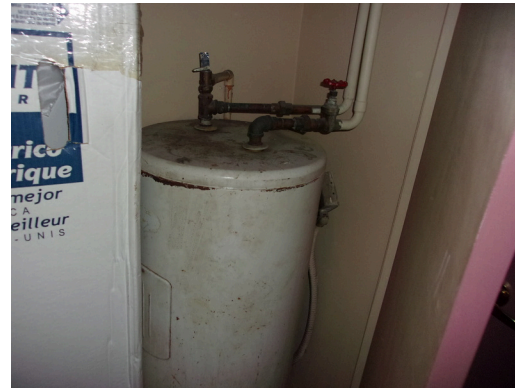
The 50-gallon electric water heaters at 349 W Bryan were observed as past its Estimated Useful Life (EUL). In order to maintain the system and to improve the condition of the property, the replacement of the water heaters is recommended (Non-Critical Repair).

349 West Bryan Street - Community center - Replace old 50-gallon water heater (Non-Critical Repair)

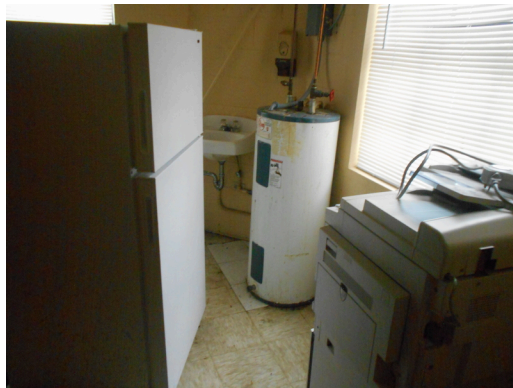
349 West Bryan Street - Community center - Replace old 50-gallon water heater (Non-Critical Repair)

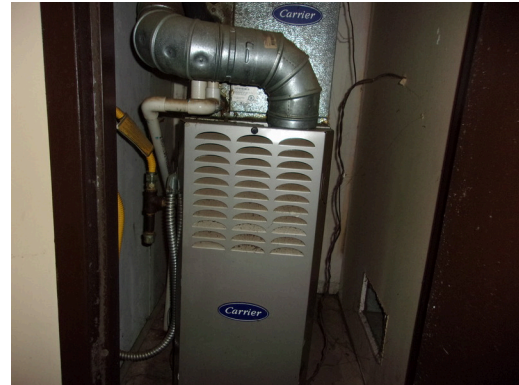
141-148 Yamacraw Village - Unit 142 - 3-bed/ 1-bath TH - Replace old gas furnace (Non-Critical Repair)

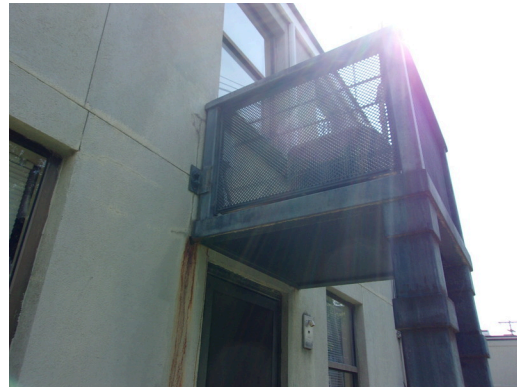
Replace metal AC canopies, rusting and causing water infiltration issues (Non-Critical Repair)

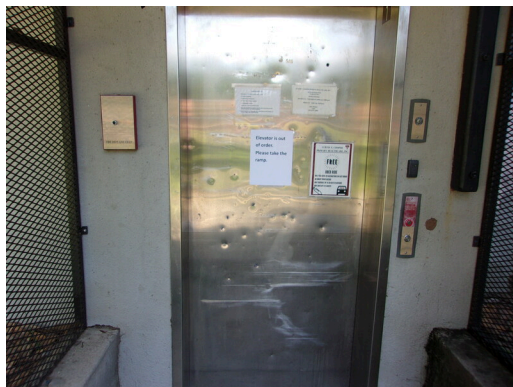
The hydraulic elevator equipment at 349 W Bryan was out of operation during the site visit. In order to provide an accessible elevator access to the second floor of 349 W Bryan, the repair of the hydraulic elevator is required (Critical Repair).

An elevator certificate for the hydraulic elevator at 349 W Bryan was not provided. Provisioning a current elevator inspection and certificate for the elevator is required (Critical Repair).

Hydraulic elevator at 349 West Bryan Street is not working and a certificate was not provided (Critical Repair)

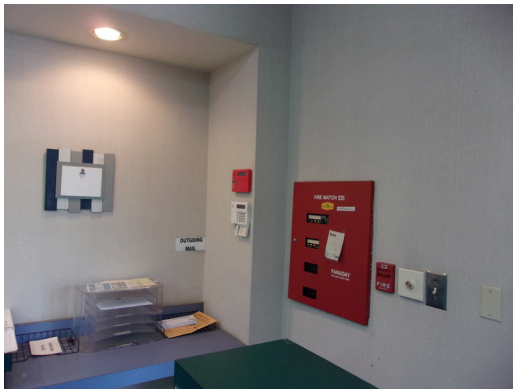
The annual inspection report for the fire alarm systems within 555 West Bay Street office and 349 W Bryan were not available, AEI recommends inspecting all fire systems yearly. Please provide the current annual fire alarm inspection reports (Critical Repair).

555 West Bay Street Office - Fire alarm -
Provide annual report (Critical Repair)

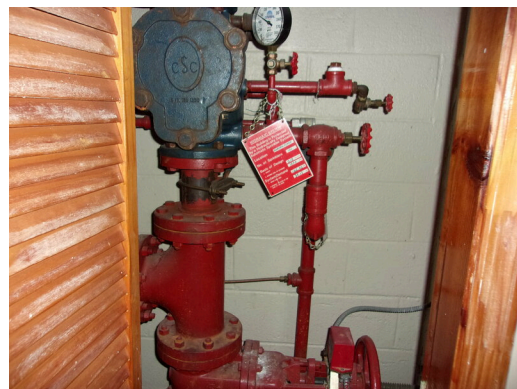
A current annual fire sprinkler inspection report for 349 W Bryan was not observed at the site. AEI recommends inspecting all fire systems yearly. Inspection of the fire sprinklers is recommended (Critical Repair).

349 West Bryan Street - Community center -
Fire riser - Provide annual sprinkler report
(Critical Repair)

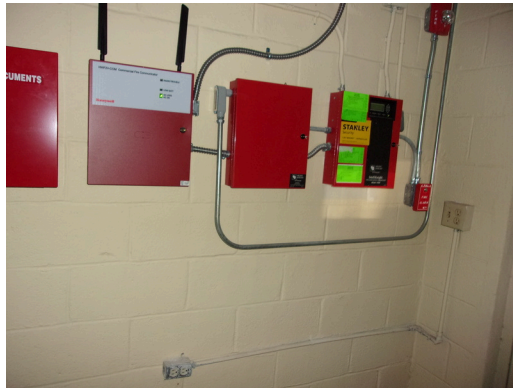
349 West Bryan Street - Community center -
Fire alarm panel - Provide annual report
(Critical Repair)

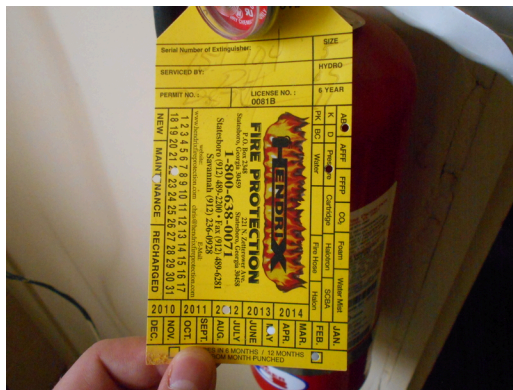
The inspection tags on two (2) the fire extinguishers within the 349 W Bryan community space were observed expired, AEI recommends inspecting all fire systems yearly. Inspection of the fire extinguishers is recommended (Critical Repair).

349 West Bryan Street - Community center -
Inspect fire extinguishers annually (Critical
Repair)

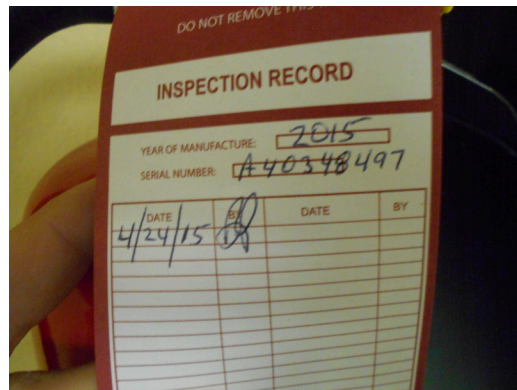
349 West Bryan Street - Community center -
Inspect fire extinguishers annually (Critical
Repair)

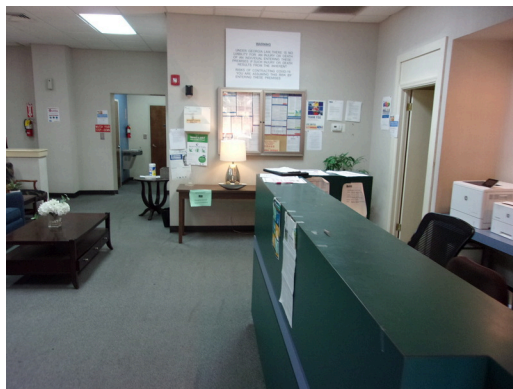
The carpet flooring in the 555 West Bay Street office was observed as deteriorating and past its Estimated Useful Life (EUL). In order to prevent further damage and to improve the condition of the property, the replacement of the carpet flooring is recommended (Non-Critical Repair).

555 West Bay Street Office - Replace old carpet flooring (Non-Critical Repair)

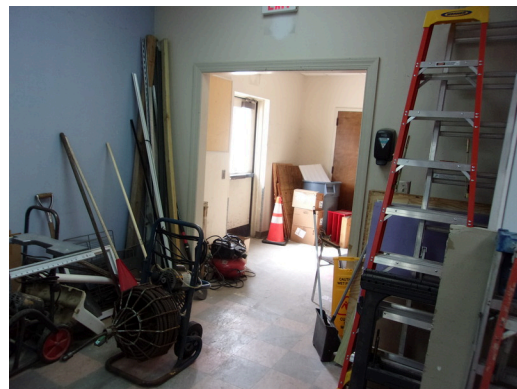
The older vinyl flooring in the 555 West Bay Street office and 349 W Bryan was observed as deteriorating and past its Estimated Useful Life (EUL). In order to prevent further damage and to improve the condition of the property, the replacement of the vinyl flooring is recommended (Non-Critical Repair).

555 West Bay Street Office - Maintenance areas - Replace old vinyl flooring (Non-Critical Repair)

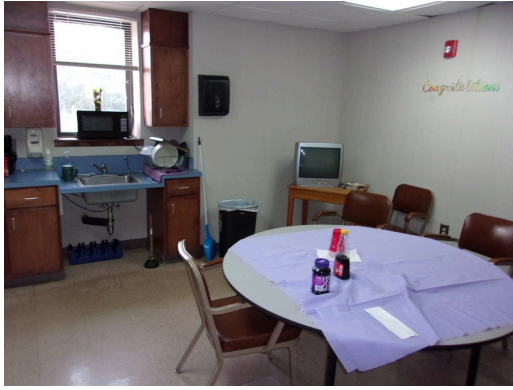
The older kitchen cabinets in the 555 West Bay Street office and 349 W Bryan were observed as deteriorating and past their Estimated Useful Life (EUL). In order to prevent further damage and to improve the condition of the property, the replacement of the older kitchen cabinets is recommended (Non-Critical Repair).

555 West Bay Street Office - Common staff kitchen - Replace kitchen cabinetry (Non-Critical Repair)

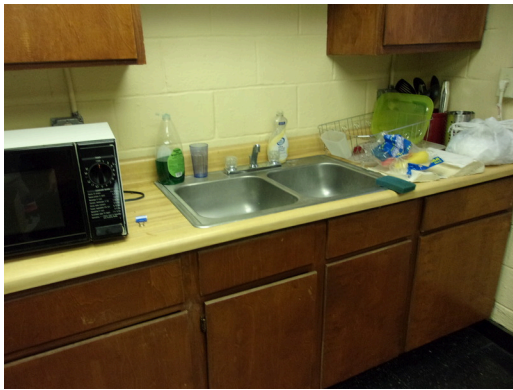
349 West Bryan Street - Community center - Common kitchen - Replace old kitchen cabinetry (Non-Critical Repair)

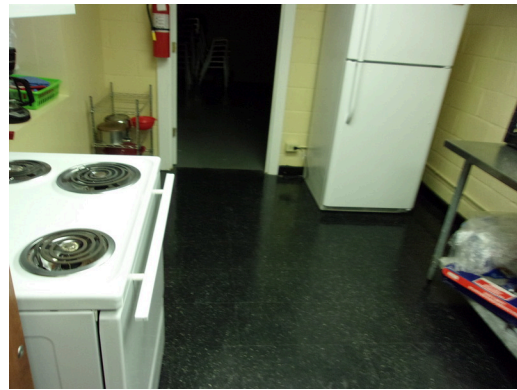
349 West Bryan Street - Community center - Replace old vinyl flooring (Non-Critical Repair)

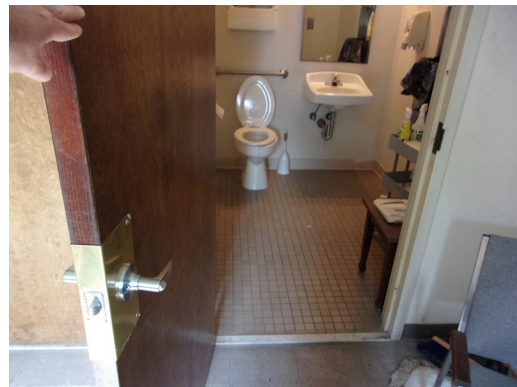
The older common restroom accessories in the 555 West Bay Street office and 349 W Bryan were observed as past their Estimated Useful Life (EUL). In order to prevent further damage and to improve the condition of the property, the replacement of the older common restroom accessories is recommended (Non-Critical Repair).

555 West Bay Street Office - Women's staff restroom - Replace common restroom accessories (Non-Critical Repair)

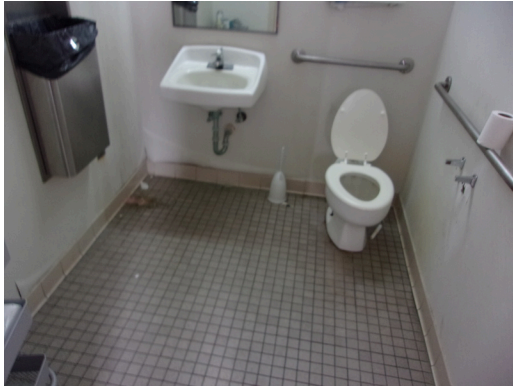
555 West Bay Street Office - Men's staff restroom - Replace common restroom accessories (Non-Critical Repair)

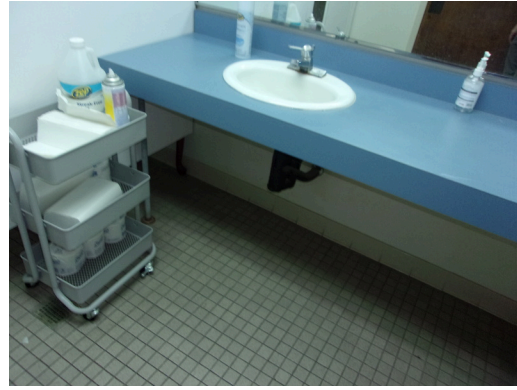
555 West Bay Street Office - Women's public restroom - Levered sink with scald and abrasion protection, replace common restroom accessories (Non-Critical Repair)

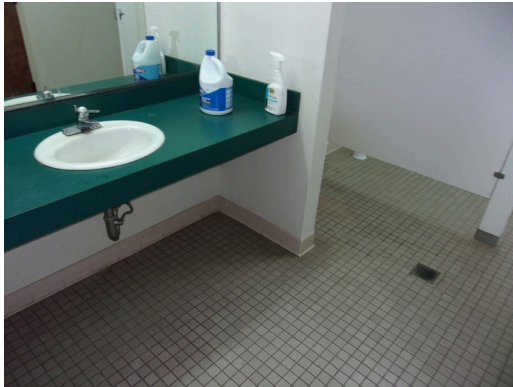
555 West Bay Street Office - Men's public restroom - Replace common restroom accessories (Non-Critical Repair)

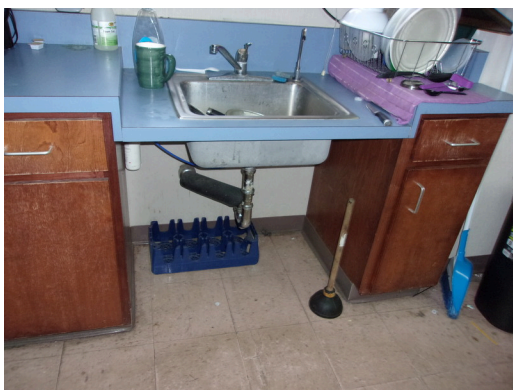
555 West Bay Street Office - No scald and abrasion protection at kitchen sink (Critical Repair)

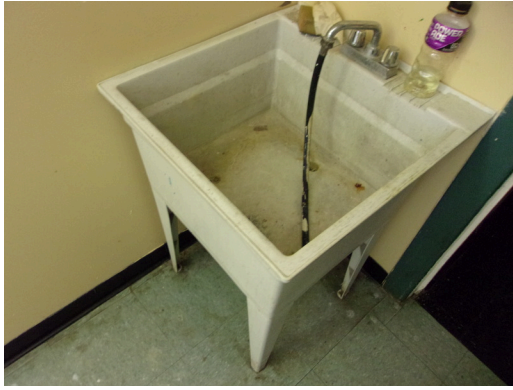
349 West Bryan Street - Community center - Staff restroom - Replace common restroom accessories (Non-Critical Repair)

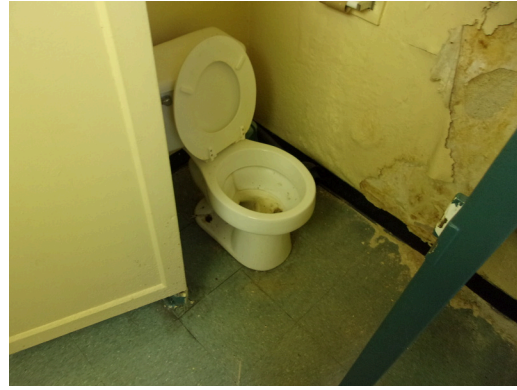
The plaster walls and ceilings within 349 W Bryan community center were observed as water-damaged. In order to prevent further damage, it is recommended that the root cause of the water intrusion must be investigated, repaired and the water-damaged plaster walls and ceilings be repaired (Non-Critical Repair).

349 West Bryan Street - Community center - Water-damaged interior walls (Non-Critical Repair)

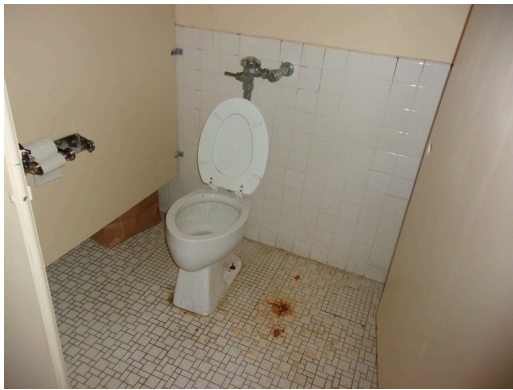
349 West Bryan Street - Community center - Women's restroom - Replace common restroom accessories (Non-Critical Repair)

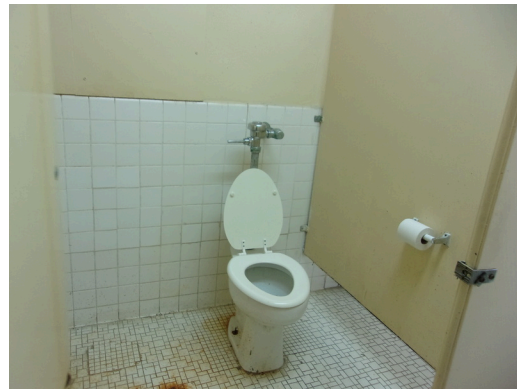
349 West Bryan Street - Community center - Men's restroom - Replace common restrooms accessories (Non-Critical Repair)

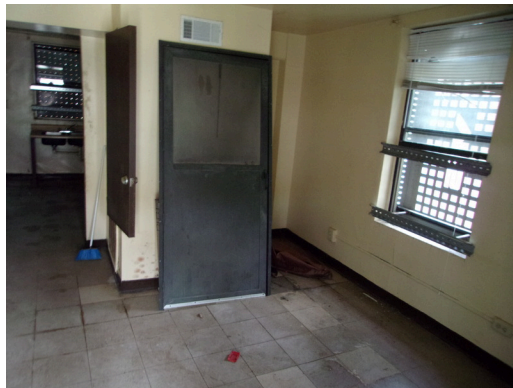
260-268 Yamacraw Village - Unit 264 - 2-bed/
1-bath TH - Plaster wall damage (Non-Critical
Repair)

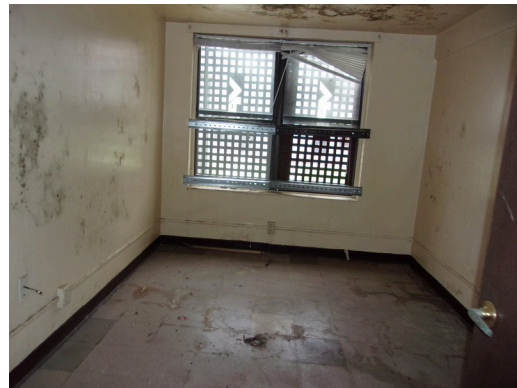
460-467 Yamacraw Village - Unit 461 - 1-bed/
1-bath - HC unit/Down unit - Living room
view, replace flooring (Non-Critical Repair)

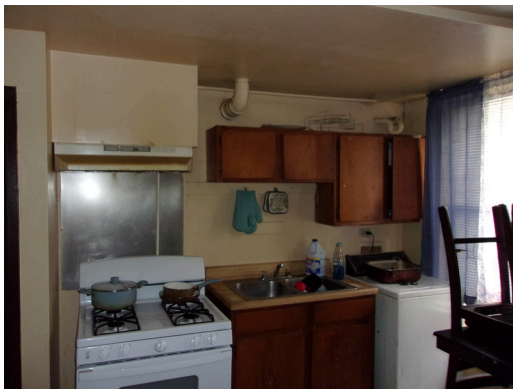
141-148 Yamacraw Village - Unit 142 - 3-bed/
1-bath TH - Kitchen view, replace old
cabinetry (Non-Critical Repair)

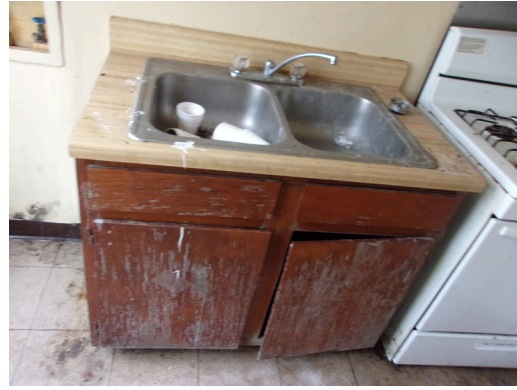
260-268 Yamacraw Village - Unit 264 - 2-bed/
1-bath TH - Replace cabinetry and fixtures
(Non-Critical Repair)

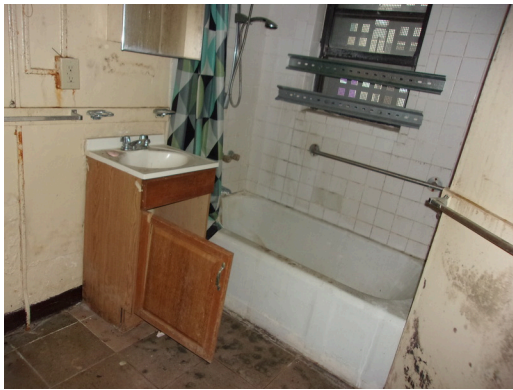
460-467 Yamacraw Village - Unit 461 - 1-bed/
1-bath - HC unit/Down unit - Mold growth
throughout, replace plumbing fixtures and
vanity (Non-Critical Repair)

Mold growth and water damage was observed in numerous down, vacant and occupied. The mold growth was typically attributed to plumbing leaks and water infiltration at the rear doors.

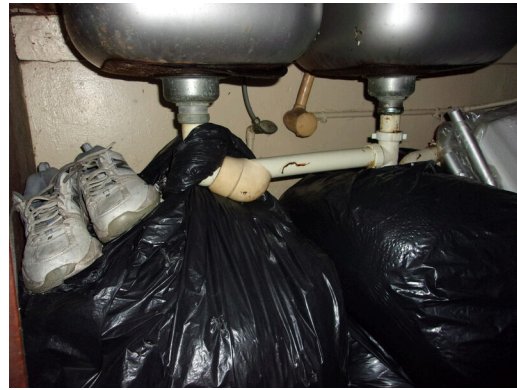
260-268 Yamacraw Village - Unit 261 - 1-bed/
1-bath - HC unit - No scald and abrasion at
sink

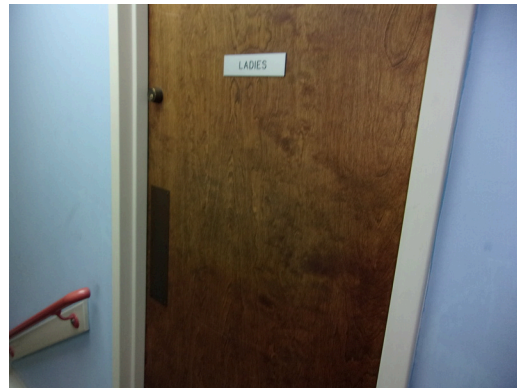
555 West Bay Street Office - Women's restroom - No scald and abrasion protection (Critical Repair)

- One (1) public restroom sink within the 555 West Bay Street office was observed without scald and abrasion protection at the roll under sink. In order to comply with the Americans with Disabilities Act Accessibility Guidelines (ADAAG), the installation of scald and abrasion protection is required (Critical Repair).

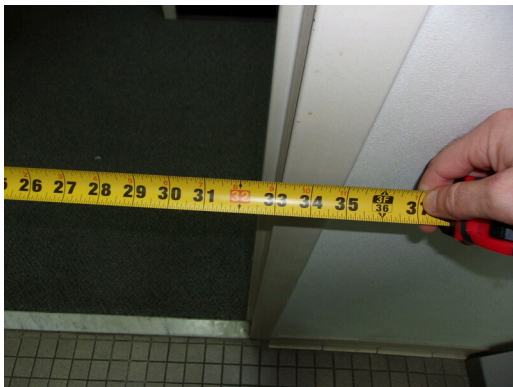
555 West Bay Street Office - Men's staff restroom - No scald and abrasion protection (Critical Repair)

- Please also note that Section 504 requires 5% UFAS and 2% audio/visual equipped units. These units would have to be designed into future construction. The lack these compliant units currently.
- Two (2) restroom sinks and one (1) kitchen sink within the 555 West Bay Street office and three (3) restroom sinks within the 349 W Bryan community center were observed without scald and abrasion protection at the roll under sink. In order to comply with the Uniformed Federal Accessibility Standards (UFAS), the installation of scald and abrasion protection is required (Critical Repair).

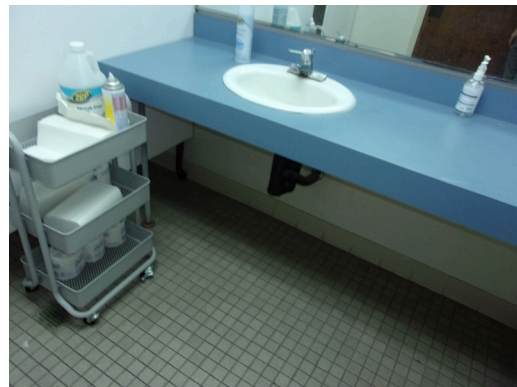
555 West Bay Street Office - Women's public restroom - No ADA signage (Critical Repair)

- The 555 West Bay Street public restrooms were observed without ADA signage. In order to comply with the American with Disabilities Act Accessibility Guidelines (ADAAG), the installation of ADA signage is required (Critical Repair).

Common area bath accessories (towel bars, grab bars, toilet stalls, etc.)	ADA - Public Restroom ADA Signage (Critical Repair)	555 West Bay Street public restrooms	Level 1 Alteration	2	Each	\$ 75.00	\$ 150.00	The 555 West Bay Street public restrooms were observed without ADA signage. In order to comply with the American with Disabilities Act Accessibility Guidelines (ADAAG), the installation of ADA signage is required.
CRITICAL REPAIRS (LIFE SAFETY)								
Concrete	Correct Concrete Sidewalk Trip Hazards (Critical Repair)	Sidewalks	Level 1 Alteration	75356	SF	\$ 10.00	\$ 753,560.00	Concrete sidewalks throughout property were observed as cracking, deteriorating, heaving/sunken from tree roots and with abrupt elevation changes, resulting in tripping hazards. In order to prevent injury to a resident, replacement of the concrete sidewalks is required. It is also important to note that all playgrounds do not feature accessible routes; this issue should be addressed when designing the new concrete sidewalk network at this property.

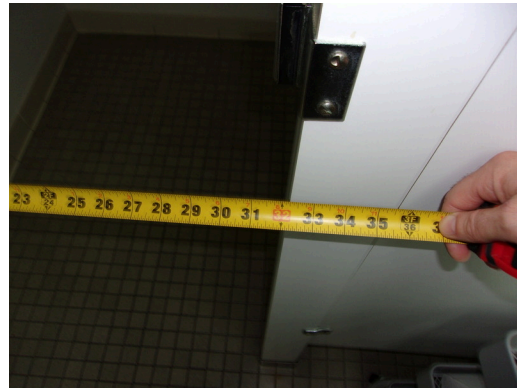
555 West Bay Street Office - Women's public restroom - Levered sink with scald and abrasion protection, replace common restroom accessories (Non-Critical Repair)

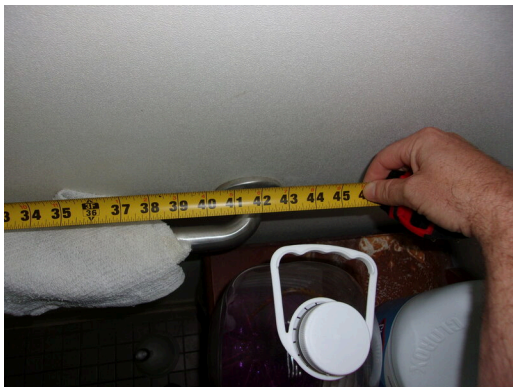
555 West Bay Street Office - Women's public restroom - Move toilet to 18 inches from centerline to side wall (Critical Repair)

- The women's public restroom toilet within the 555 West Bay Street office was observed as 12 inches from the side wall and does not allow for clear floor space at the toilet. In order to comply with the American with Disabilities Act Accessibility Guidelines (ADAAG), the toilet must be moved to allow 18 inches distance between the centerline of the toilet and the side wall (Critical Repair).

Common area bath accessories (towel bars, grab bars, toilet stalls, etc.)	ADA - Reconfigure Public Restroom (Critical Repair)	555 West Bay Street women's public restroom	Level 1 Alteration	1	Each	\$ 1,500.00	\$ 1,500.00	The women's public restroom toilet within the 555 West Bay Street office was observed as 12 inches from the side wall and does not allow for clear floor space at the toilet. In order to comply with the American with Disabilities Act Accessibility Guidelines (ADAAG), the toilet must be moved to allow 18 inches distance between the centerline of the toilet and the side wall.
Striping and Marking	ADA - Reconfigure Handicapped Parking (Critical Repair)	Parking lot	Repair	1	Each	\$ 650.00	\$ 650.00	Based upon the two-hundred fifty (250) standard uncovered parking spaces available at the site, seven (7) handicapped accessible parking spaces, inclusive of two (2) van accessible handicapped parking space are required by the Americans with Disabilities Act Accessibility Guidelines (ADAAG). The site currently features seven (7) designated handicapped spaces; however three (3) of the existing spaces at 349 W Bryan were observed without an access aisle and no spaces are van accessible. In order for the existing designated handicapped parking spaces to comply with ADAAG, the installation of two (2) access aisles and conversion of two (2) spaces to van accessible is required. Standard handicapped spaces require a 60-inch wide access aisles and vertical and horizontal identification. Van accessible handicapped spaces require a 96-inch wide access aisle, vertical signage identifying the space as van accessible, and horizontal identification. The designated handicapped parking spaces should be located at the closest accessible route to the building entrances and two (2) spaces may share a single access aisle.

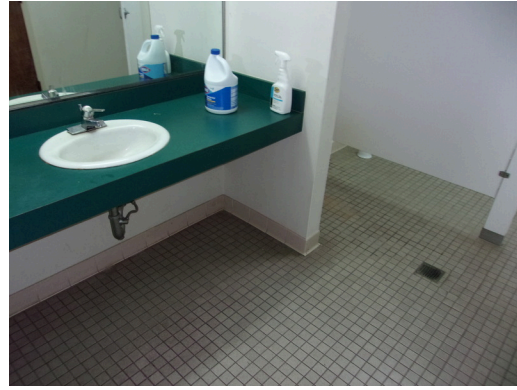
555 West Bay Street Office - Men's public restroom - No ADA signage (Critical Repair)

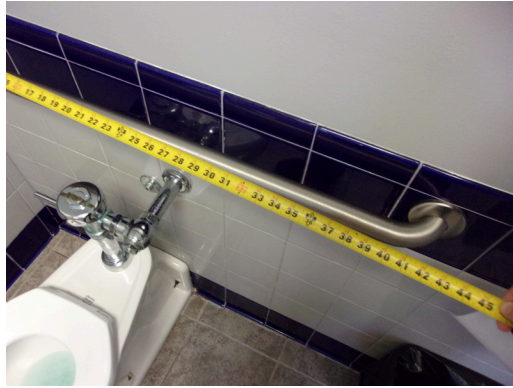
349 West Bryan Street - 2nd floor Doctor's office - Men's public restroom - Compliant side grab bar

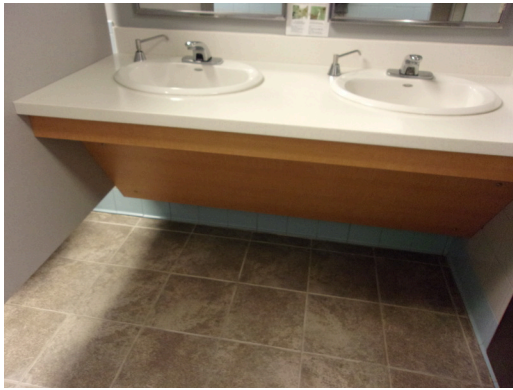
349 West Bryan Street - 2nd floor Doctor's office - Women's public restroom - Clear floor space at sinks

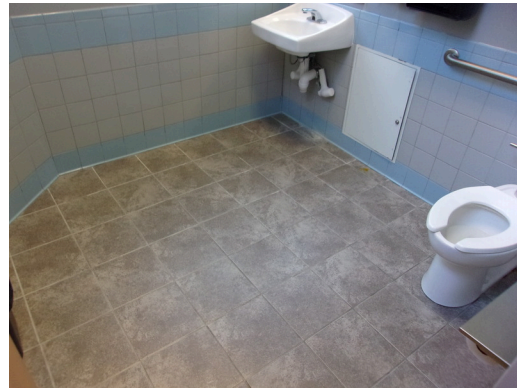
349 West Bryan Street - 2nd floor Doctor's office - Women's public restroom - Scald and abrasion protection at sinks

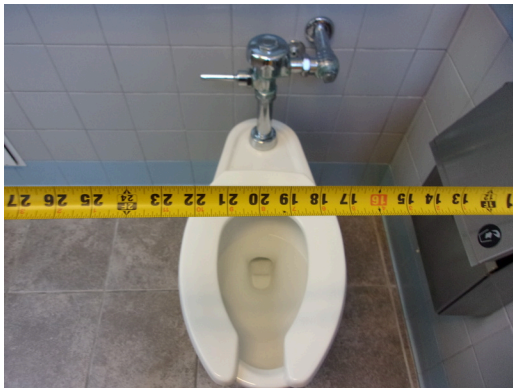
349 West Bryan Street - 2nd floor Doctor's office - Women's public restroom - HC stall view

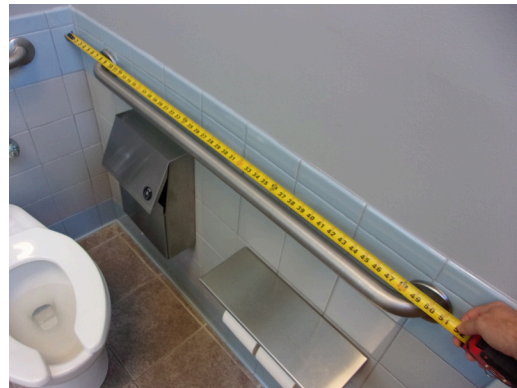
349 West Bryan Street - 2nd floor Doctor's office - Women's public restroom - Clear floor space at toilet

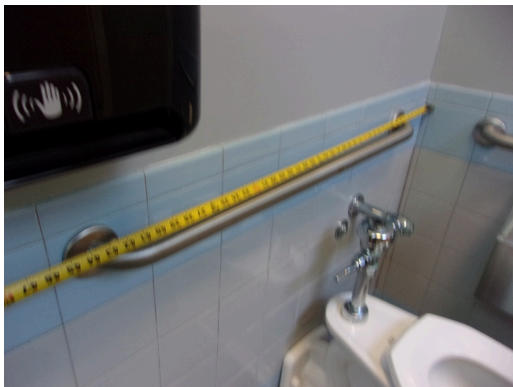
349 West Bryan Street - 2nd floor Doctor's office - Women's public restroom - Compliant side grab bar

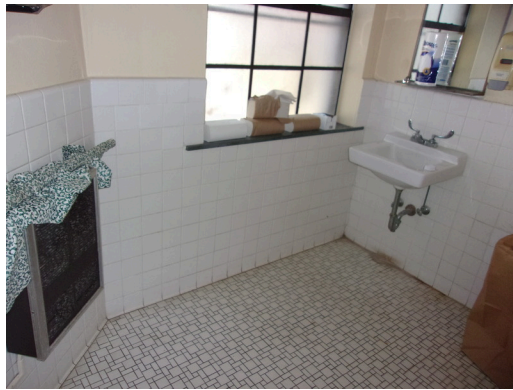
349 West Bryan Street - Community center -
Staff restroom with no scald and abrasion at
the sink (Critical Repair)

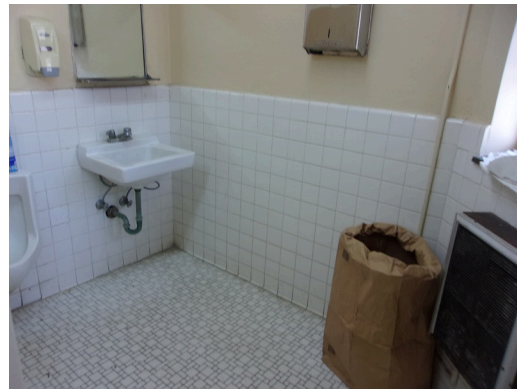
349 West Bryan Street - Community center -
Women's restroom - Install scald and abrasion
protection (Critical Repair)

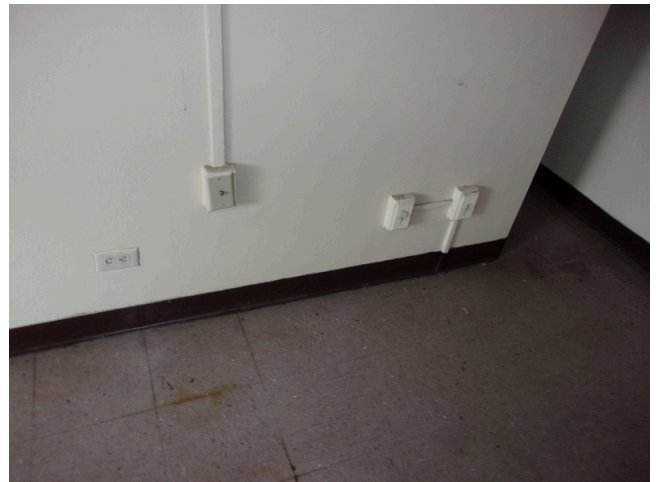
4. 121-128 Yamacraw Village - Unit 126 - 2-bed/
1-bath TH - Cable and electrical outlets

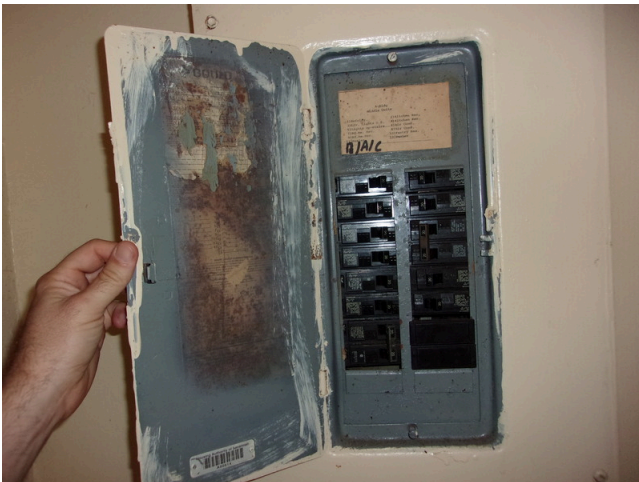
7. 121-128 Yamacraw Village - Unit 126 - 2-bed/
1-bath TH - Breaker panel

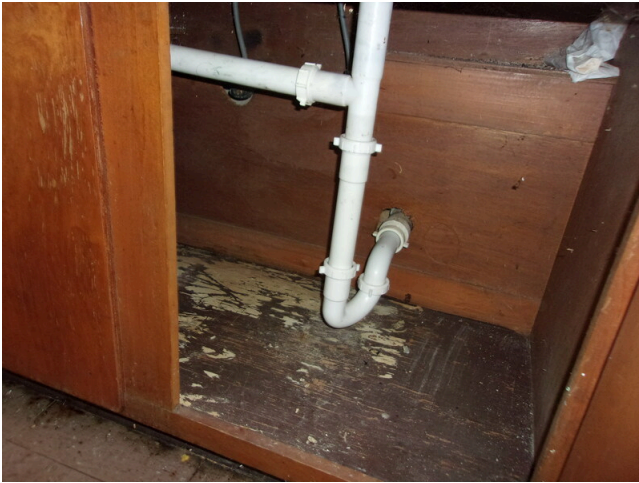
9. 121-128 Yamacraw Village - Unit 126 - 2-bed/
1-bath TH - PVC waste pipe

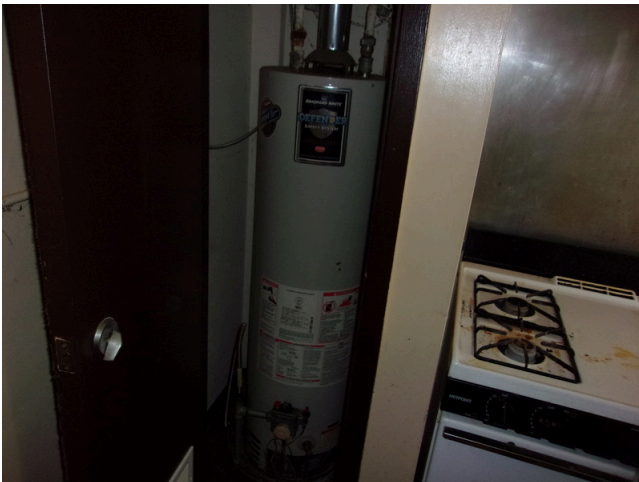
11. 121-128 Yamacraw Village - Unit 126 - 2-bed/
1-bath TH - Replace gas-fired water heater (Non-
Critical Repair)

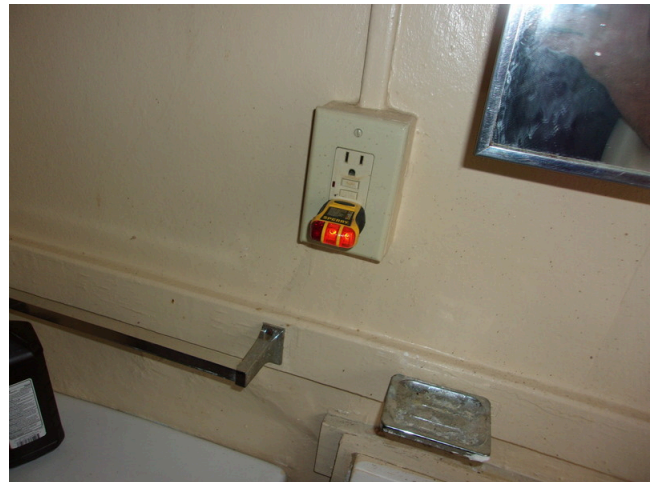
16. 121-128 Yamacraw Village - Unit 126 - 2-bed/
1-bath TH - GFCI in bathroom

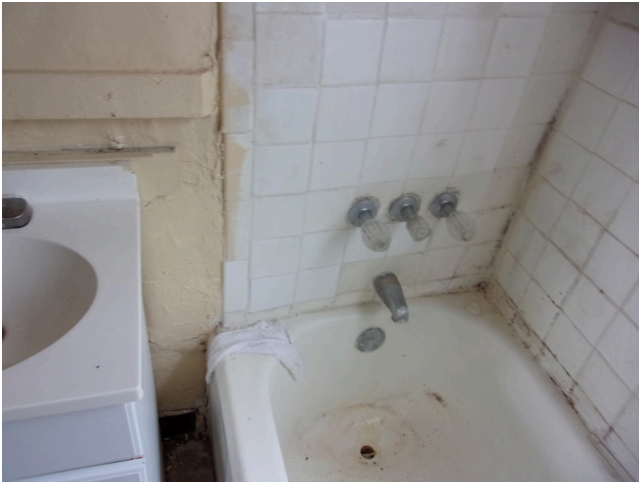
17. 121-128 Yamacraw Village - Unit 126 - 2-bed/
1-bath TH - Replace ceramic tile surround (Non-
Critical Repair)
