HUD MAP Capital Needs Assessment

REPORT DATE: August 21, 2023

Yamacraw Village
555 West Bay Street
Savannah, Chatham County, Georgia 31401

AEI Project No. 480855
Site Assessment Date: July 31 and August 1, 2023

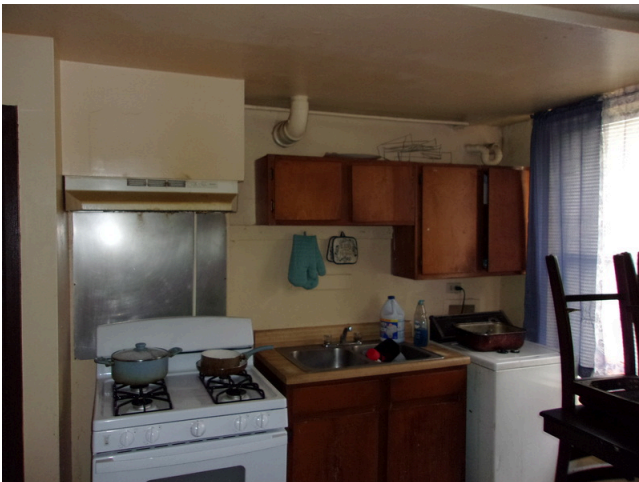
19. 141-148 Yamacraw Village - Unit 142 - 3-bed/
1-bath TH - Kitchen view, replace old cabinetry
(Non-Critical Repair)

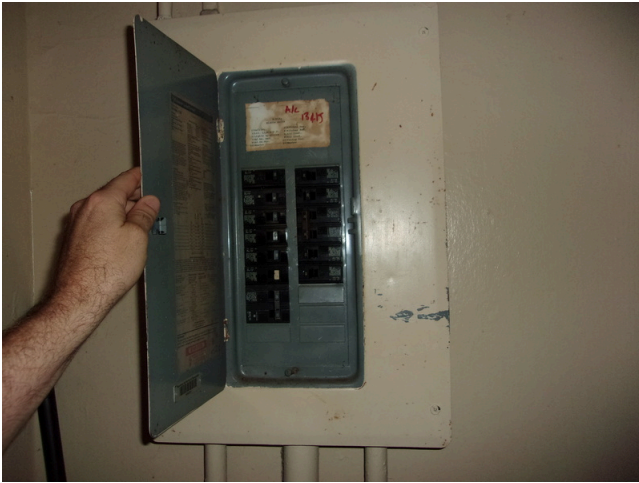
21. 141-148 Yamacraw Village - Unit 142 - 3-bed/
1-bath TH - Breaker panel

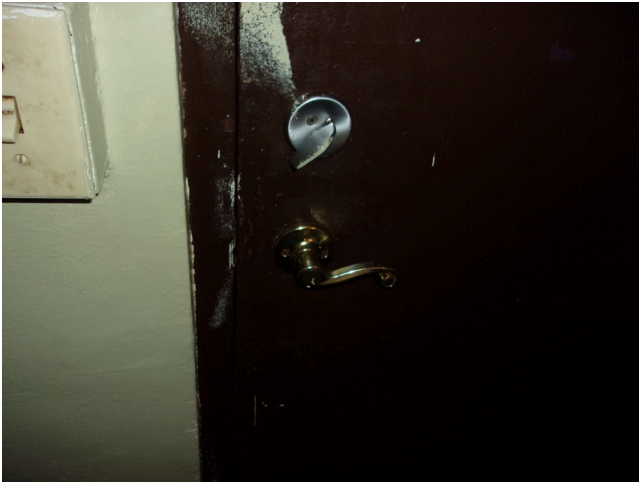
32. 260-268 Yamacraw Village - Unit 261 - 1-bed/
1-bath - HC unit - 32 inch clear opening at front
door

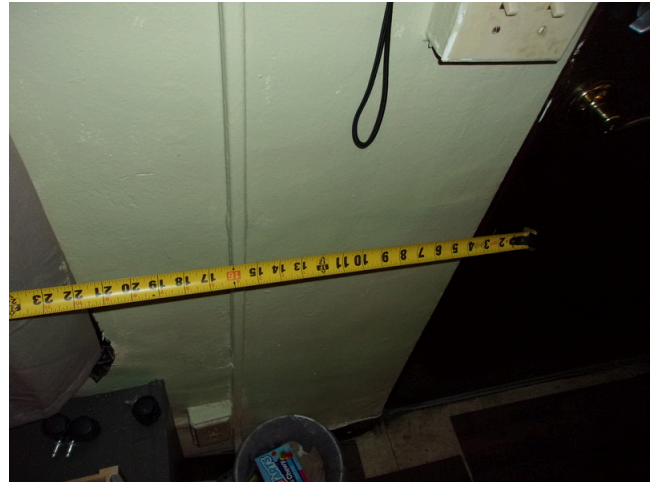
33. 260-268 Yamacraw Village - Unit 261 - 1-bed/
1-bath - HC unit - Levered door hardware

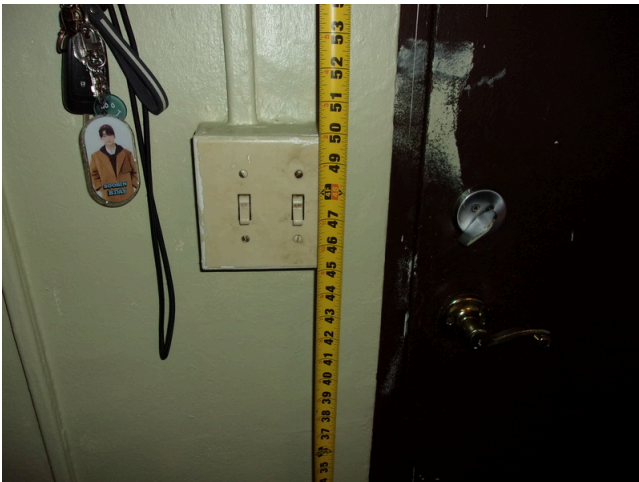
34. 260-268 Yamacraw Village - Unit 261 - 1-bed/
1-bath - HC unit - Adequate space at latch side of
door

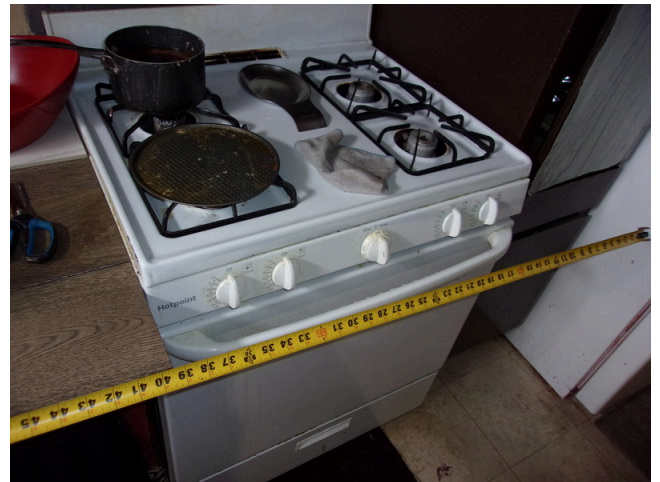
39. 260-268 Yamacraw Village - Unit 261 - 1-bed/
1-bath - HC unit - Front control range/oven

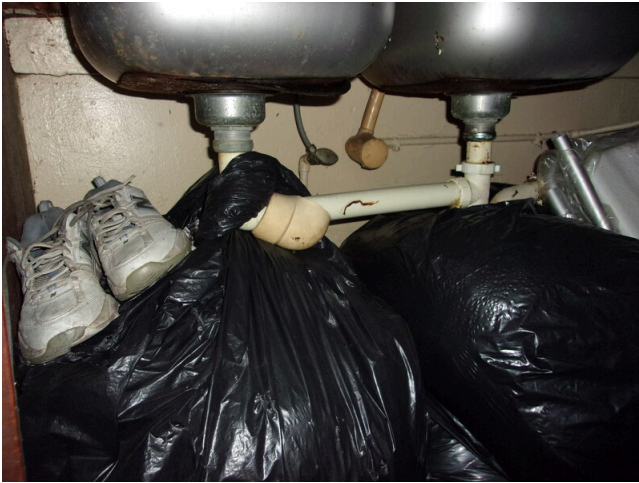
44. 260-268 Yamacraw Village - Unit 261 - 1-bed/
1-bath - HC unit - Roll-under sink

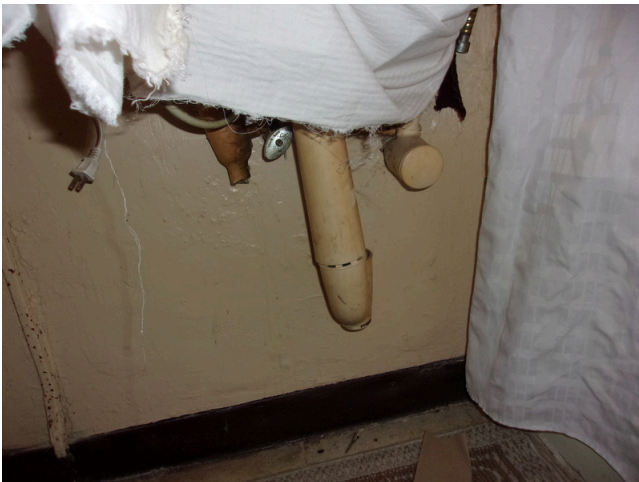
50. 260-268 Yamacraw Village - Unit 261 - 1-bed/
1-bath - HC unit - Clear floor space at roll-under
sink

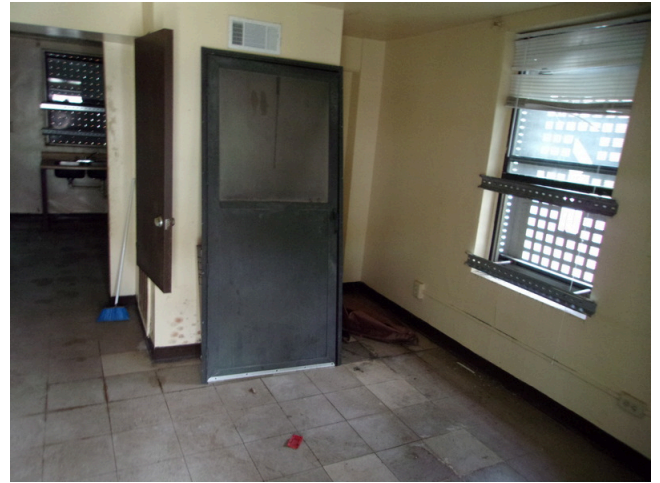
66. 460-467 Yamacraw Village - Unit 461 - 1-bed/
1-bath - HC unit/Down unit - Living room view,
replace flooring (Non-Critical Repair)

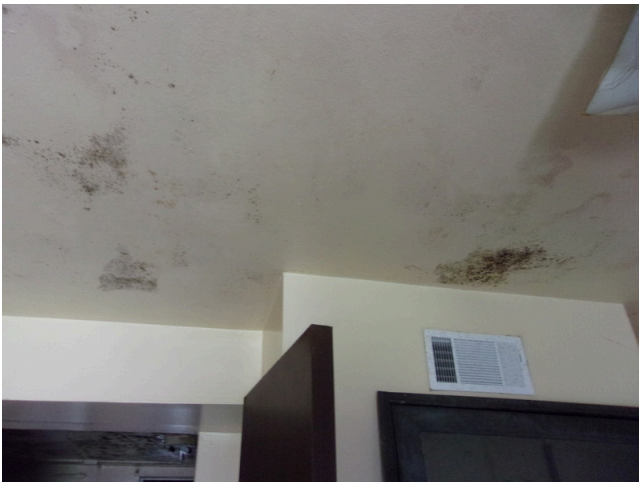
67. 460-467 Yamacraw Village - Unit 461 - 1-bed/
1-bath - HC unit/Down unit - Mold growth
throughout (Non-Critical Repair)

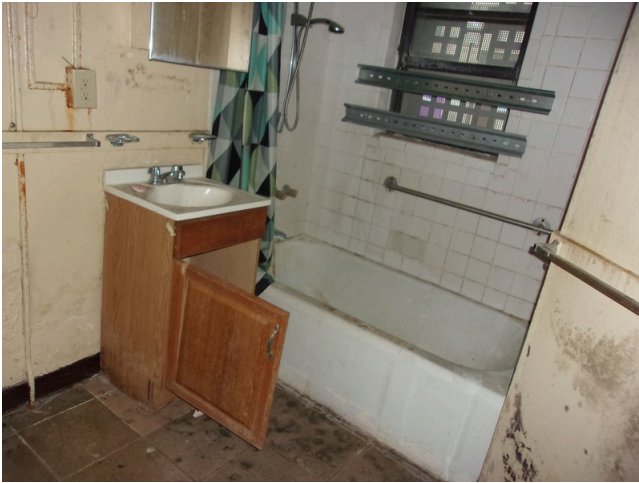
69. 460-467 Yamacraw Village - Unit 461 - 1-bed/
1-bath - HC unit/Down unit - Mold growth
throughout, replace plumbing fixtures and vanity
(Non-Critical Repair)

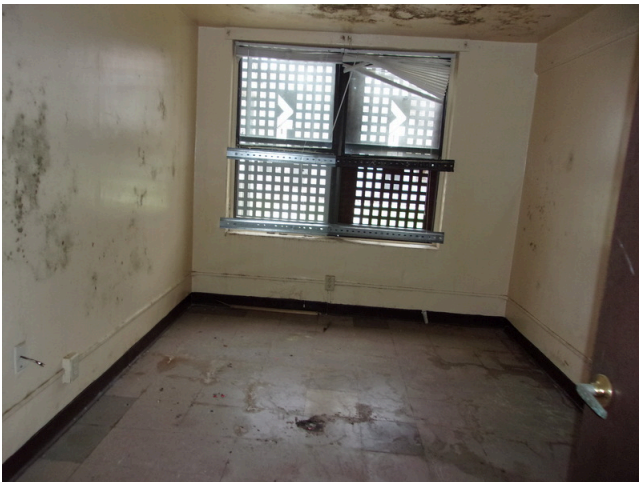
71. 460-467 Yamacraw Village - Unit 461 - 1-bed/
1-bath - HC unit/Down unit - Bedroom view

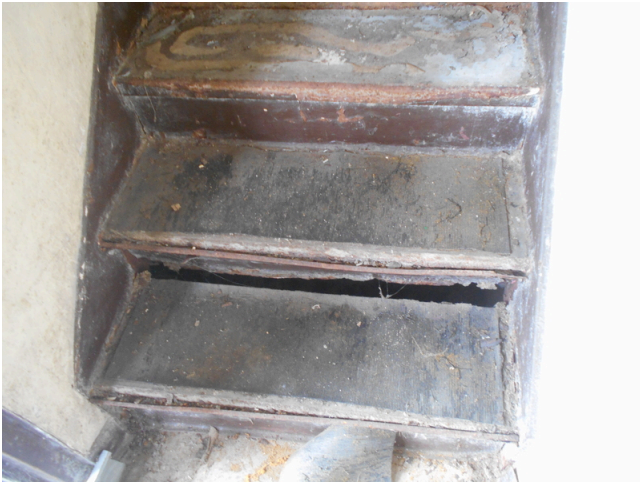
73. 460-467 Yamacraw Village - Unit 460 - 1-bed/
1-bath - Down unit - Replace damaged interior
stairs (Non-Critical Repair)

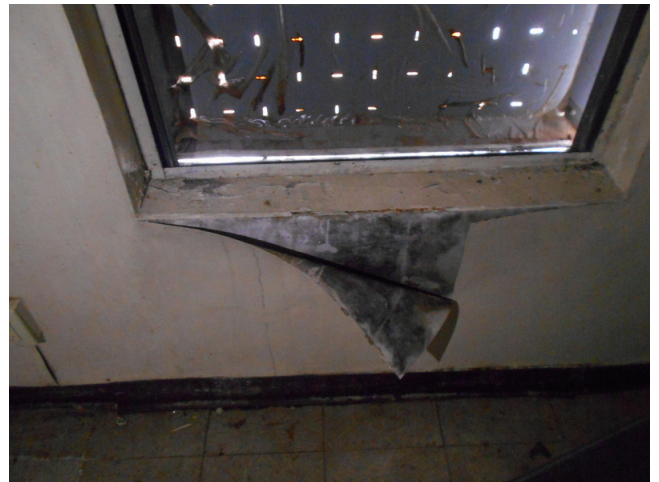
76. 460-467 Yamacraw Village - Unit 460 - 1-bed/
1-bath - Down unit - Damaged plaster walls (Non-
Critical Repair)

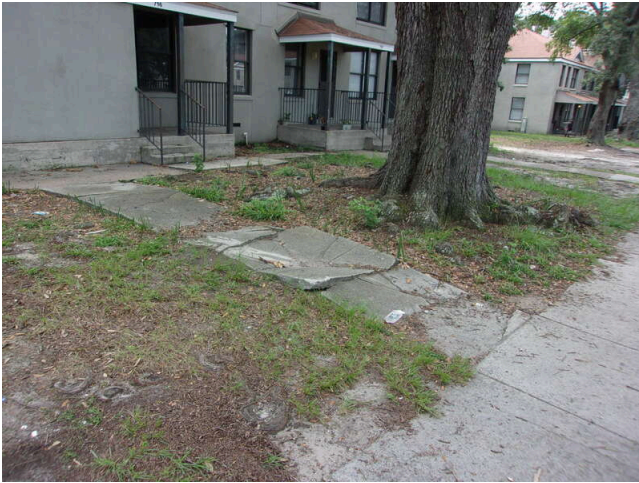
5. Typical damaged concrete sidewalk with trip hazards (Critical Repair)

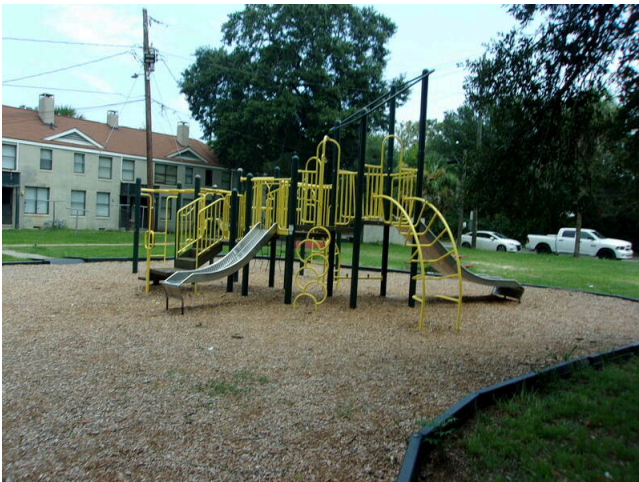
7. Playground equipment is past its EUL (Non-Critical Repair)

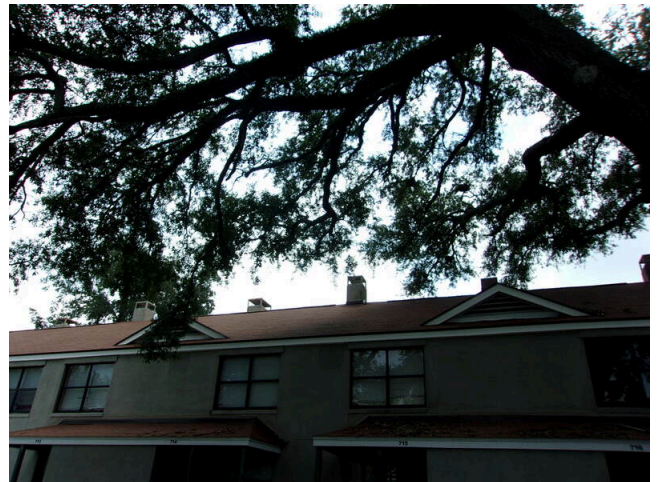
8. Typical trees touching apartment building roofs (Non-Critical Repair)

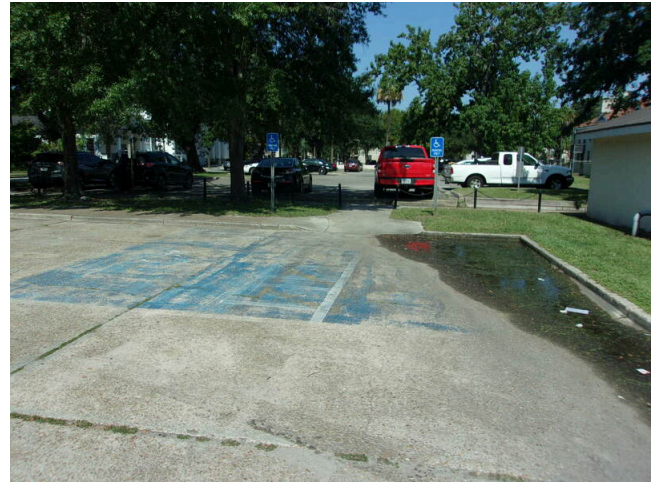
14. HC parking at 555 West Bay Street - Two (2) standard spaces, convert two (2) spaces to van accessible (Critical Repair)

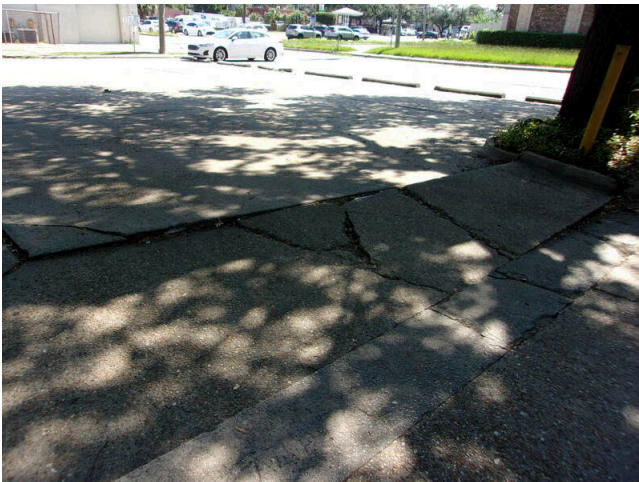
15. Replace heaving and cracked concrete parking lot (Non-Critical Repair)

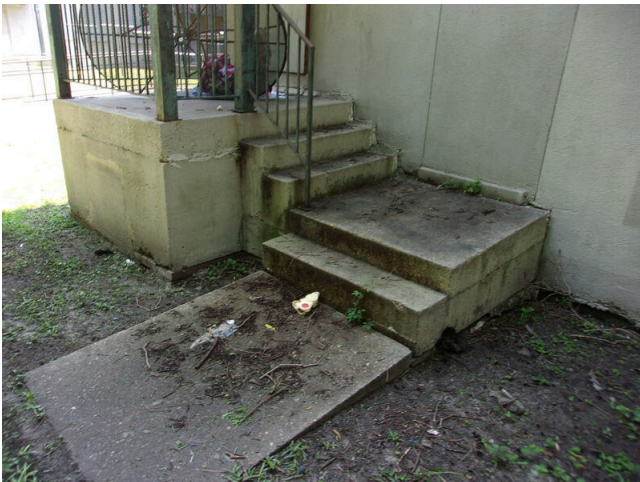
27. Sinking porch steps (Non-Critical Repair)

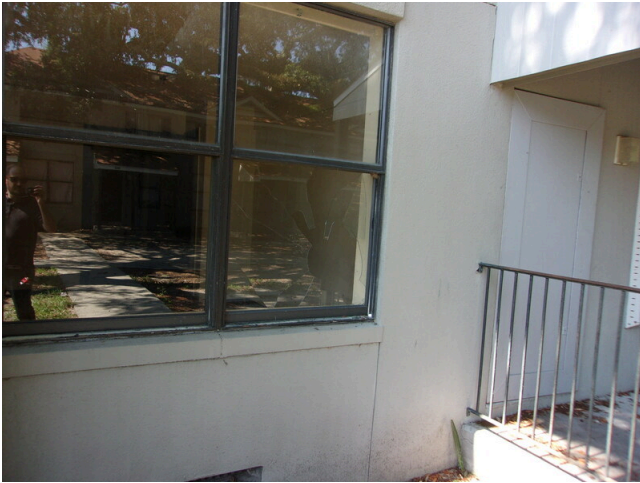
29. Typical broken window (Non-Critical Repair)

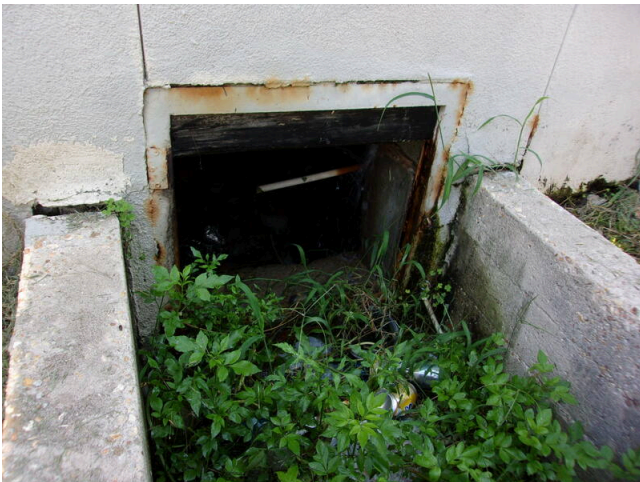
31. Broken plumbing pipe within crawlspace (Non-Critical Repair)

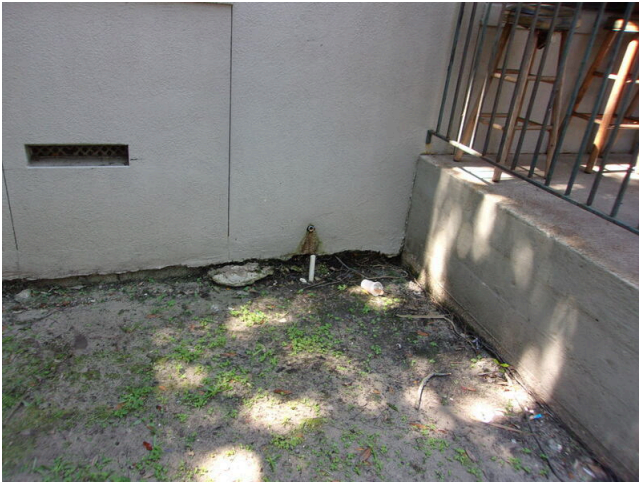
33. Damaged stucco siding (Non-Critical Repair)

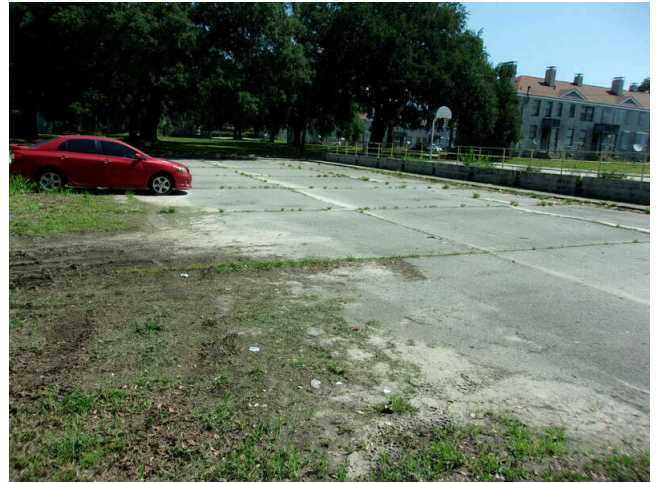
34. Replace asphalt parking lot and restripe (Non-Critical Repair)

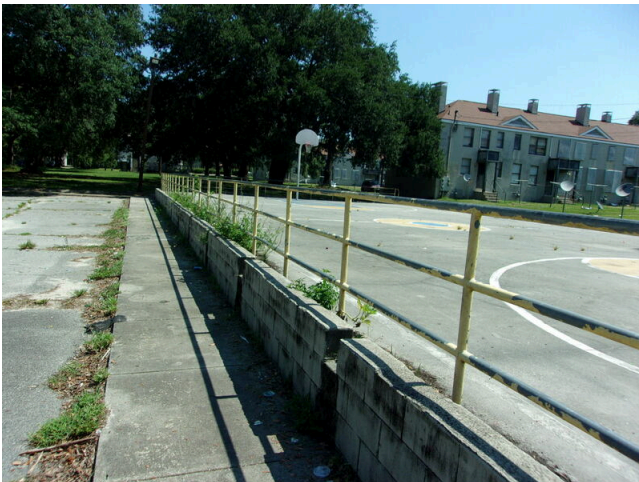
35. Refurbish and paint steel railing at basketball court (Non-Critical Repair)

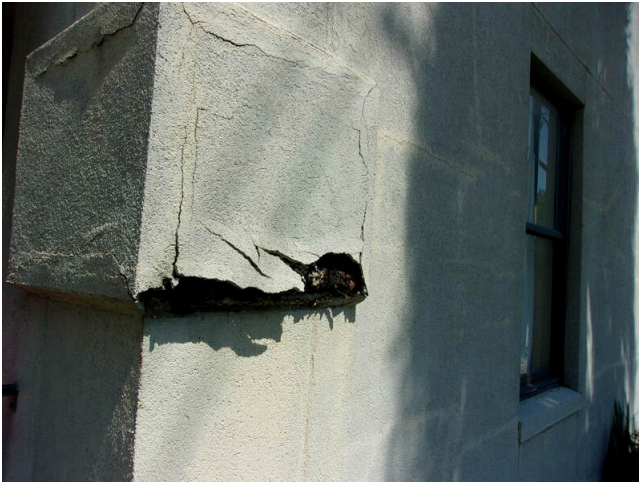
37. Damaged stucco siding (Non-Critical Repair)

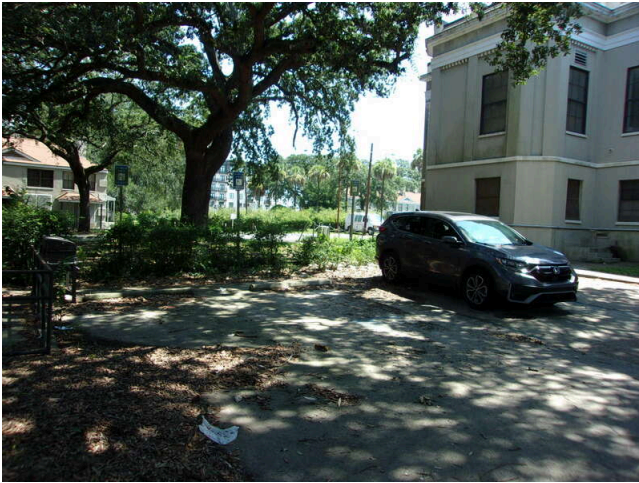
41. HC spaces near 349 West Bryan Street, install access aisles for spaces (Critical Repair)

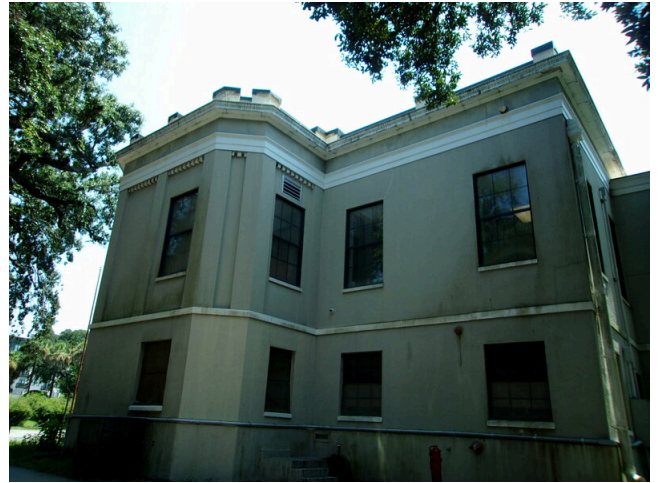
42. 349 West Bryan Street - West elevation

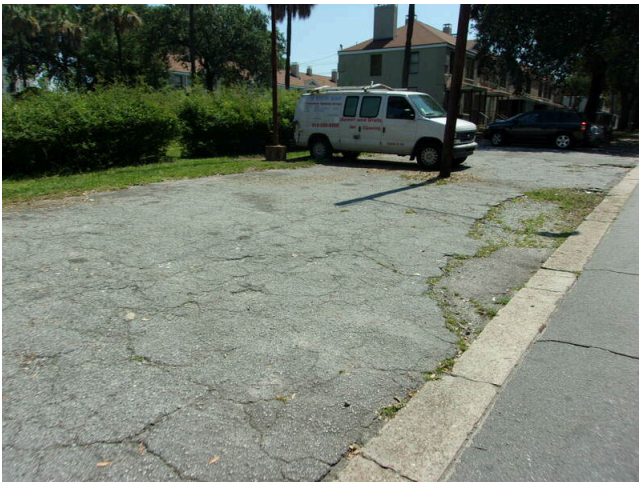
43. Replace and restripe asphalt parking surfaces (Non-Critical Repair)

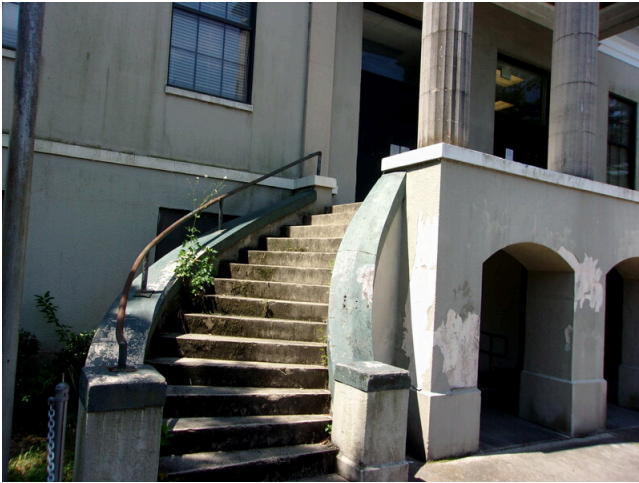
45. Replace deteriorating concrete steps at 349 West Bryan Street (Non-Critical Repair)

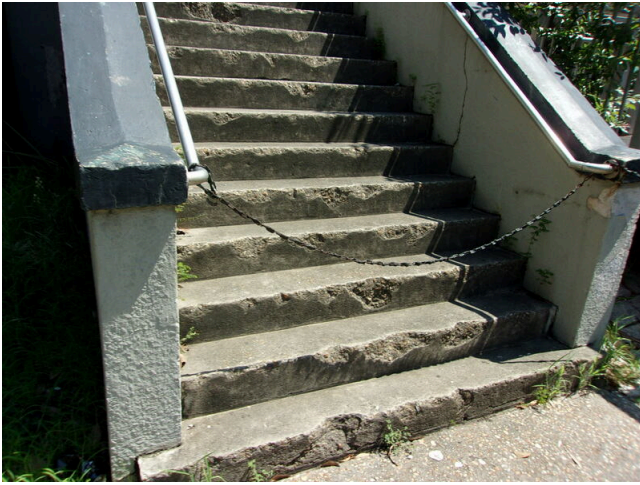
49. 349 West Bryan Street - Replace steep and deteriorating concrete steps at rear (Non-Critical Repair)

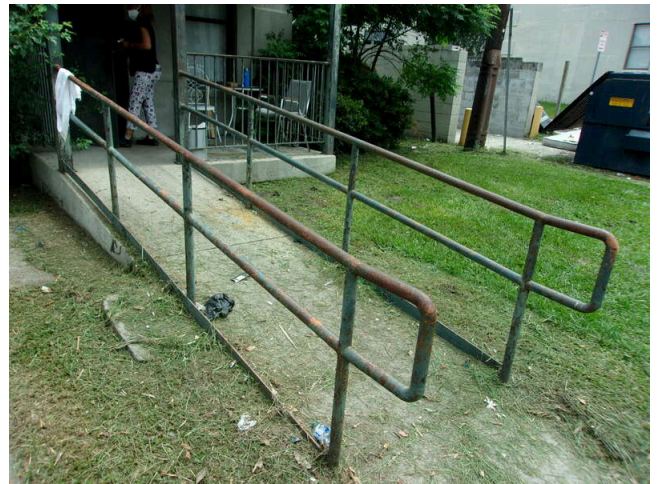
52. Replace concrete and metal HC unit ramps (Non-Critical Repair)

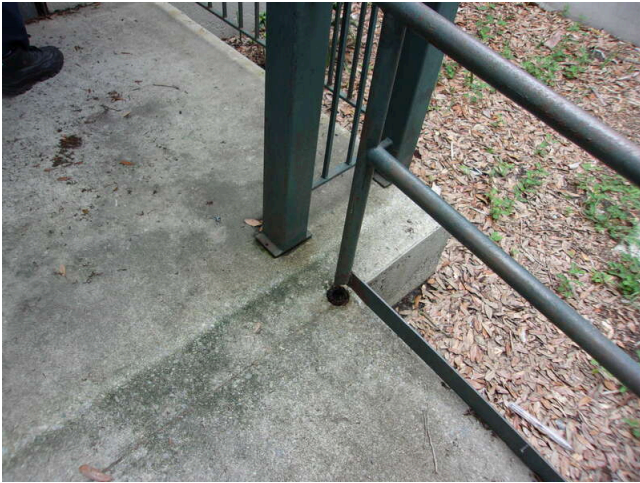
53. Replace concrete and metal HC unit ramps (Non-Critical Repair)

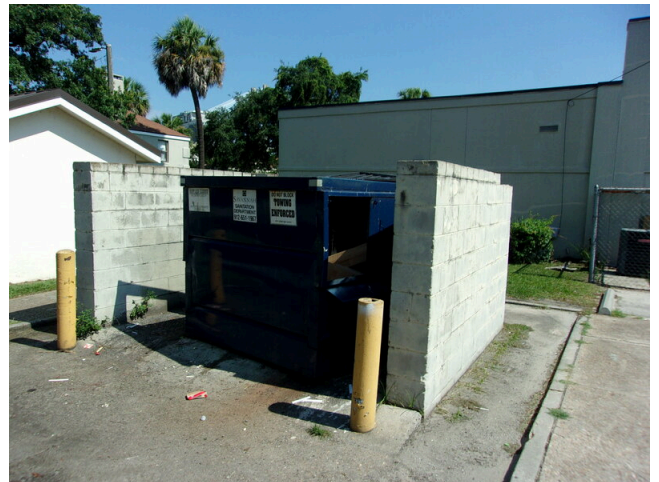
56. Replace CMU dumpster enclosures (Non-Critical Repair)

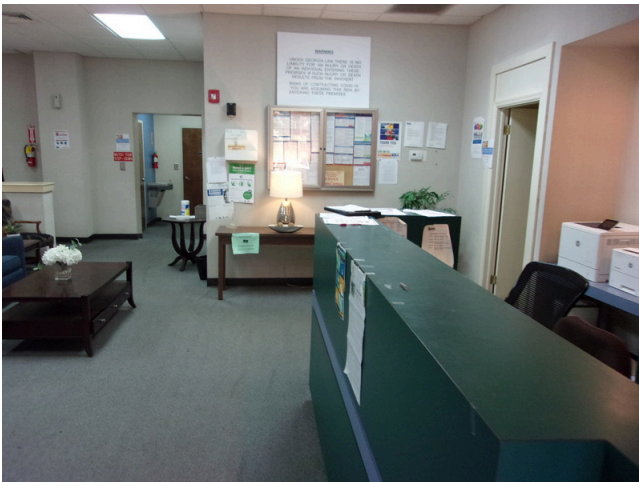
63. 555 West Bay Street Office - Replace old carpet flooring (Non-Critical Repair)

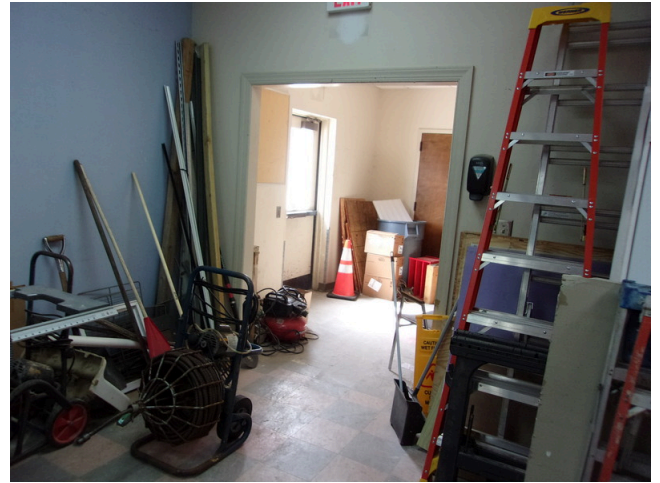
66. 555 West Bay Street Office - Maintenance areas
- Replace old vinyl flooring (Non-Critical Repair)

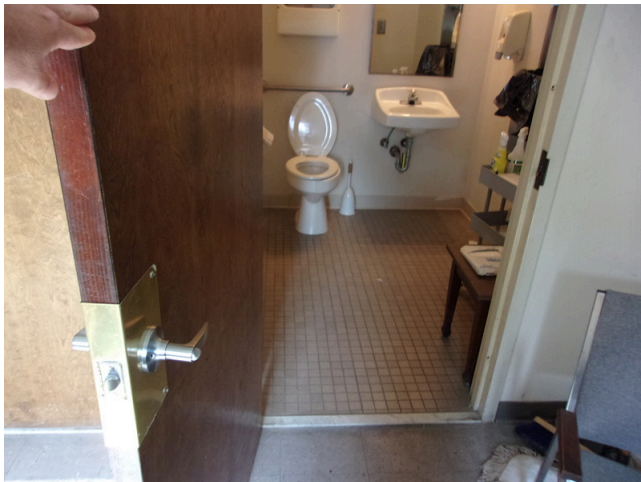
67. 555 West Bay Street Office - Women's staff
restroom - Replace common restroom accessories
(Non-Critical Repair)

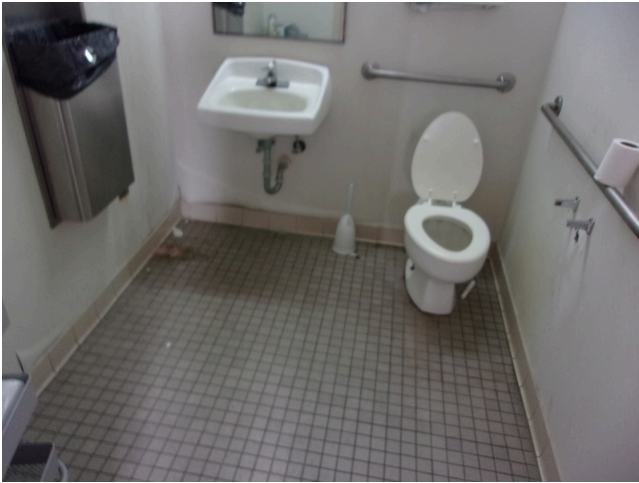
69. 555 West Bay Street Office - Men's staff restroom - Replace common restroom accessories (Non-Critical Repair)

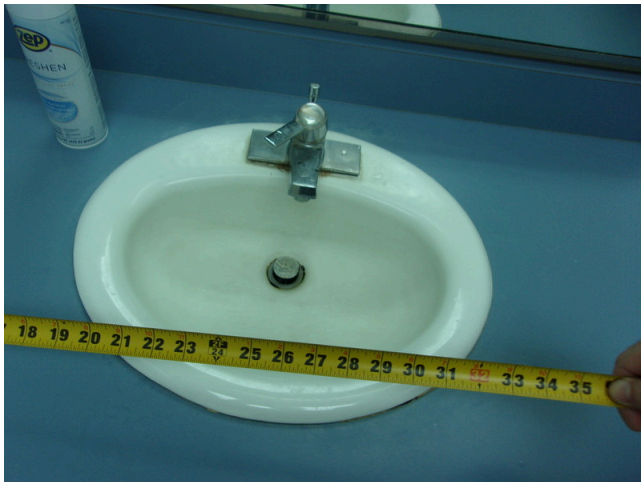
74. 555 West Bay Street Office - Women's public restroom - Levered sink with scald and abrasion protection, replace common restroom accessories (Non-Critical Repair)

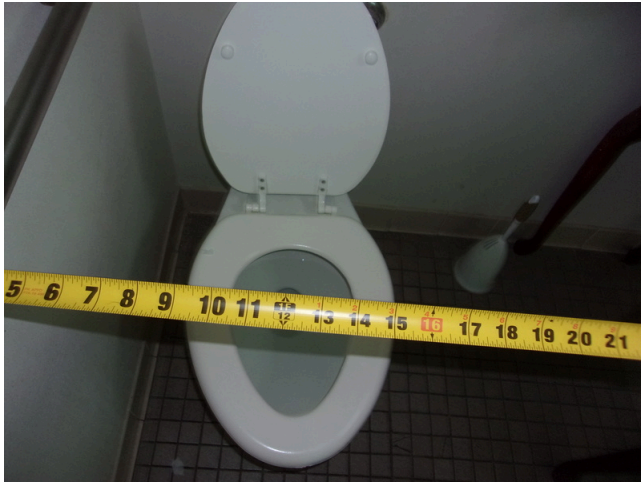
77. 555 West Bay Street Office - Women's public restroom - Move toilet to 18 inches from centerline to side wall (Critical Repair)

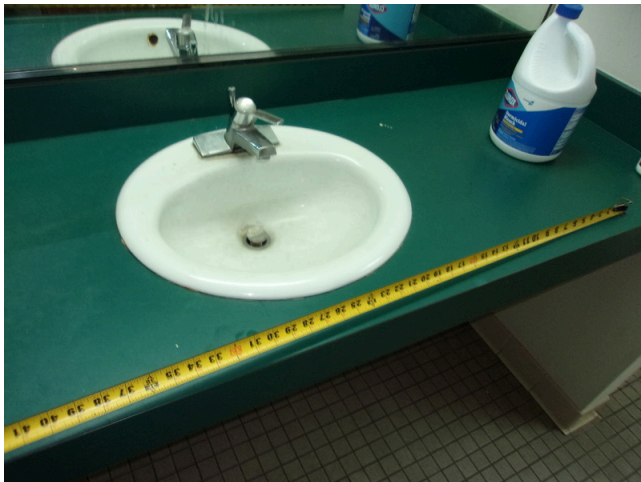
82. 555 West Bay Street Office - Men's public restroom - Replace common restroom accessories (Non-Critical Repair)

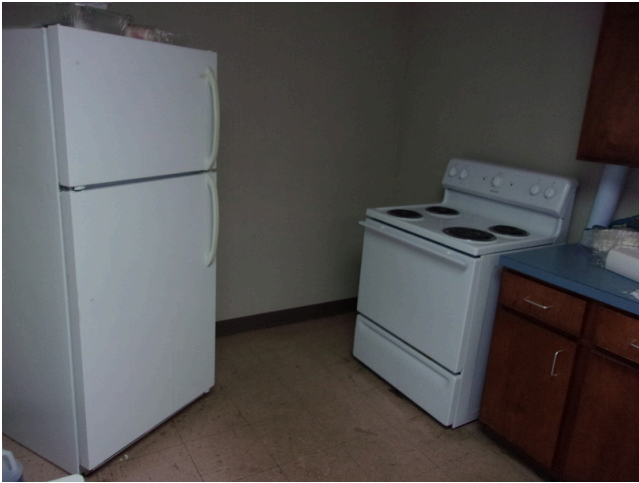
88. 555 West Bay Street Office - Common staff kitchen - Replace kitchen cabinetry (Non-Critical Repair)

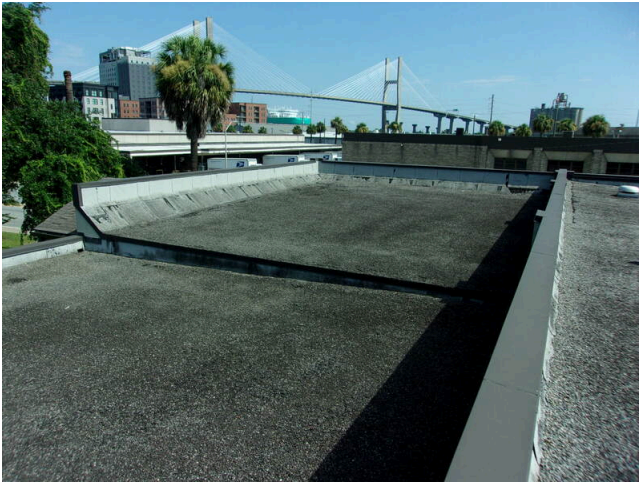
92. 555 West Bay Street built-up roofing view

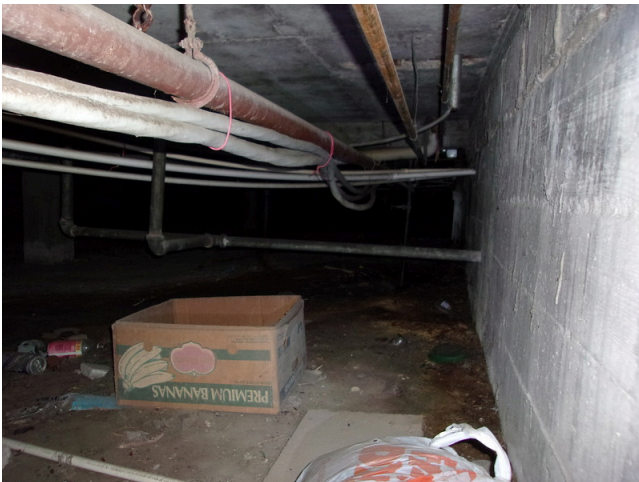
94. Crawlspace floor without vapor barrier

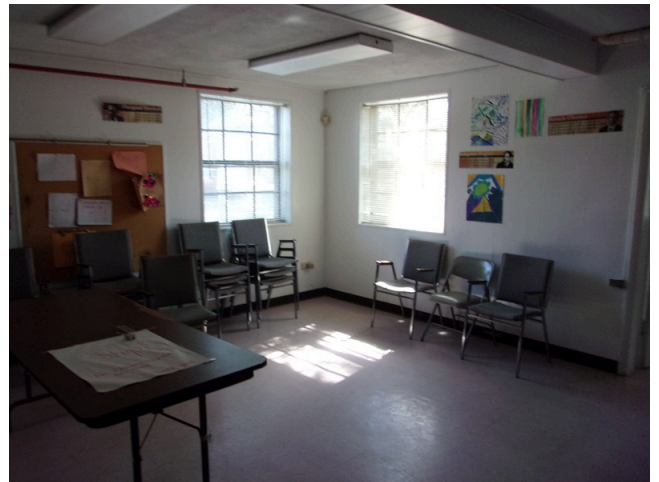
132. 349 West Bryan Street - Community center - Classroom view

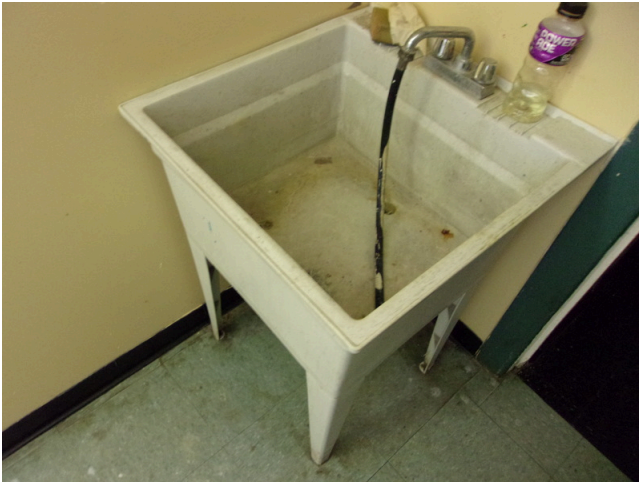
133. 349 West Bryan Street - Community center - Staff restroom - Replace common restroom accessories (Non-Critical Repair)

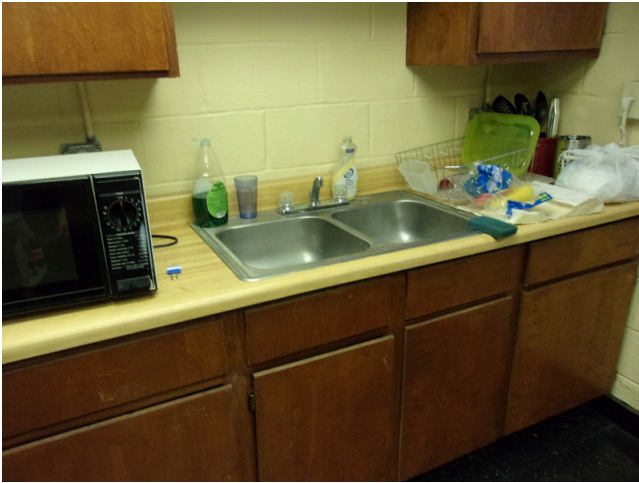
137. 349 West Bryan Street - Community center - Common kitchen - Replace old kitchen cabinetry (Non-Critical Repair)

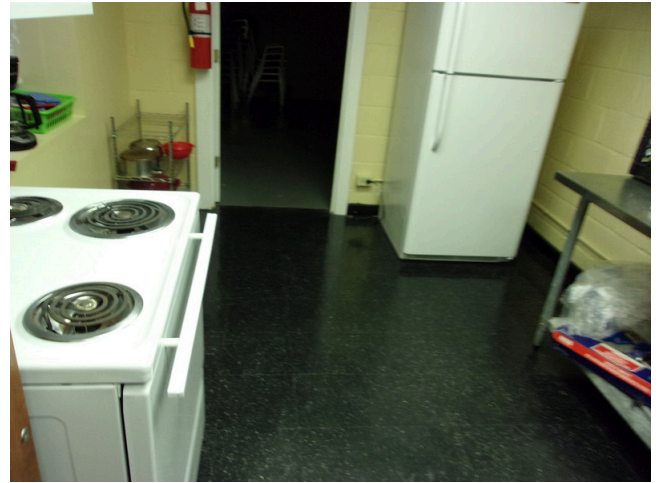
138. 349 West Bryan Street - Community center - Replace old vinyl flooring (Non-Critical Repair)

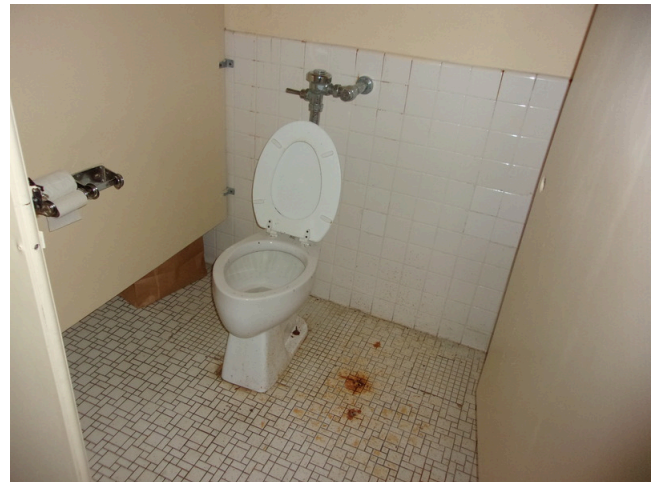
140. 349 West Bryan Street - Community center - Women's restroom - Replace common restroom accessories (Non-Critical Repair)

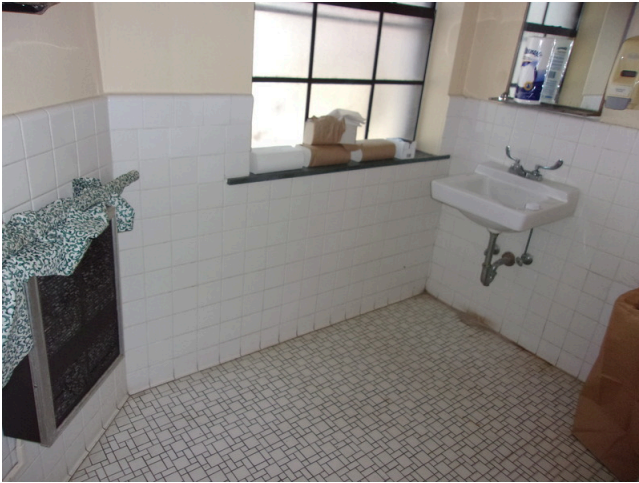
141. 349 West Bryan Street - Community center - Women's restroom - Install scald and abrasion protection (Critical Repair)

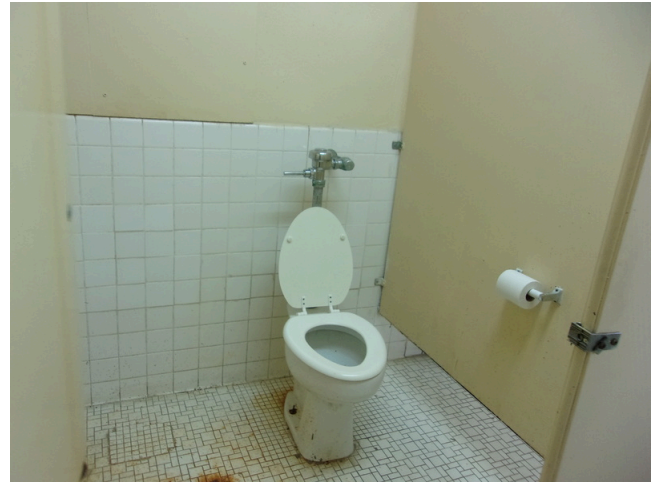
142. 349 West Bryan Street - Community center - Men's restroom - Replace common restrooms accessories (Non-Critical Repair)

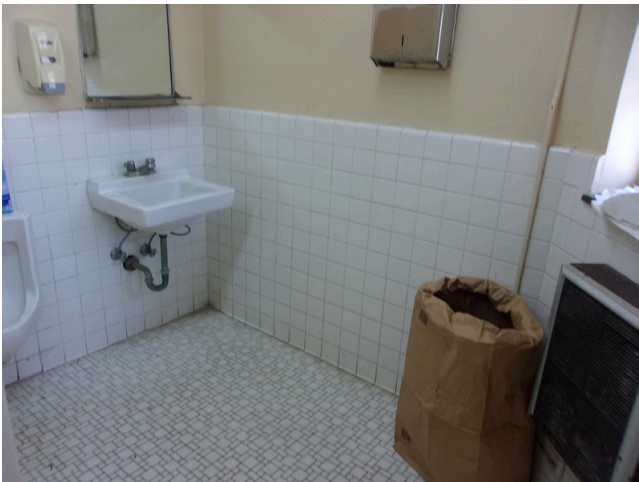
143. 349 West Bryan Street - Community center - Men's restroom - Install scald and abrasion protection (Critical Repair)

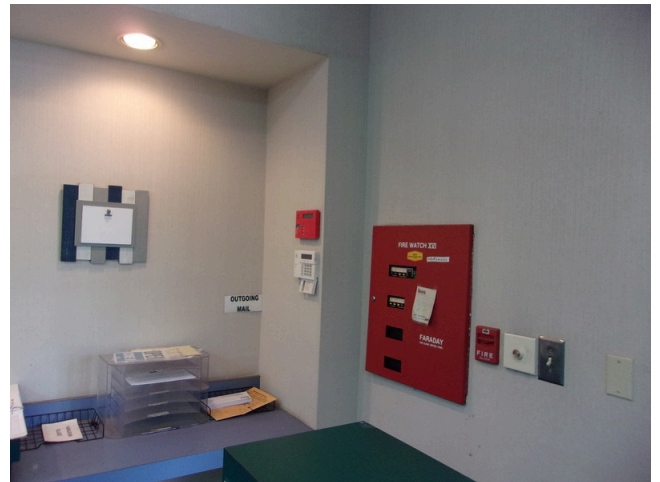
144. 555 West Bay Street Office - Fire alarm - Provide annual report (Critical Repair)

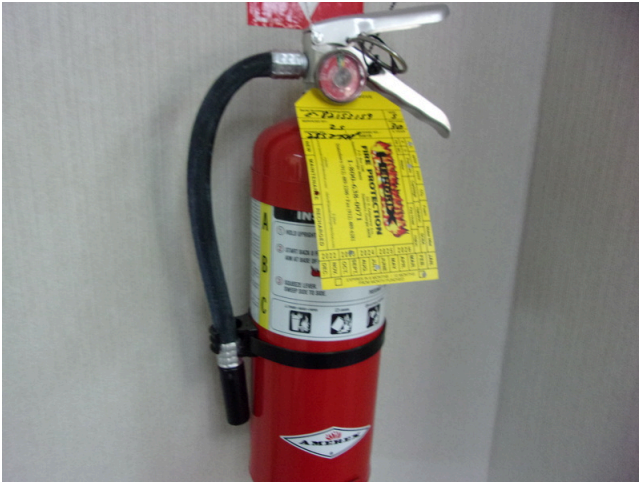
145. 555 West Bay Street Office - Fire extinguisher
- Tag dated July 2023

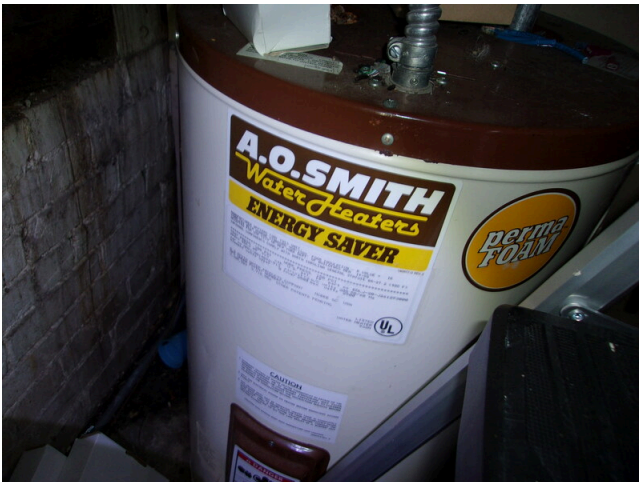
147. 555 West Bay Street Office - Replace old
20-gallon water heater (Non-Critical Repair)

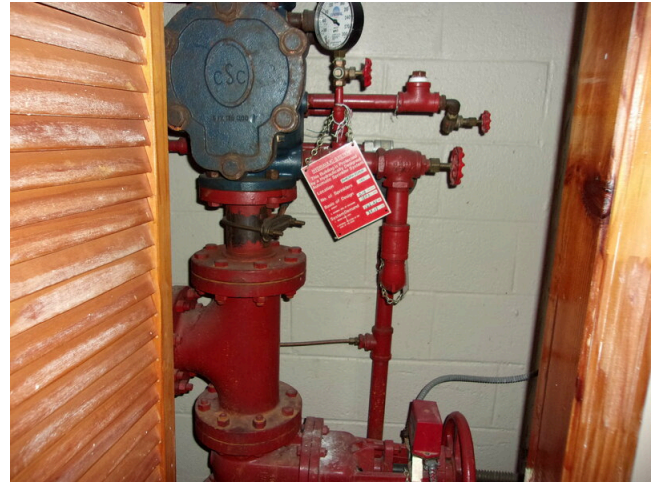
150. 349 West Bryan Street - Community center -
Fire riser - Provide annual sprinkler report (Critical
Repair)

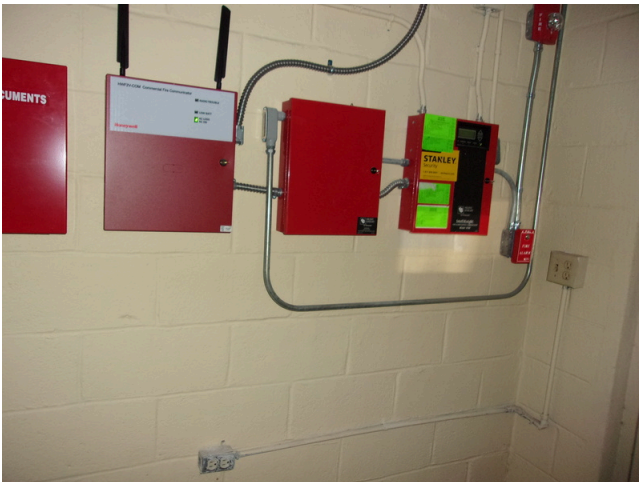
151. 349 West Bryan Street - Community center -
Fire alarm panel - Provide annual report (Critical
Repair)

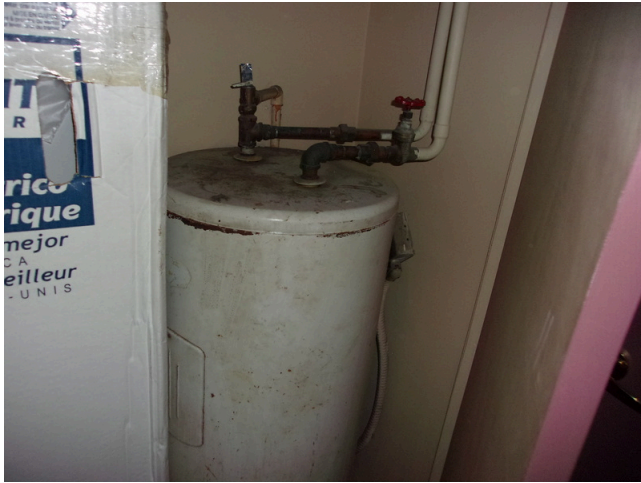
153. 349 West Bryan Street - Community center - Replace old 50-gallon water heater (Non-Critical Repair)

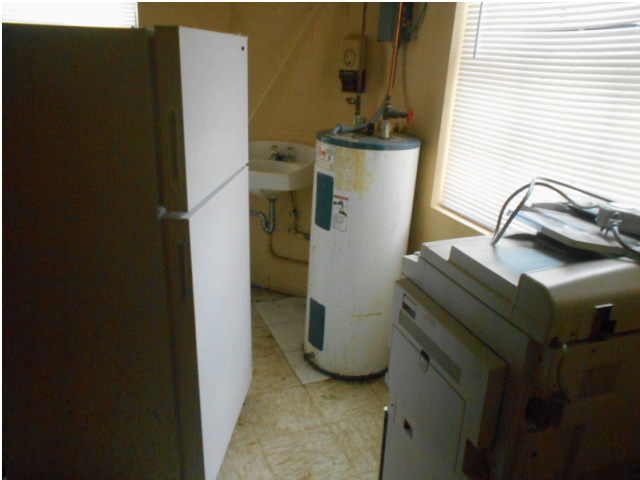
163. 349 West Bryan Street - Community center - Replace old 50-gallon water heater (Non-Critical Repair)

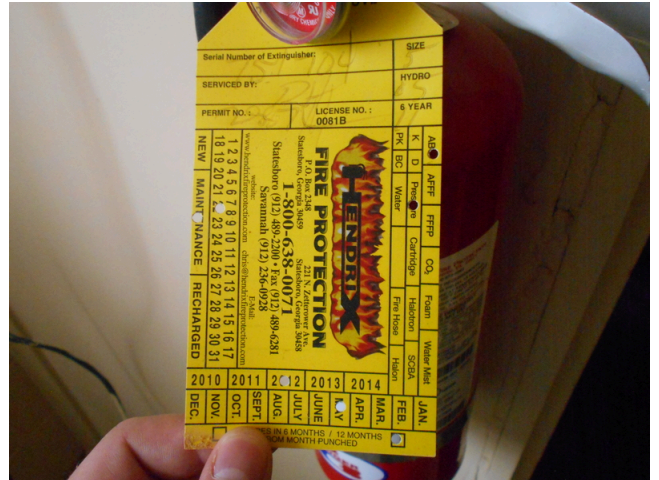
164. 349 West Bryan Street - Community center - Inspect fire extinguishers annually (Critical Repair)

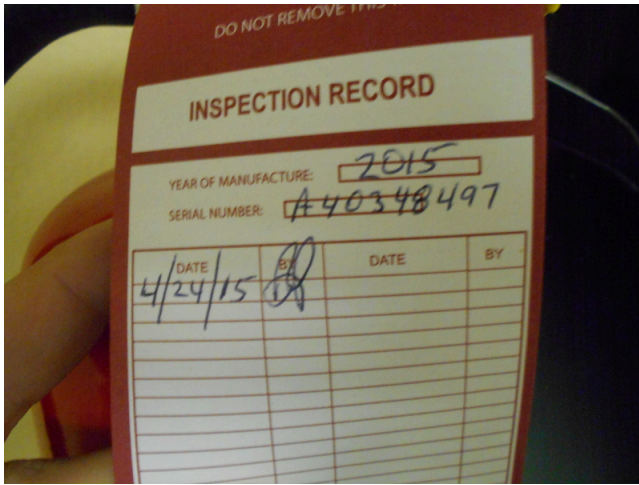
165. 349 West Bryan Street - Community center -
Inspect fire extinguishers annually (Critical Repair)
