## Daffin Park live oak preservation plan

### Overview

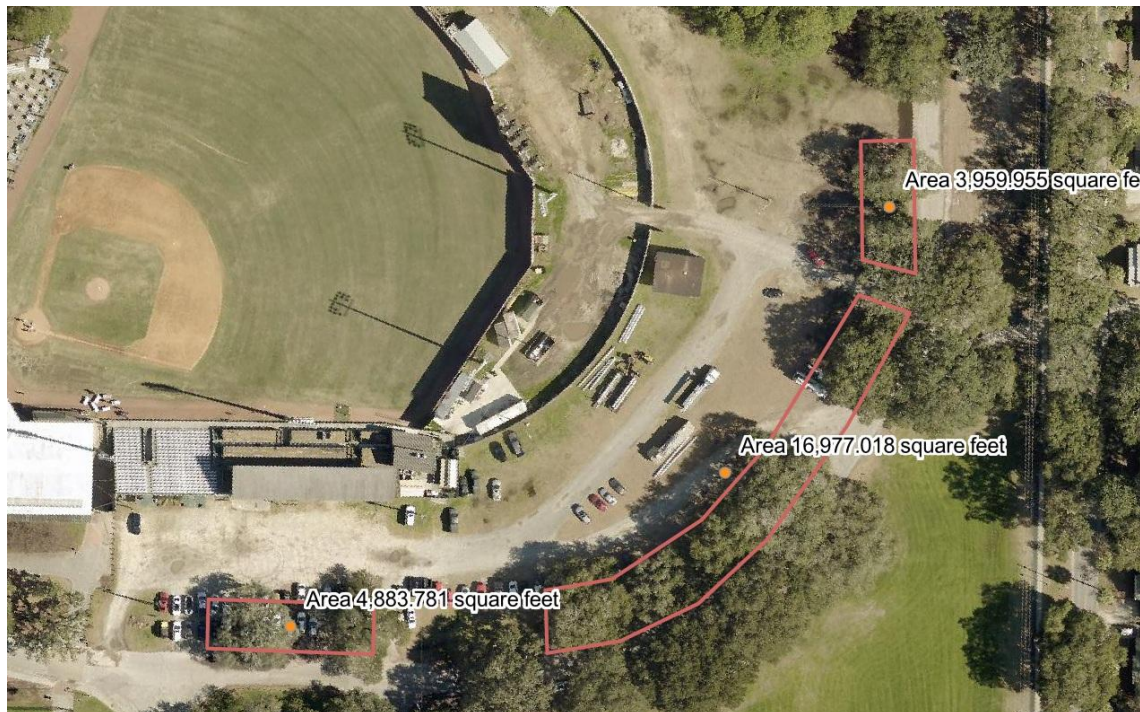
**Reason:** Soil compaction across a tree's root zone severely limits its ability to absorb water and nutrients essential for survival. The recent construction activity has further harmed the trees by physically removing many of the feeder roots that are responsible for this absorption. The most basic idea in tree preservation is to keep damaging activity away, in this case parking and vehicle or equipment activity. For Daffin Park, this should include adding bollards to eliminate the activity in the areas essential for tree survival. There should be a clear delineation of areas that are used for parking or traffic and areas that are essential for tree health. Bollards should be a minimum of 20' from each tree unless there is a permanent road present. This would result in an area of approximately 25,000 square feet being set aside for tree protection.

**Action:** Installation of bollards around damaged trees

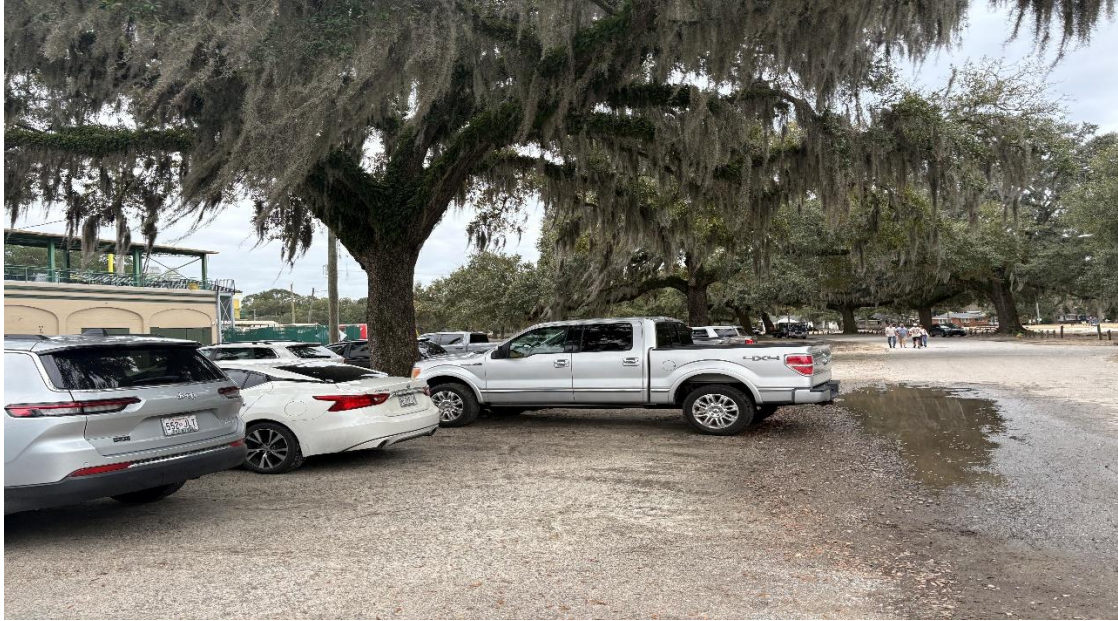
Note: There is an open area within the proposed preservation area that was previously a drive entrance. This has now been changed, and Urban Forestry would like to plant a new tree here for continuity and to protect the space for future trees.

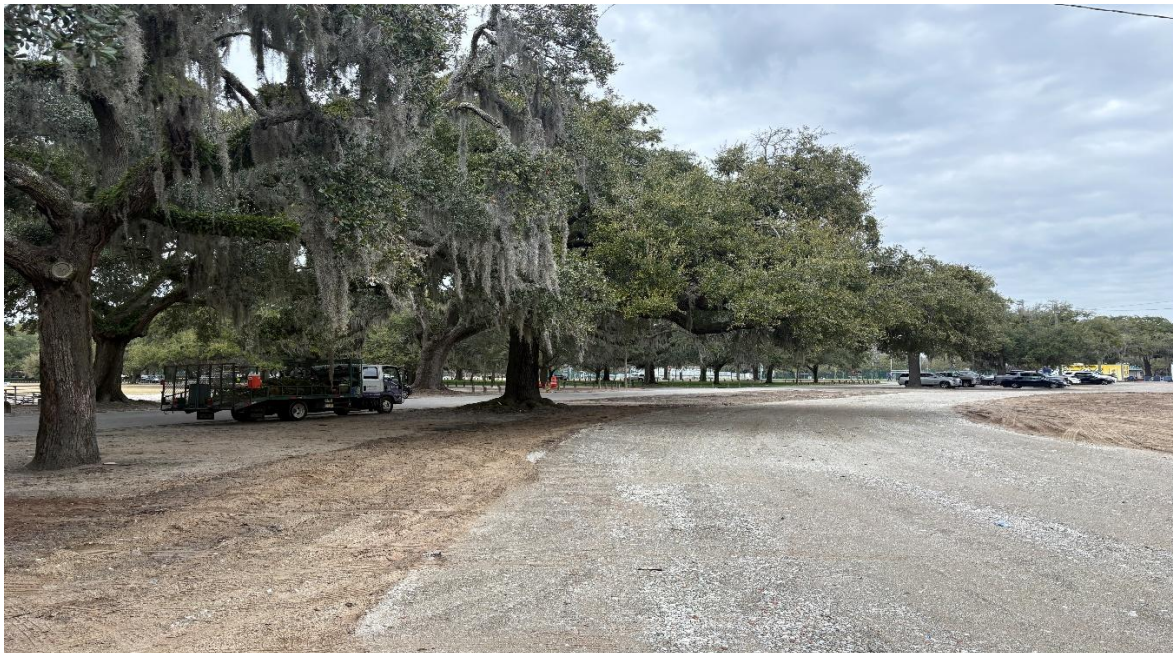
**Reason:** Gravel has been recently put down well with the critical root zone of most of these trees. This gravel will need to be removed prior to any other soil remediation. This will need to be completed somewhat carefully to avoid digging down any further than has already been done. Done properly, there should be very little additional negative impact.

**Action:** Remove recently added gravel that will be within the tree preservation areas.
