HUD MAP Capital Needs Assessment

REPORT DATE: August 21, 2023

Yamacraw Village
555 West Bay Street
Savannah, Chatham County, Georgia 31401

AEI Project No. 480855
Site Assessment Date: July 31 and August 1, 2023

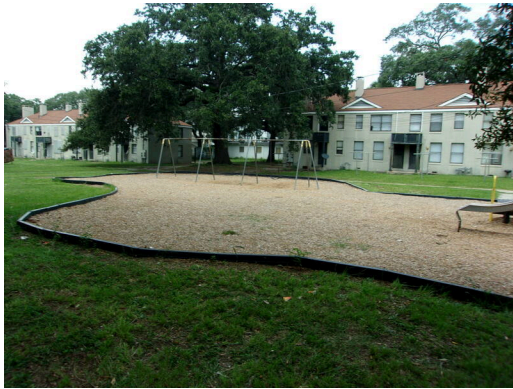
The playground equipment was observed as past its Estimated Useful Life (EUL). In order to prevent further damage and to improve the condition of the property, the replacement of the playground equipment is recommended (Non-Critical Repair).

Playground equipment is past its EUL (Non-Critical Repair)

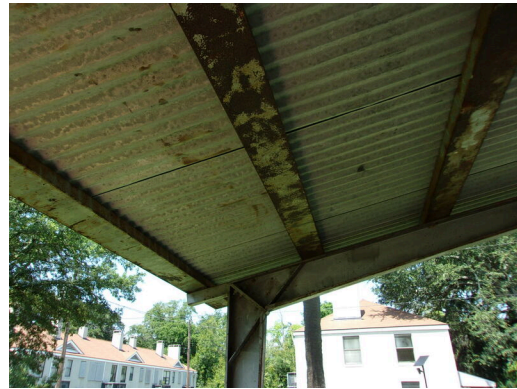
The metal gazebo was observed as deteriorating, rusting and past its Estimated Useful Life (EUL). In order to prevent further damage and to improve the condition of the property, the replacement of the metal gazebo is recommended (Non-Critical Repair).

Replace metal gazebo (Non-Critical Repair)

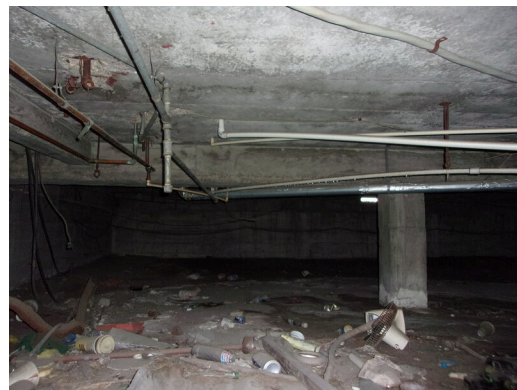
AEI recommends the substructure of the larger and smaller apartment buildings be demolished and rebuilt, due to the following issues: substructure components (CMU foundation walls, concrete piers/raised slab, porch foundations) are past their Estimated Useful Life (EUL), observed spalling concrete and rusting steel reinforcements within the raised floor concrete members, possible asbestos containing concrete deteriorating and causing tenant health issues, settling and cracking CMU foundation walls observed, porch/step foundations are settling and damaged. AEI utilized RS Means Square Foot Cost Estimator to create a report detailing the costs to rebuild this type of apartment building, and is the source of the listed cost (Non-Critical Repair).

Spalling raised concrete slab (Non-Critical Repair), galvanized water supply lines

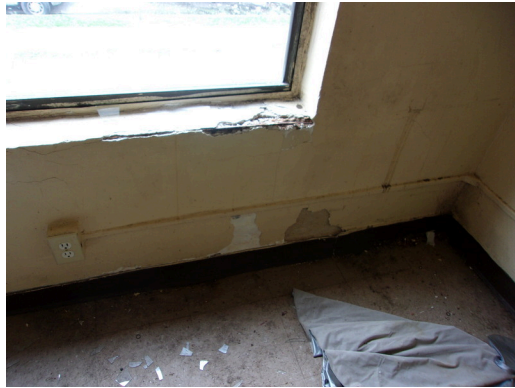
260-268 Yamacraw Village - Unit 264 - 2-bed/1-bath TH - Plaster wall damage (Non-Critical Repair)

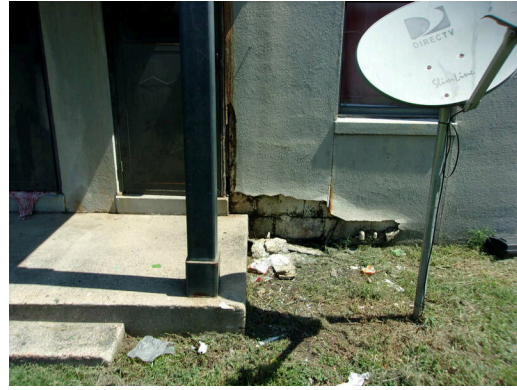
Damaged stucco siding near rear entry door (Non-Critical Repair)

AEI recommends the shell of the larger and smaller apartment buildings be demolished and rebuilt, due to the following issues: shell components (windows, doors, stucco siding) are past their Estimated Useful Life (EUL), broken windows throughout property, water-damaged stucco siding throughout site. AEI utilized RS Means Square Foot Cost Estimator to create a report detailing the costs to rebuild this type of apartment building, and is the source of the listed cost. It is important to note that the asphalt shingle roofing and soffits/fascia were replaced in 2019 and are in good physical condition, however, demolition and rebuilding of the roofs and soffit/fascia is recommended (Non-Critical Repair).

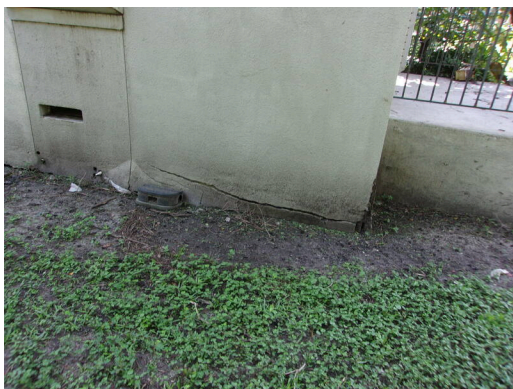
Evidence of foundation settling, damaged stucco siding (Non-Critical Repair)

AEI recommends the shell of the larger and smaller apartment buildings be demolished and rebuilt, due to the following issues: shell components (windows, doors, stucco siding) are past their Estimated Useful Life (EUL), broken windows throughout property, water-damaged stucco siding throughout site. AEI utilized RS Means Square Foot Cost Estimator to create a report detailing the costs to rebuild this type of apartment building, and is the source of the listed cost. It is important to note that the asphalt shingle roofing and soffits/fascia were replaced in 2019 and are in good physical condition, however, demolition and rebuilding of the roofs and soffit/fascia is recommended (Non-Critical Repair).

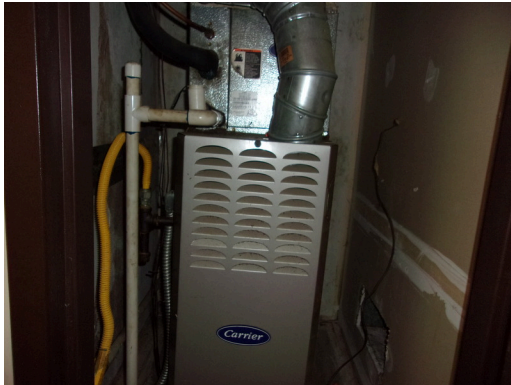
121-128 Yamacraw Village - Unit 126 - 2-bed/ 1-bath TH - Replace gas furnace (Non-Critical Repair)

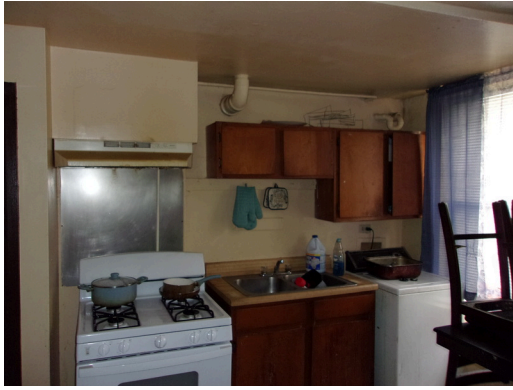
141-148 Yamacraw Village - Unit 142 - 3-bed/
1-bath TH - Kitchen view, replace old
cabinetry (Non-Critical Repair)

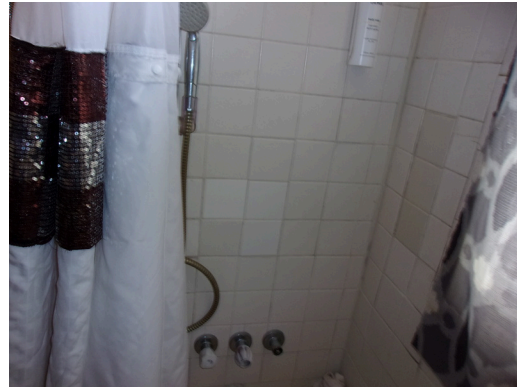
260-268 Yamacraw Village - Unit 261 - 1-bed/
1-bath - HC unit - Partial scald and abrasion
at sink

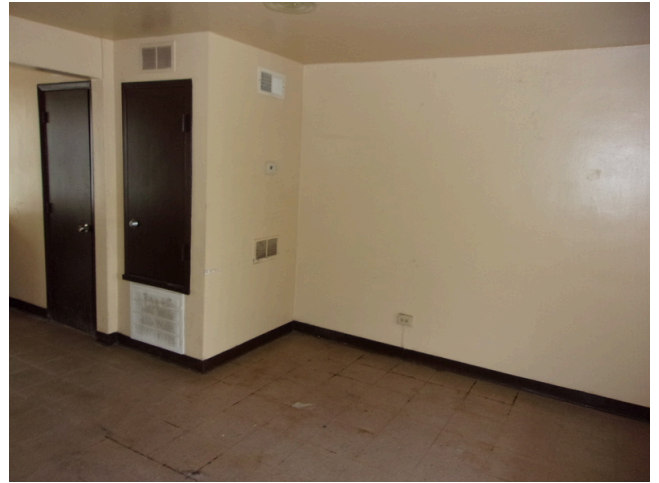
2. 121-128 Yamacraw Village - Unit 126 - 2-bed/
1-bath TH - Living room view

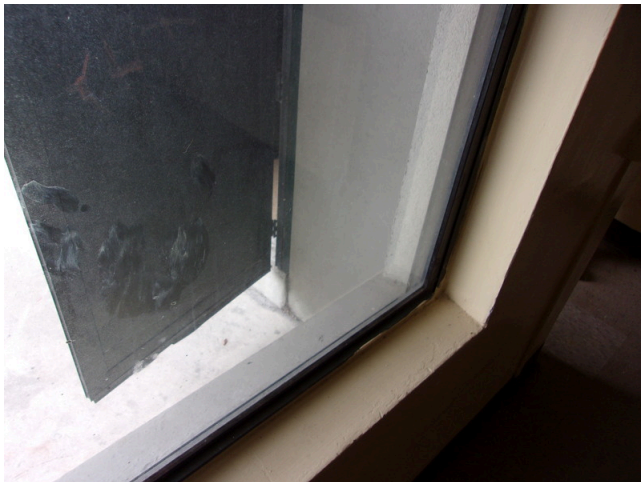
3. 121-128 Yamacraw Village - Unit 126 - 2-bed/
1-bath TH - Single pane single hung window

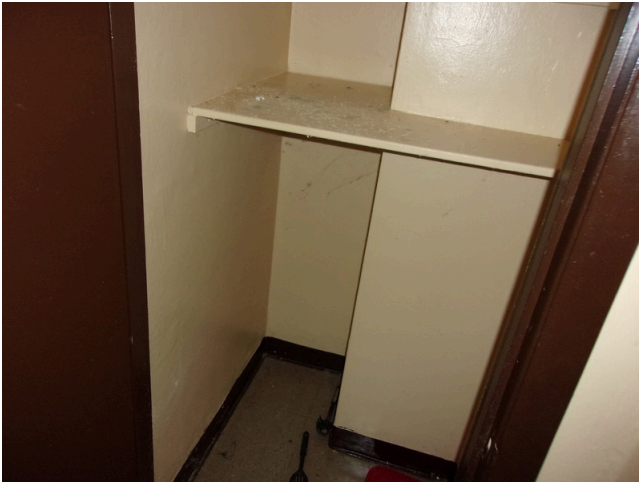
5. 121-128 Yamacraw Village - Unit 126 - 2-bed/
1-bath TH - Closet

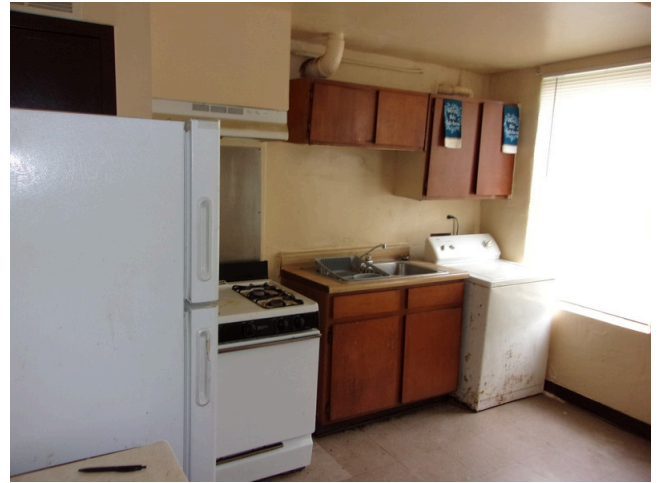
6. 121-128 Yamacraw Village - Unit 126 - 2-bed/
1-bath TH - Kitchen view

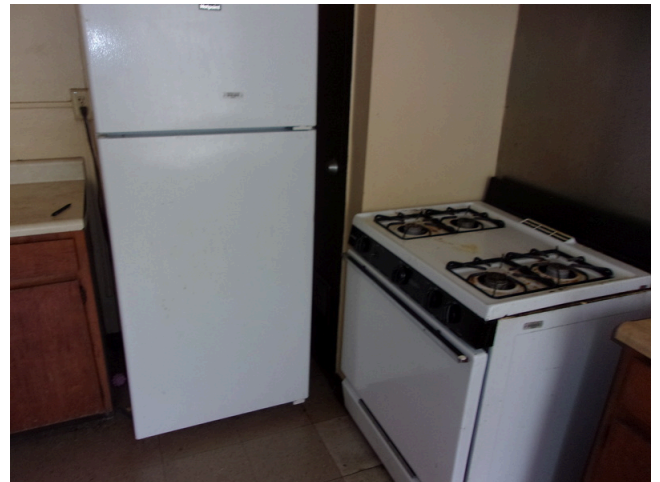
8. 121-128 Yamacraw Village - Unit 126 - 2-bed/
1-bath TH - Refrigerator and gas range/oven

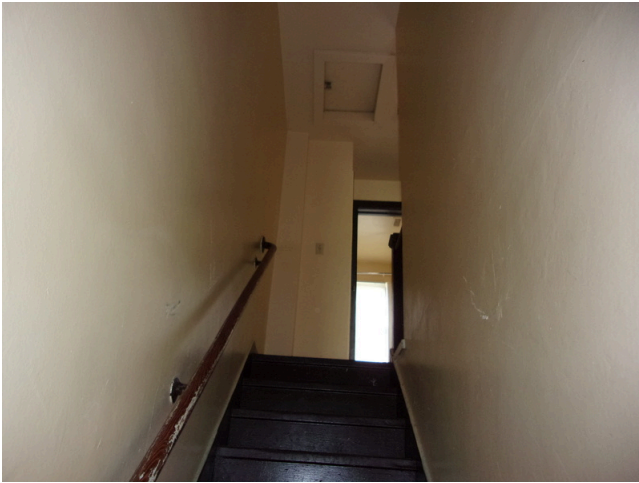
13. 121-128 Yamacraw Village - Unit 126 - 2-bed/
1-bath TH - Interior stairs

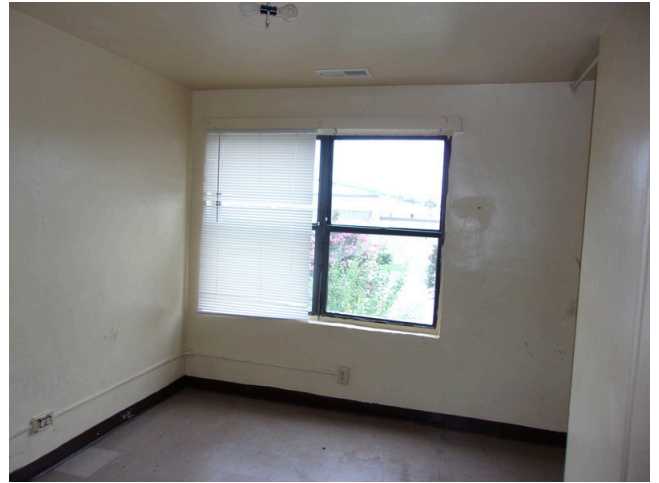
14. 121-128 Yamacraw Village - Unit 126 - 2-bed/
1-bath TH - Bedroom view

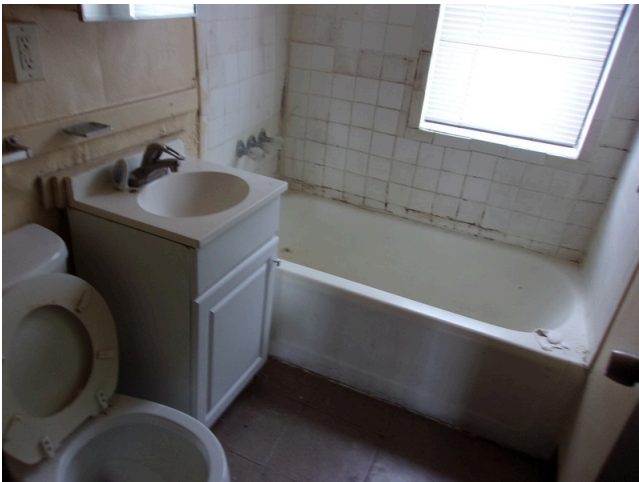
15. 121-128 Yamacraw Village - Unit 126 - 2-bed/
1-bath TH - Bathroom view

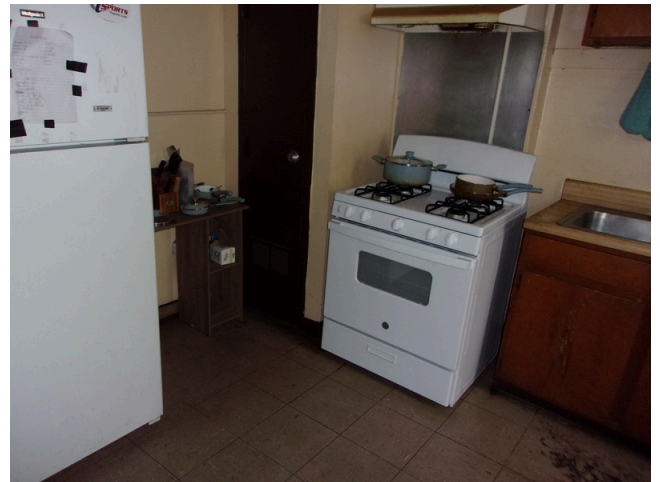
20. 141-148 Yamacraw Village - Unit 142 - 3-bed/
1-bath TH - Kitchen appliances

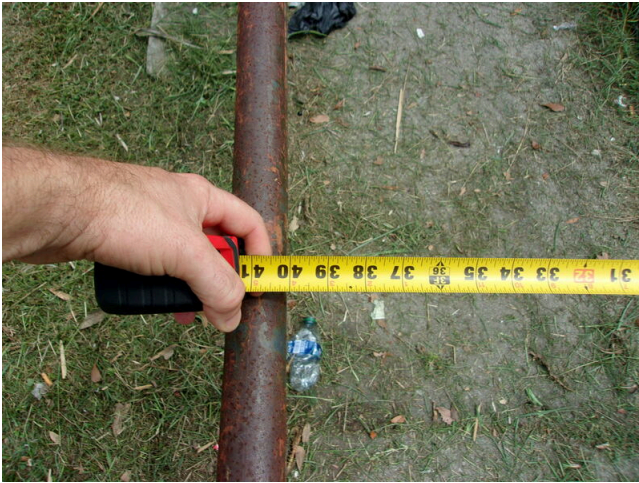
28. 260-268 Yamacraw Village - Unit 261 - 1-bed/
1-bath - HC unit - Replace metal/concrete ramp
(Non-Critical Repair)

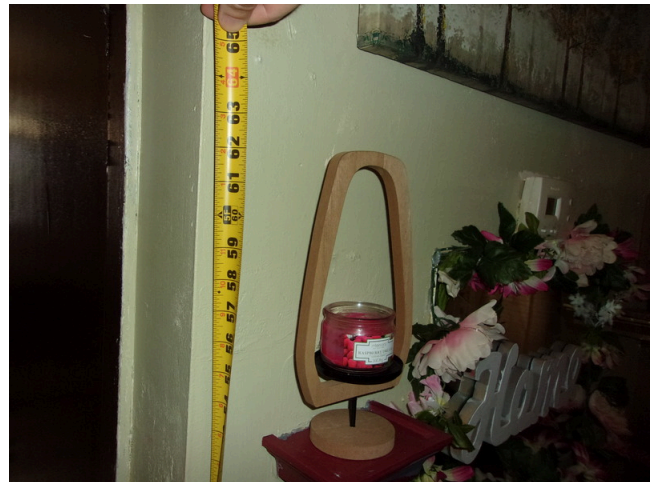
35. 260-268 Yamacraw Village - Unit 261 - 1-bed/
1-bath - HC unit - Light switch at 48 inches AFF

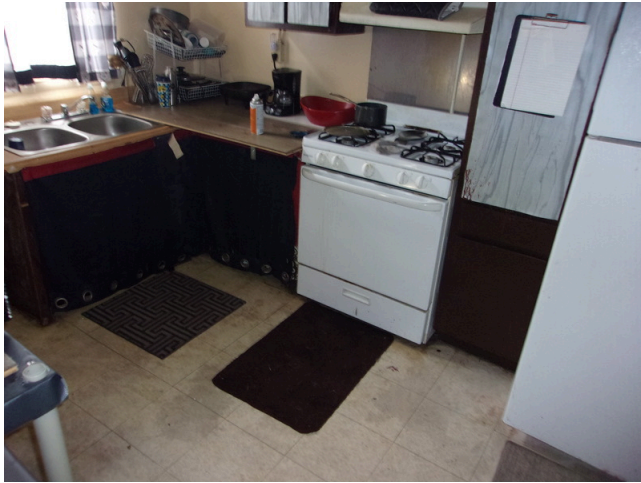
36. 260-268 Yamacraw Village - Unit 261 - 1-bed/
1-bath - HC unit - Thermostat at 60 inches AFF

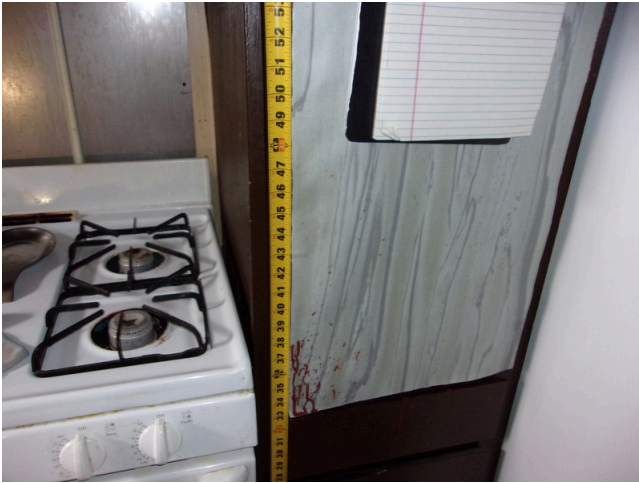
40. 260-268 Yamacraw Village - Unit 261 - 1-bed/
1-bath - HC unit - Clear floor space at range/oven

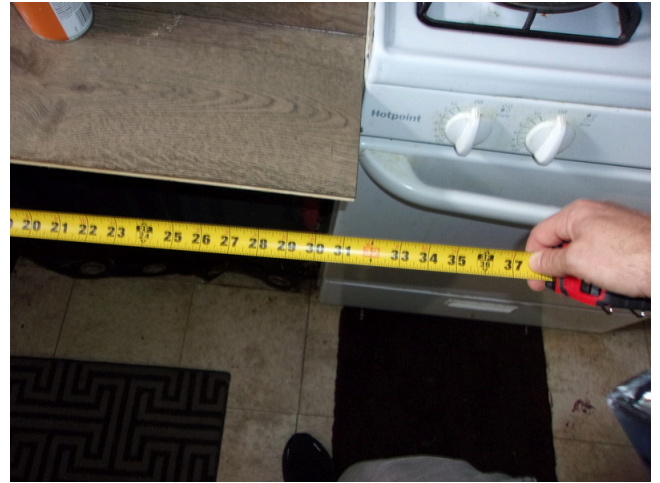
41. 260-268 Yamacraw Village - Unit 261 - 1-bed/
1-bath - HC unit - Cabinets at 48 inches AFF

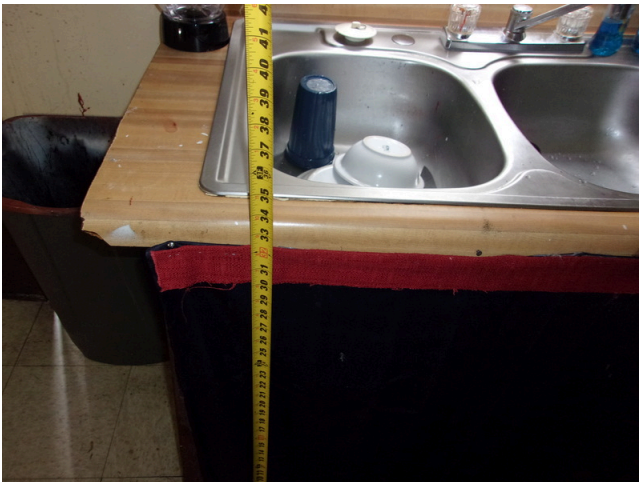
42. 260-268 Yamacraw Village - Unit 261 - 1-bed/
1-bath - HC unit - 30 inch roll-under workspace

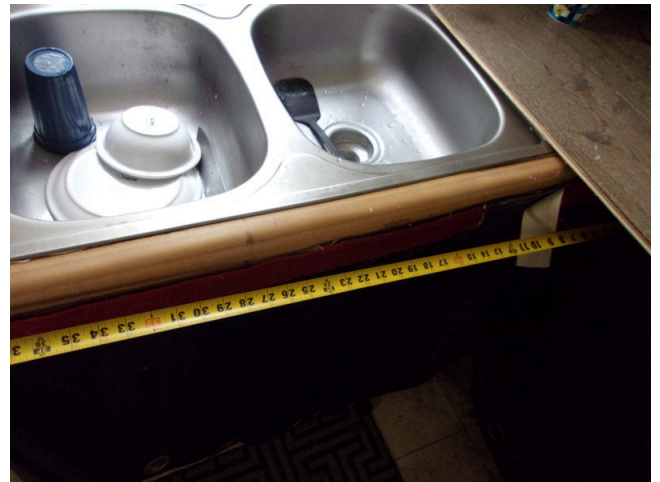
43. 260-268 Yamacraw Village - Unit 261 - 1-bed/
1-bath - HC unit - Lowered countertops at sink

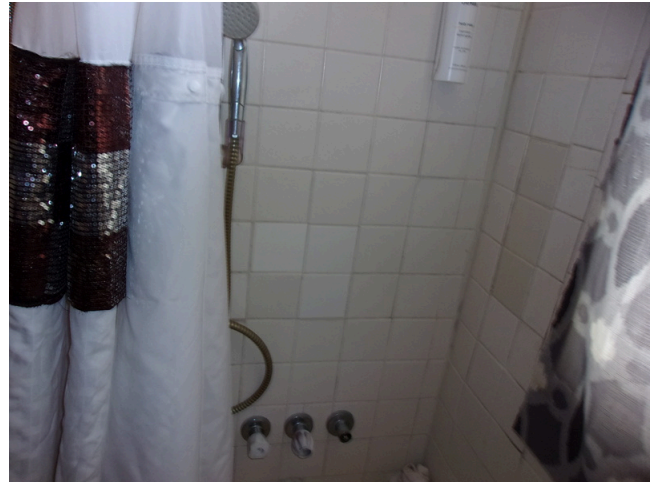
53. 260-268 Yamacraw Village - Unit 261 - 1-bed/
1-bath - HC unit - Tub/shower view with grab bars

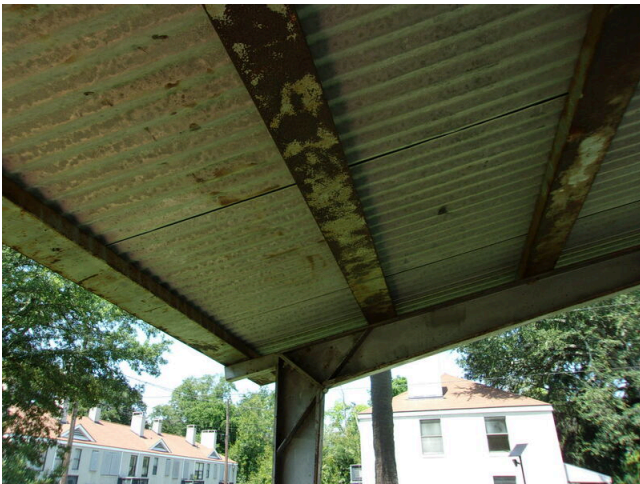
51. Replace metal gazebo (Non-Critical Repair)

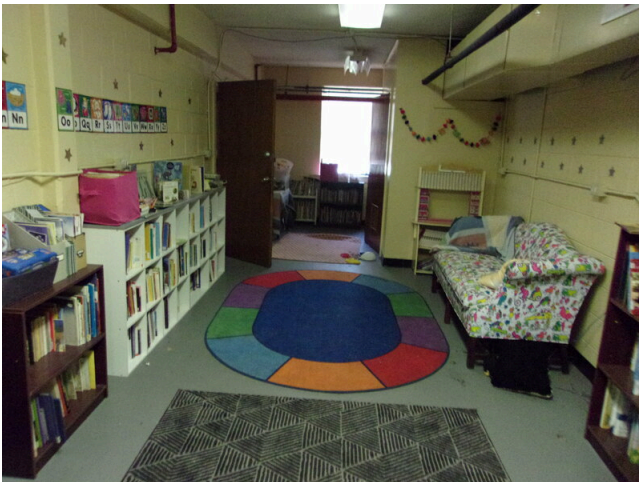
139. 349 West Bryan Street - Community center - Classroom

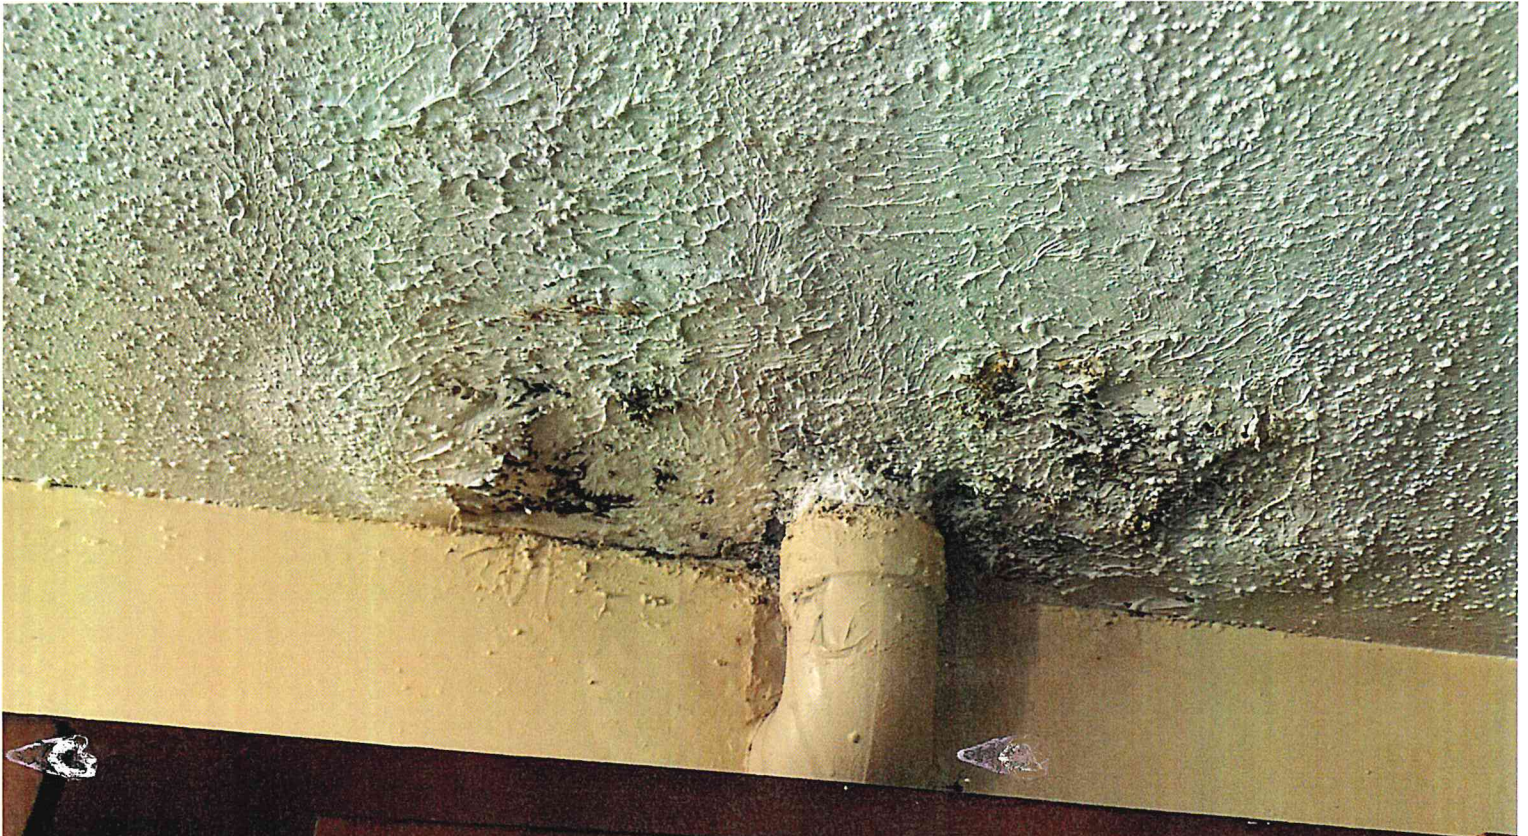
Mar 31, 2023 at 10:01:08 AM
1056 Yamacraw Village
Savannah GA 31401
United States
Address:
Officer Miccoli

Violation: 305.1 - Interior General
Description: The interior of a structure and equipment therein shall be maintained in good repair , structurally sound and in a sanitary condition. Occupants shall keep that part of the structure which they occupy or control in a clean and sanitary condition. Every owner of a structure containing a rooming house, housekeeping units, a hotel, a dormitory, two or more dwelling units or two or more nonresidential occupancies, shall maintain, in a clean and sanitary condition, the shared or public areas of the structure and exterior property.
Corrective Action: **Bubbling and discoloration of ceiling near the pipe in the kitchen and the discoloration of the wall needs to be repaired or replaced.**
Required Compliance Date: 05/01/2023

Violation: 305.6 - Interior Doors
Description: Every interior door shall fit reasonably well within its frame and shall be capable of being opened and closed by being properly and securely attached to jambs, headers or tracks as intended by the manufacturer of the attachment hardware.
Corrective Action: **Cabinetry door needs to be repaired or replaced.**
Required Compliance Date: 05/01/2023

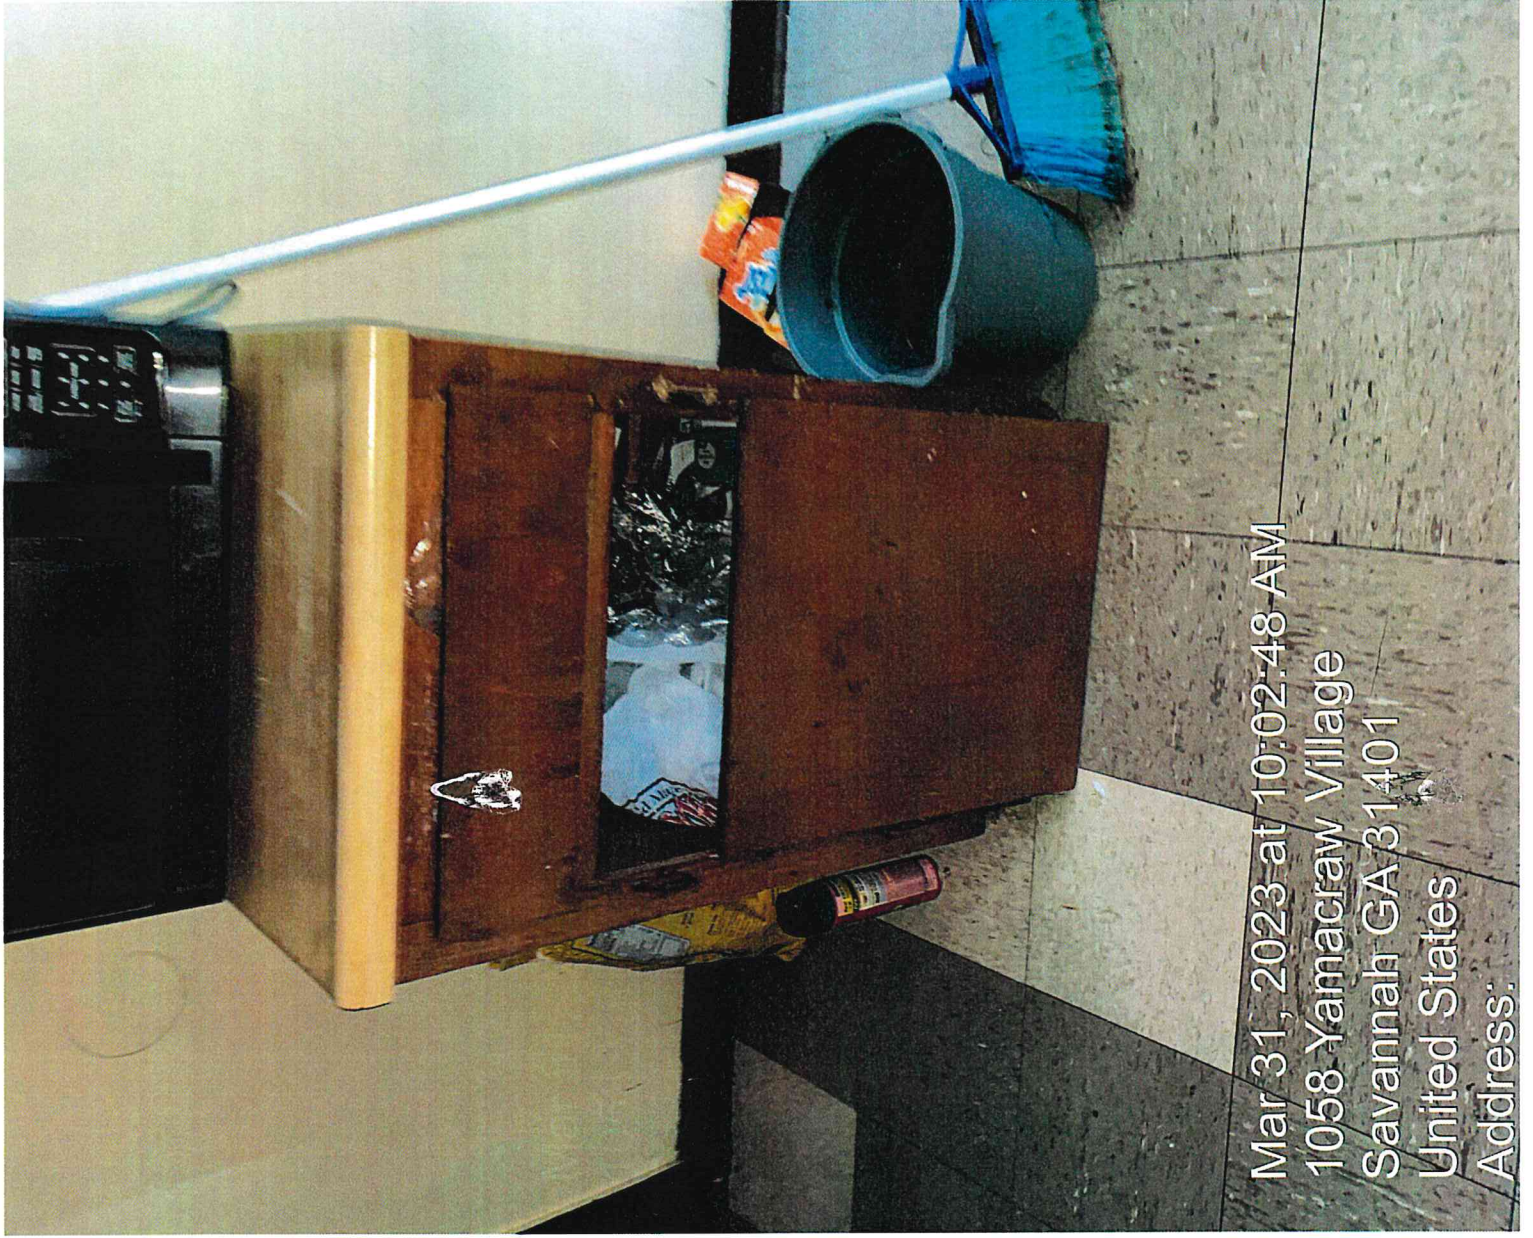
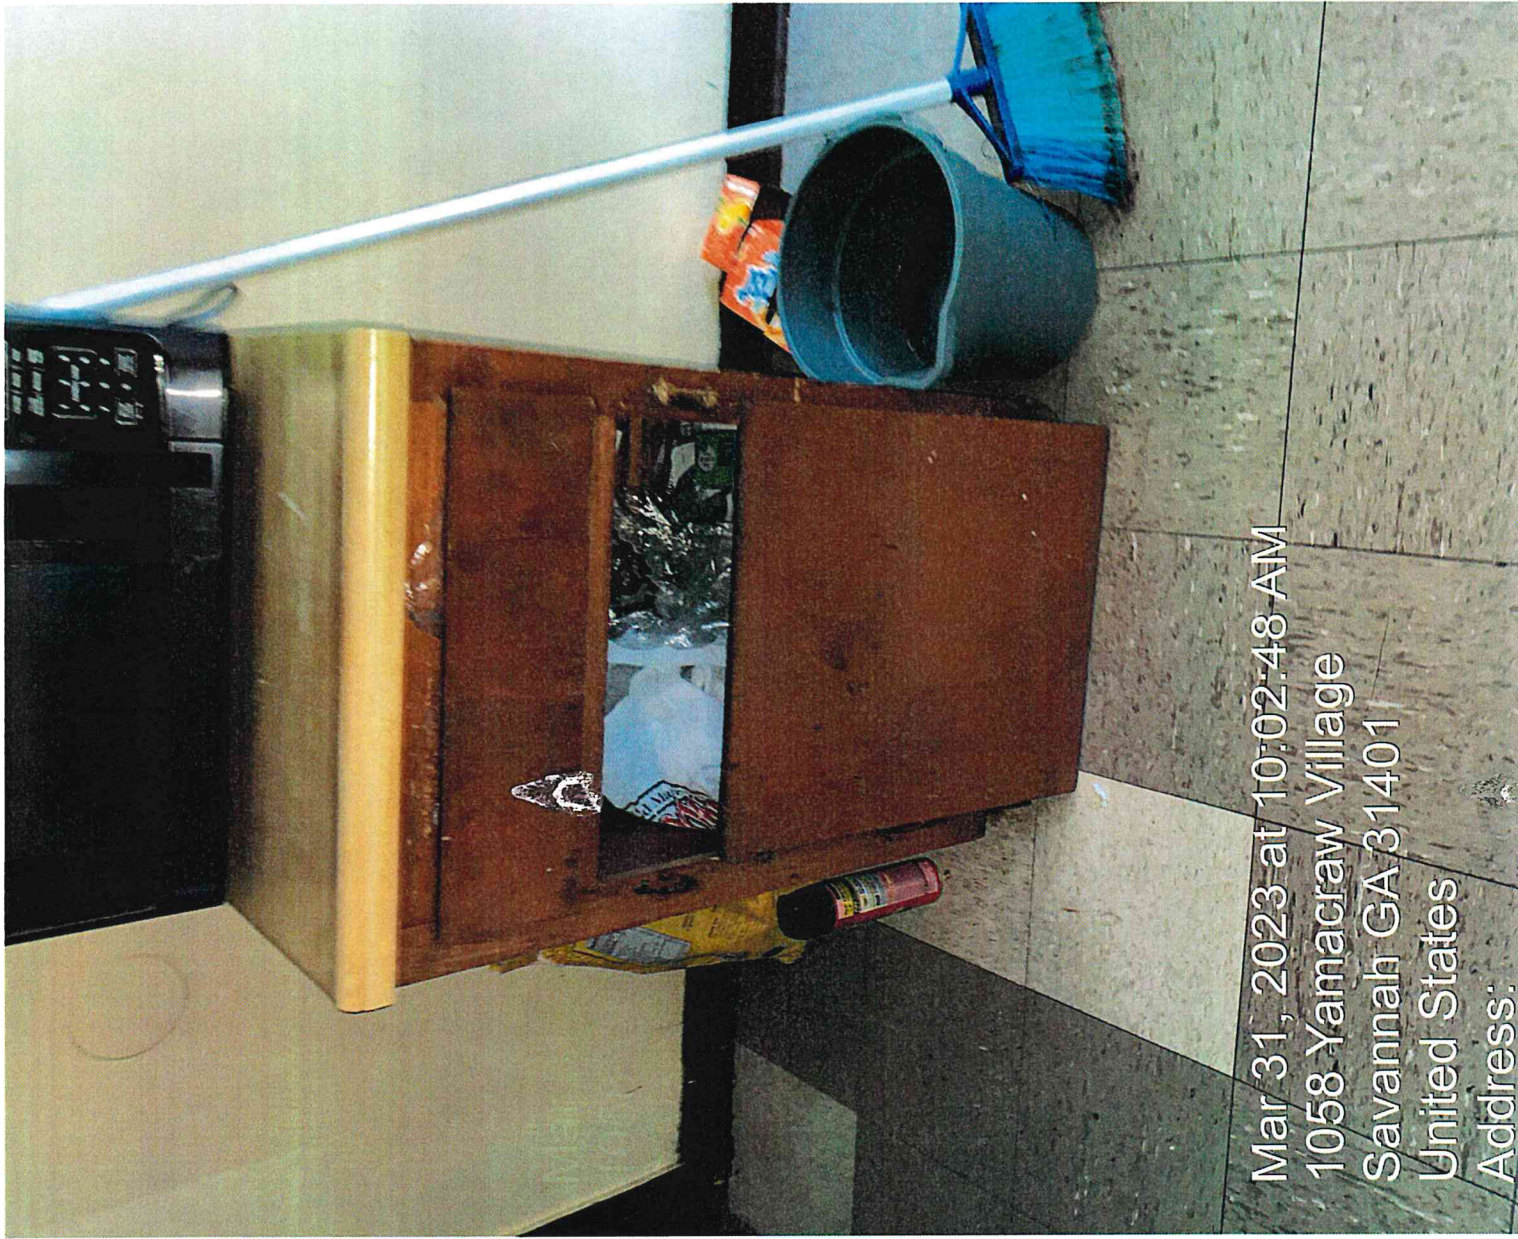
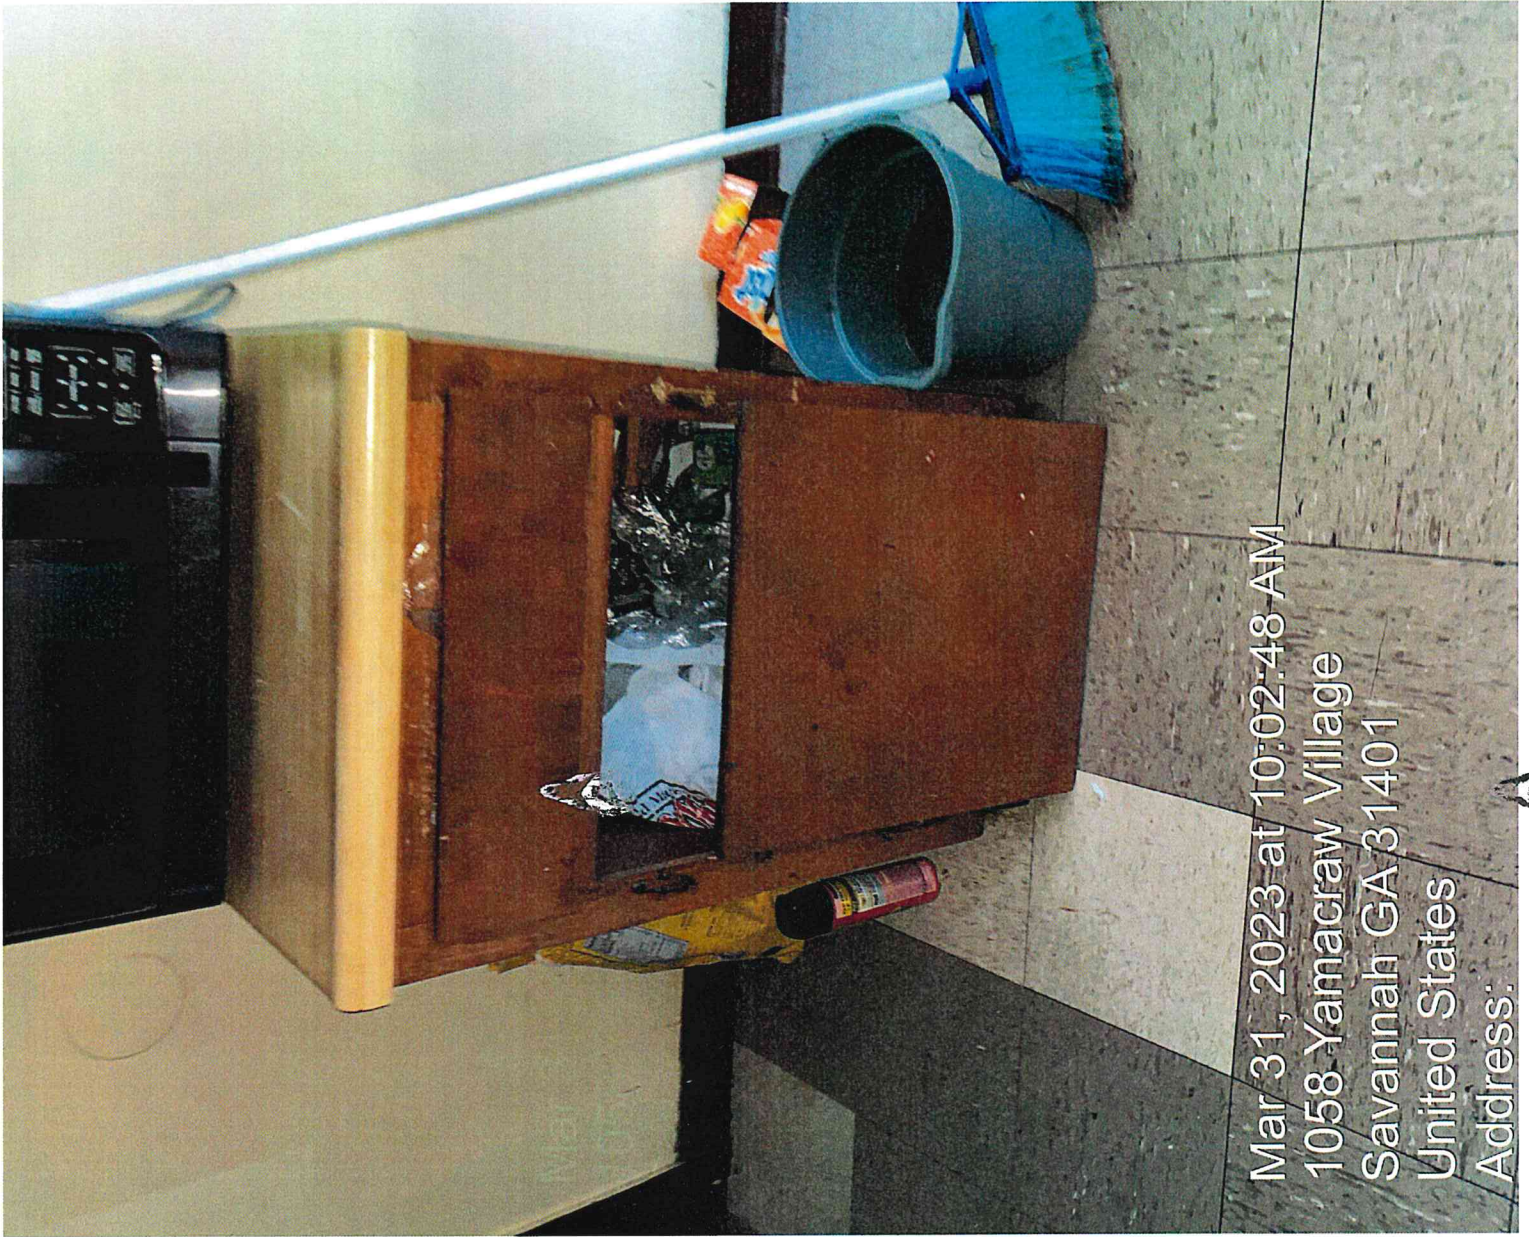
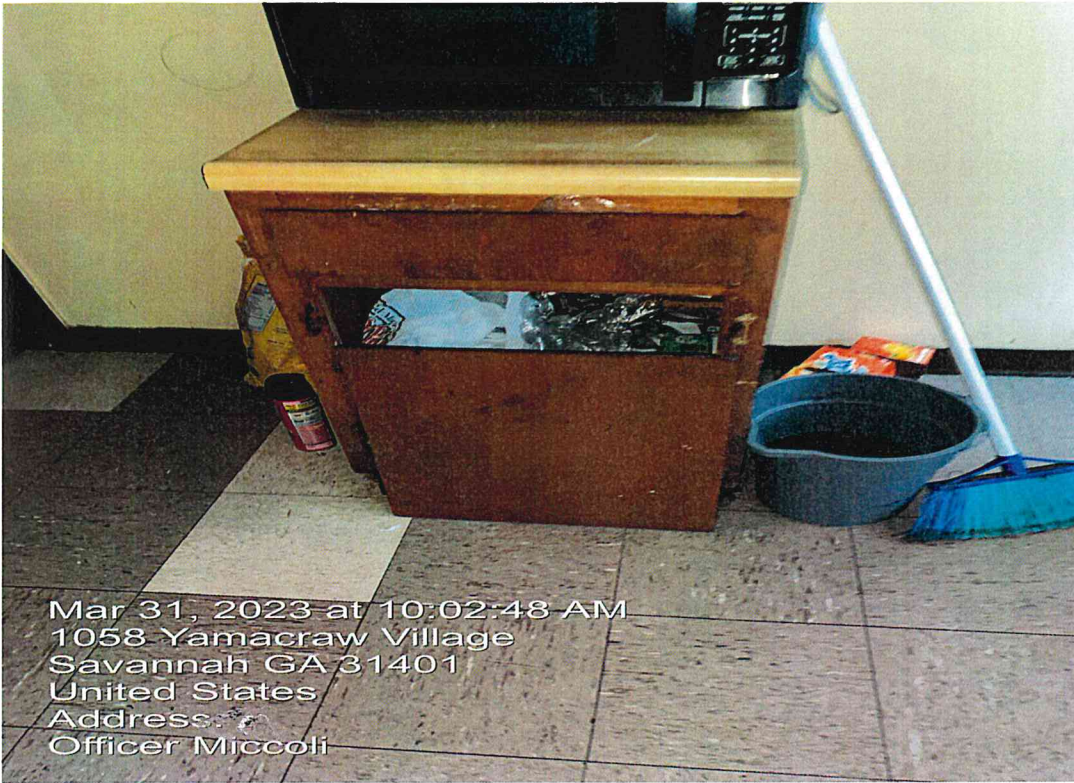
Mar 31, 2023 at 10:02:48 AM
1058 Yamacraw Village
Savannah GA 31401
United States
Address:

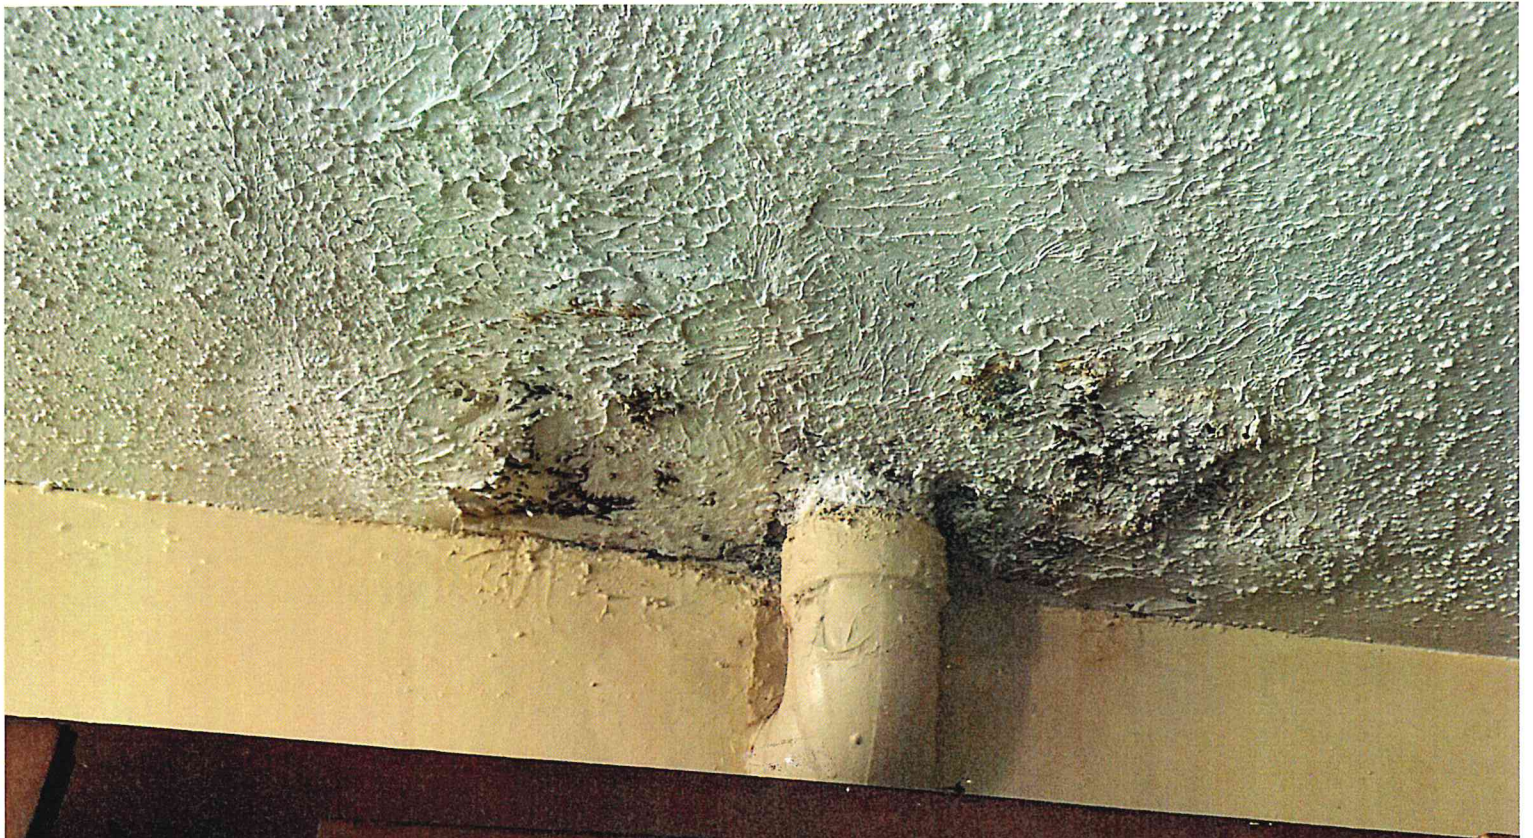
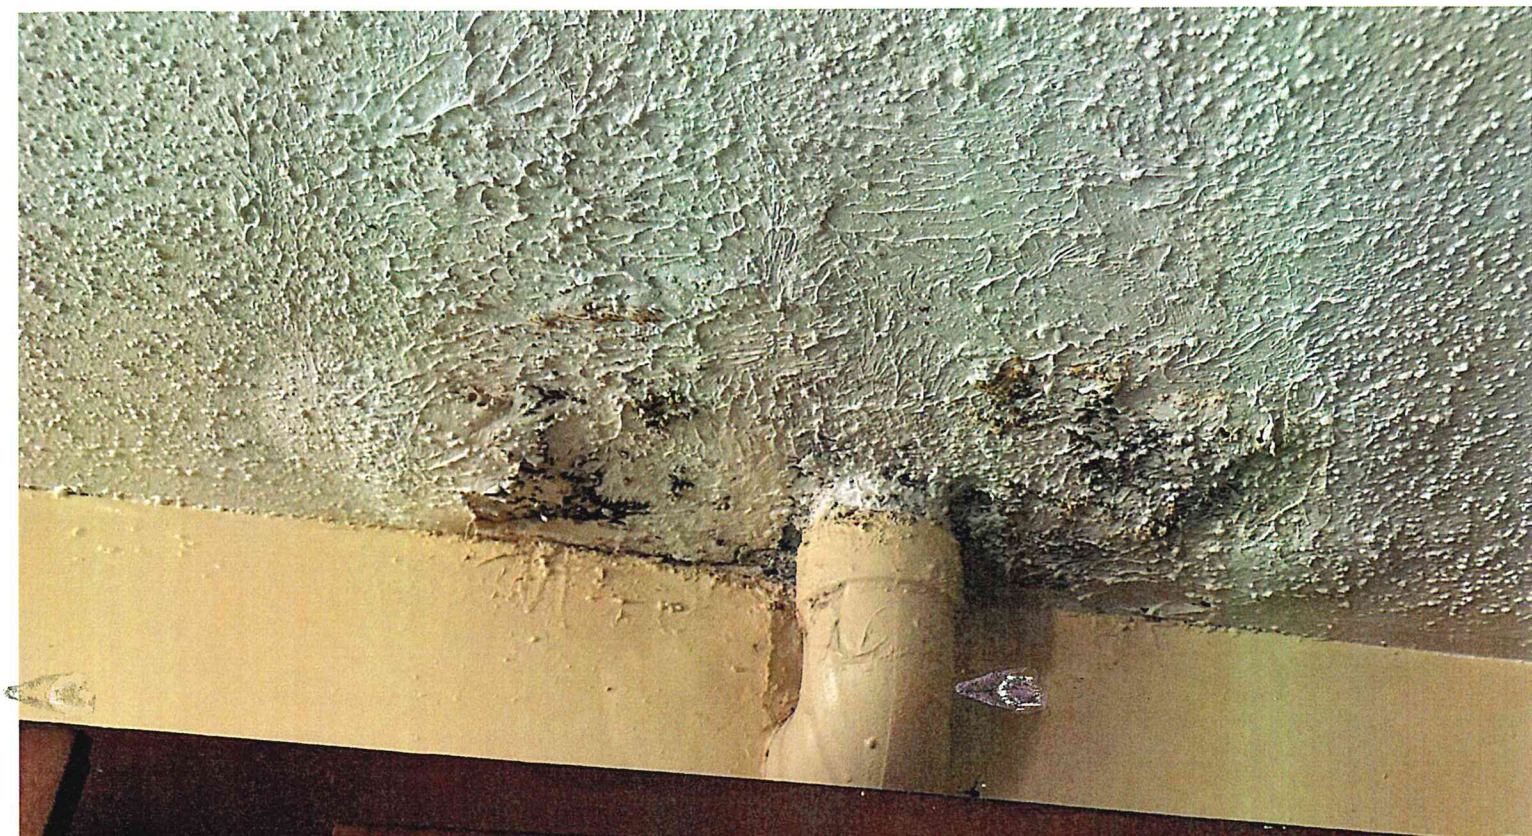
Violation: 305.1 - Interior General
Description: The interior of a structure and equipment therein shall be maintained in good repair , structurally sound and in a sanitary condition. Occupants shall keep that part of the structure which they occupy or control in a clean and sanitary condition. Every owner of a structure containing a rooming house, housekeeping units, a hotel, a dormitory, two or more dwelling units or two or more nonresidential occupancies, shall maintain, in a clean and sanitary condition, the shared or public areas of the structure and exterior property.
Corrective Action: **Bubbling and discoloration of ceiling near the pipe in the kitchen and the discoloration of the wall needs to be repaired or replaced.**
Required Compliance Date: 05/01/2023

Mar 31, 2023 at 10:01:08 AM
1056 Yamacraw Village
Savannah GA 31401
United States
Address:
Officer Miccoli

Violation: 305.6 - Interior Doors
Description: Every interior door shall fit reasonably well within its frame and shall be capable of being opened and closed by being properly and securely attached to jambs, headers or tracks as intended by the manufacturer of the attachment hardware.
Corrective Action: **Cabinetry door needs to be repaired or replaced.**
Required Compliance Date: 05/01/2023
