HUD MAP Capital Needs Assessment

REPORT DATE: August 21, 2023

Yamacraw Village
555 West Bay Street
Savannah, Chatham County, Georgia 31401

AEI Project No. 480855
Site Assessment Date: July 31 and August 1, 2023

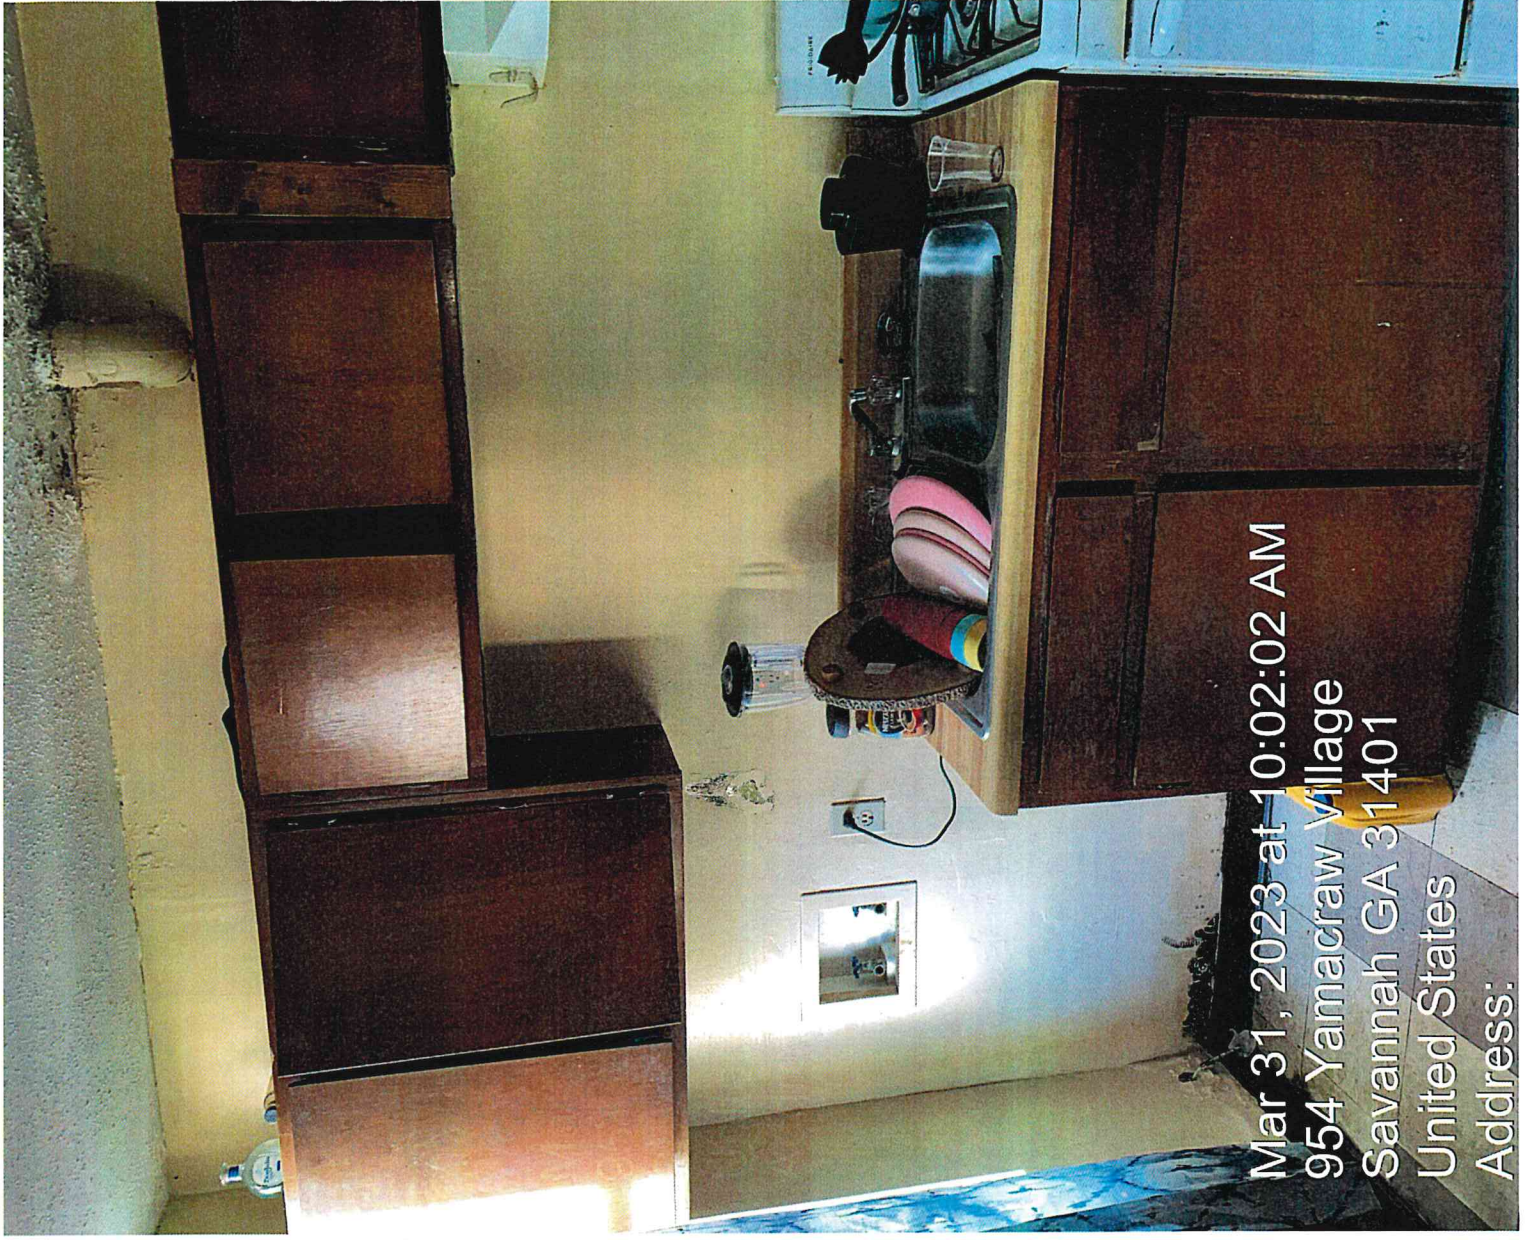
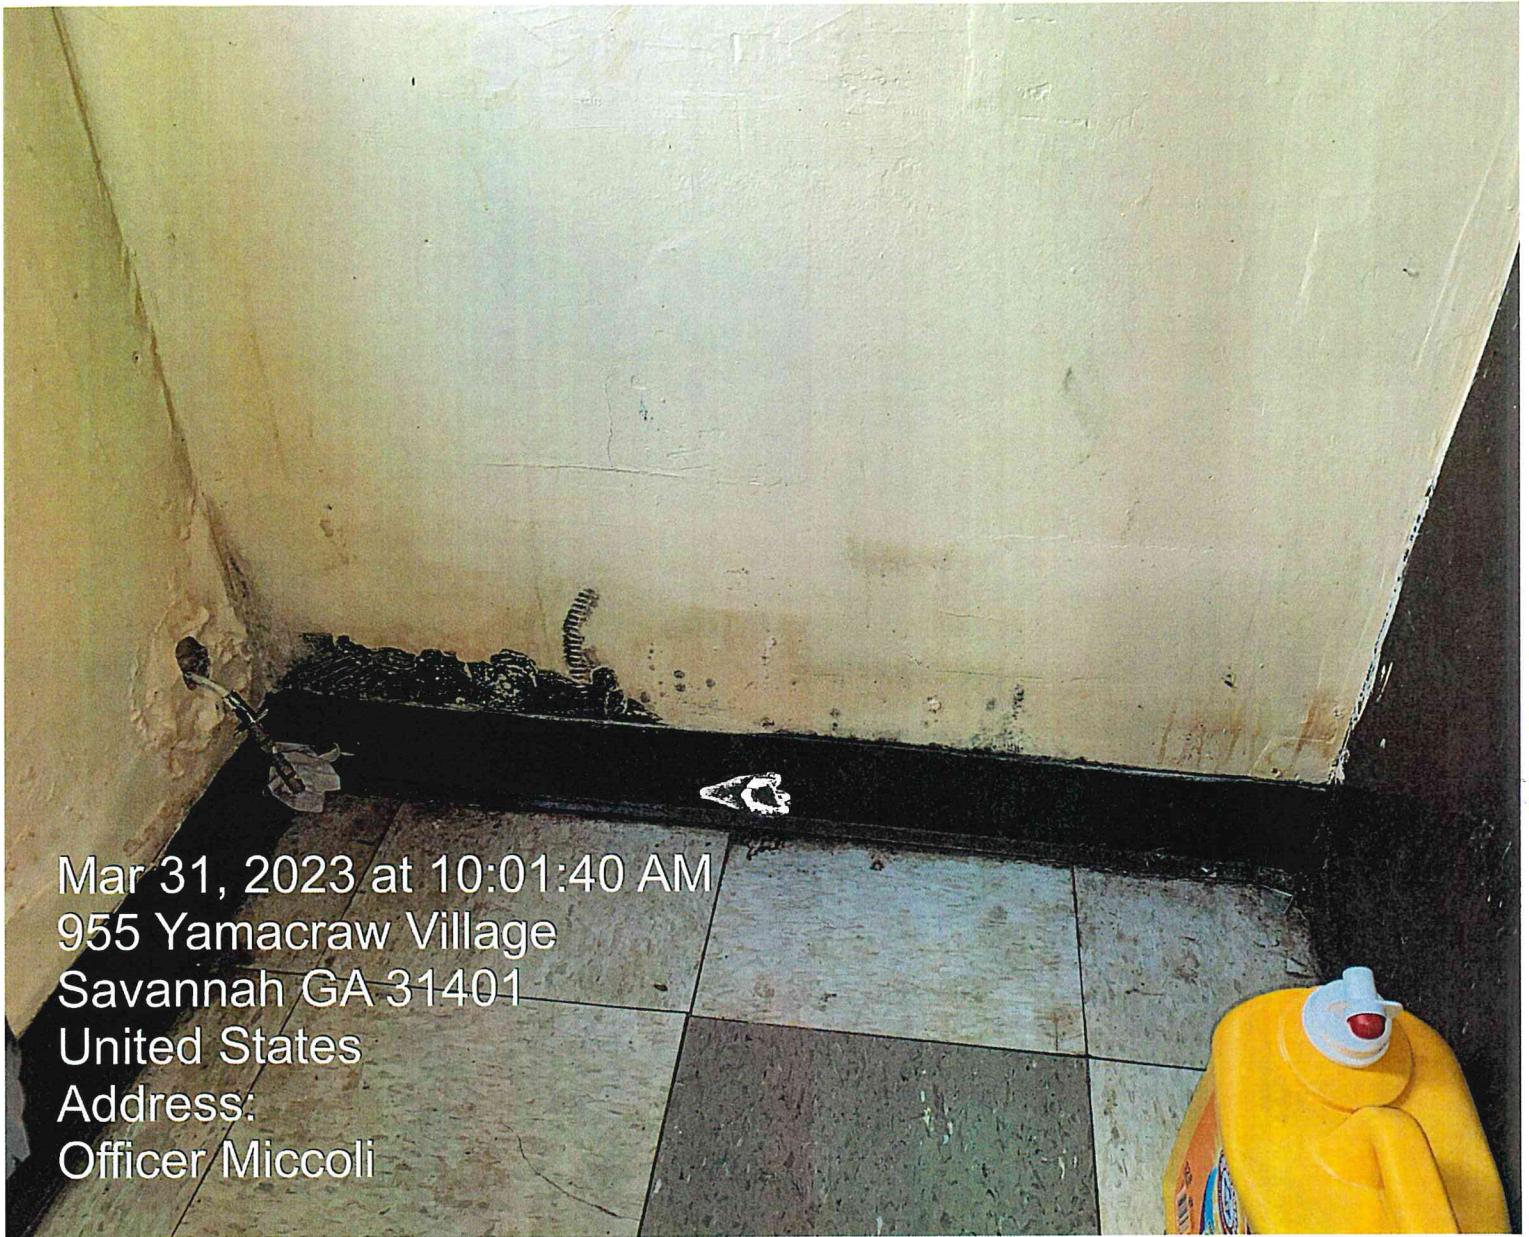
Mar 31, 2023 at 10:01:40 AM
955 Yamacraw Village
Savannah GA 31401
United States
Address:
Officer Miccoli
